**RAILWAY INVESTIGATION REPORT  
R11T0016**

**MAIN TRACK DERAILMENT**

**CANADIAN PACIFIC RAILWAY  
FREIGHT TRAIN 220-24  
MILE 105.1, MACTIER SUBDIVISION  
BUCKSKIN, ONTARIO  
26 JANUARY 2011**

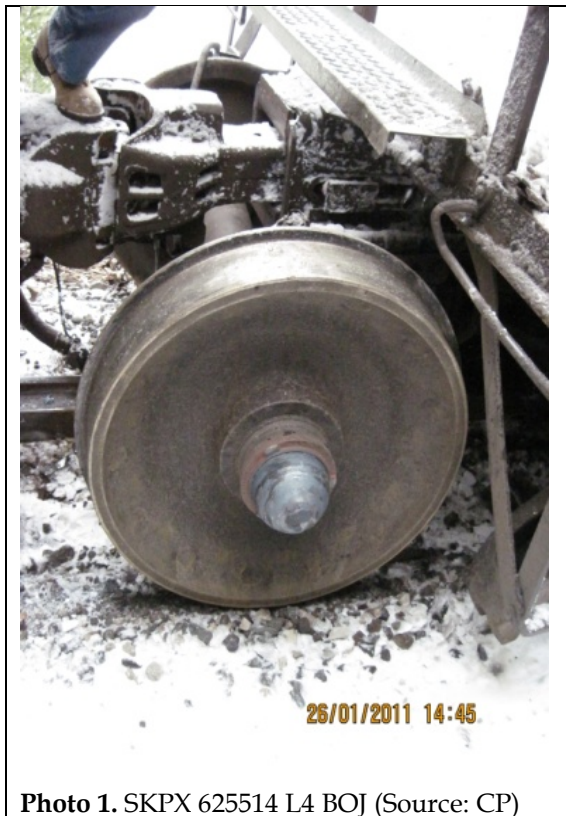
**Photo 1.** SKPX 625514 L4 BOJ (Source: CP)

A total of 21 cars on train 220 (27<sup>th</sup> to 47<sup>th</sup> cars) had derailed. The lead truck of the lead locomotive on train 221 was also derailed. The 27<sup>th</sup> to 29<sup>th</sup> cars had remained coupled to the head- end of train 220 and had side swiped the locomotives and first 9 cars of train 221, which was stationary in the siding. The 30<sup>th</sup> to 47<sup>th</sup> cars on train 220 came to rest in various positions in the vicinity of the Buckskin North siding switch (Mile 103.75). Inspection revealed that the L4 roller bearing in the trailing truck of train 220's 27<sup>th</sup> car (freight car SKPX 625514), a covered hopper car with a 286 000 gross rail load (GRL) capacity loaded with grain, had failed. Subsequently, the L4 axle journal had burnt off (BOJ) and separated from the axle (see Photo 1).

The L-4 axle journal had burnt off the axle approximately 4 inches from the axle journal fillet radius. The remaining axle journal profile was typically conical in shape tapering down to a 4 inch diameter at the point of separation. All remaining L-4 bearing components were severely heat discoloured, smeared, and plastically deformed (see Photo 2). Heavy spalling was observed on the inboard cup raceway. The corresponding cage, rollers and all seals lips were destroyed (see Photo 3). The outboard cone assembly, spacer and both seal casings remained fused to the cup through the load zone.

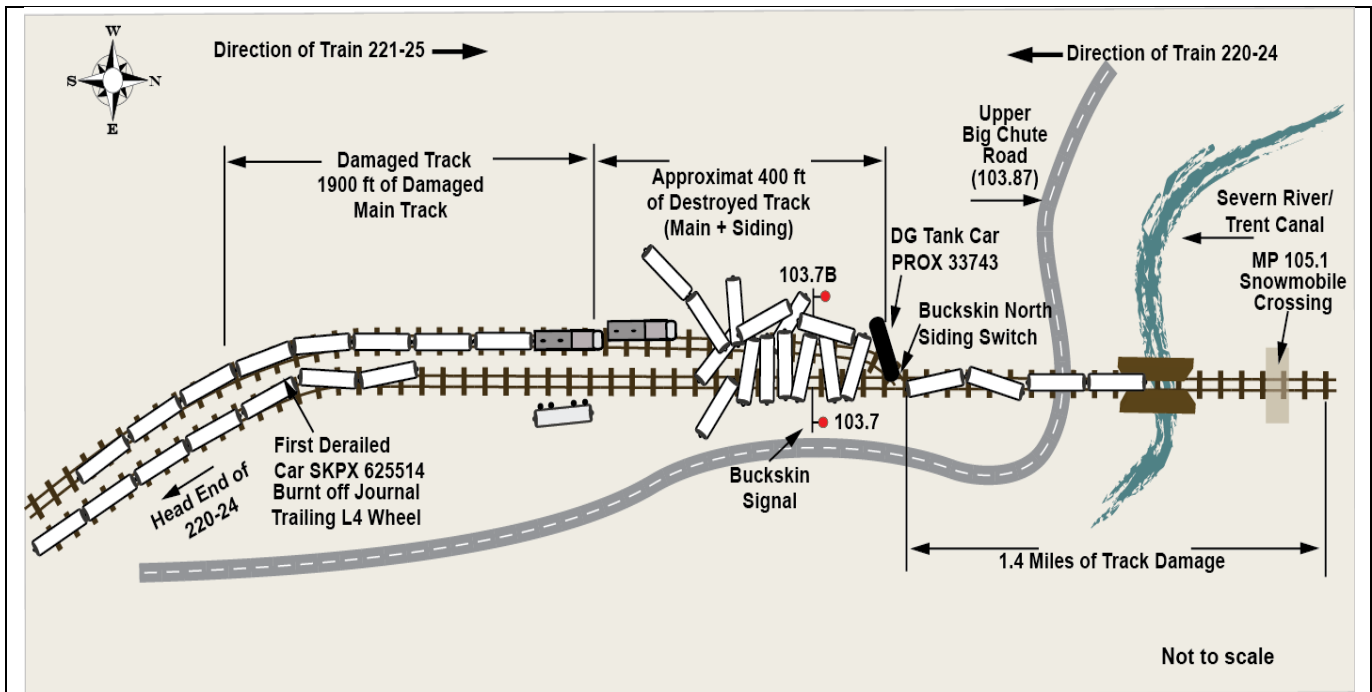
Figure 2. Derailment site diagram

About 400 feet of track, including the Buckskin Siding north turnout and signal structures, were destroyed. Approximately 1900 feet of track in the area of the accident and 1.4 miles of the main track approaching the siding was damaged (see Figure 2).

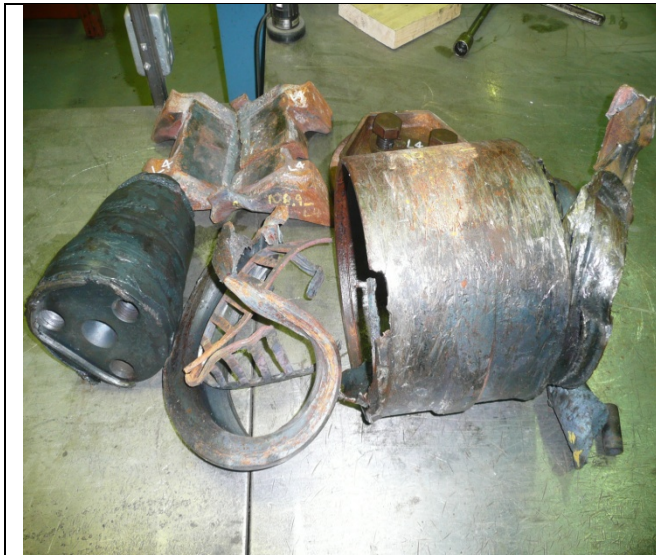
**Photo 2.** L-4 roller bearing components

Eventually, the cage fails, the rollers are no longer held in place and the roller bearing geometry is compromised. This ultimately results in bearing failure, seizure and, if undetected, a BOJ. In this occurrence, severe spalling on the inboard cup raceway of the SKPX 625514 L-4 roller bearing generated an inboard cage failure which resulted in bearing seizure and the subsequent BOJ.

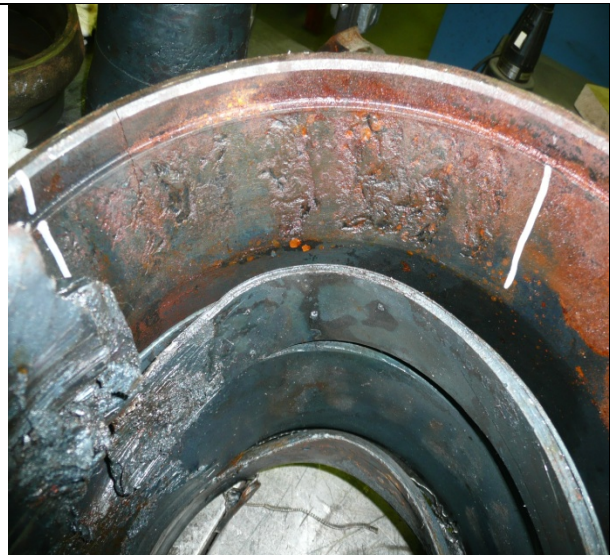
**Photo 3.** L-4 spalled inboard cup path (typical)

1. The derailment occurred when the L-4 roller bearing from car SKPX 625514 on train 220 overheated, seized and failed due to severe spalling on the inboard cup path which ultimately resulted in the burnt-off axle journal.
2. The absence of an HBD within the 43.3 miles of CP track, limited the opportunities to detect the overheated roller bearing prior to failure.
