**RAILWAY INVESTIGATION REPORT  
R12E0004**

**MAIN-TRACK COLLISION  
CANADIAN NATIONAL  
RUNAWAY ROLLING STOCK AND TRAIN A45951-16  
MILE 44.5, GRANDE CACHE SUBDIVISION  
HANLON, ALBERTA  
18 JANUARY 2012**

Report Number R12E0004

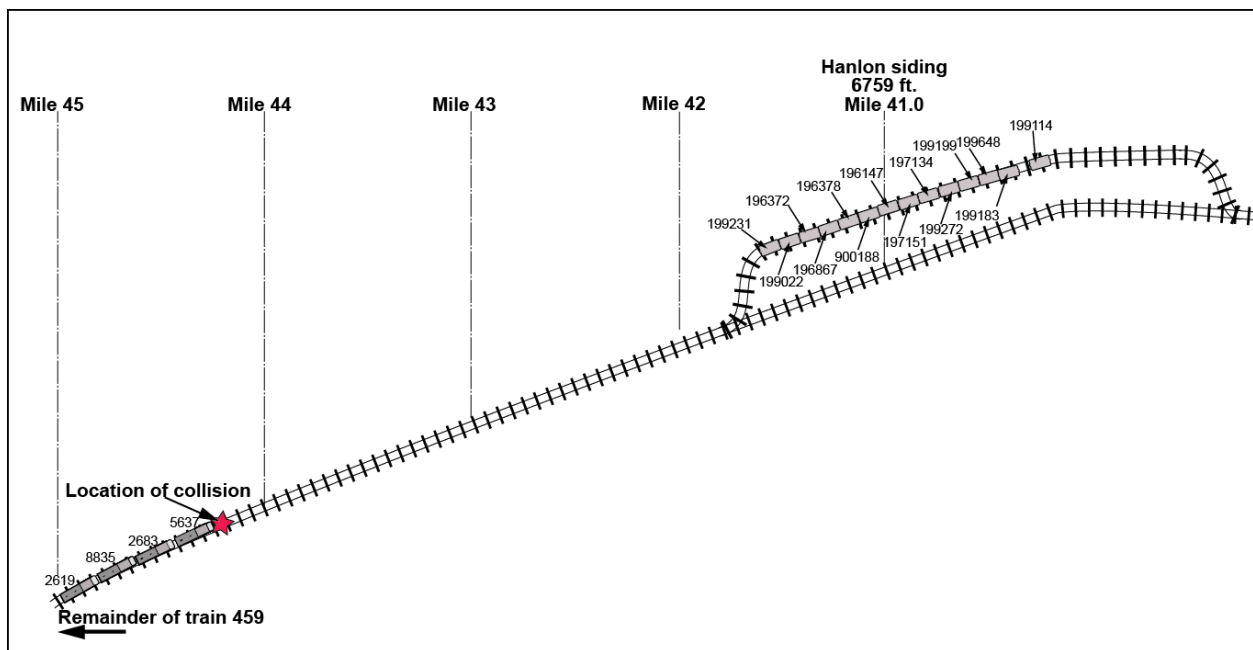
After completing the brake test, the tail-end 13 cars of the movement were left in the siding along with the original defective car, CN 199114 (see Figure 2). The 4 north-end cars were taken back to the train at Mile 25.7. To protect the point of the movement, the conductor was required to ride on the leading end of the 4th car. Due to the cold temperatures and long distance back to the train, frequent stops were made to allow the conductor to warm up in the locomotive cab. Once back at Mile 25.7, the train was recoupled and the brake system recharged. The crew had used their allowable hours of service and were relieved of duty at approximately 1000.

Figure 2. Site diagram (not to scale)

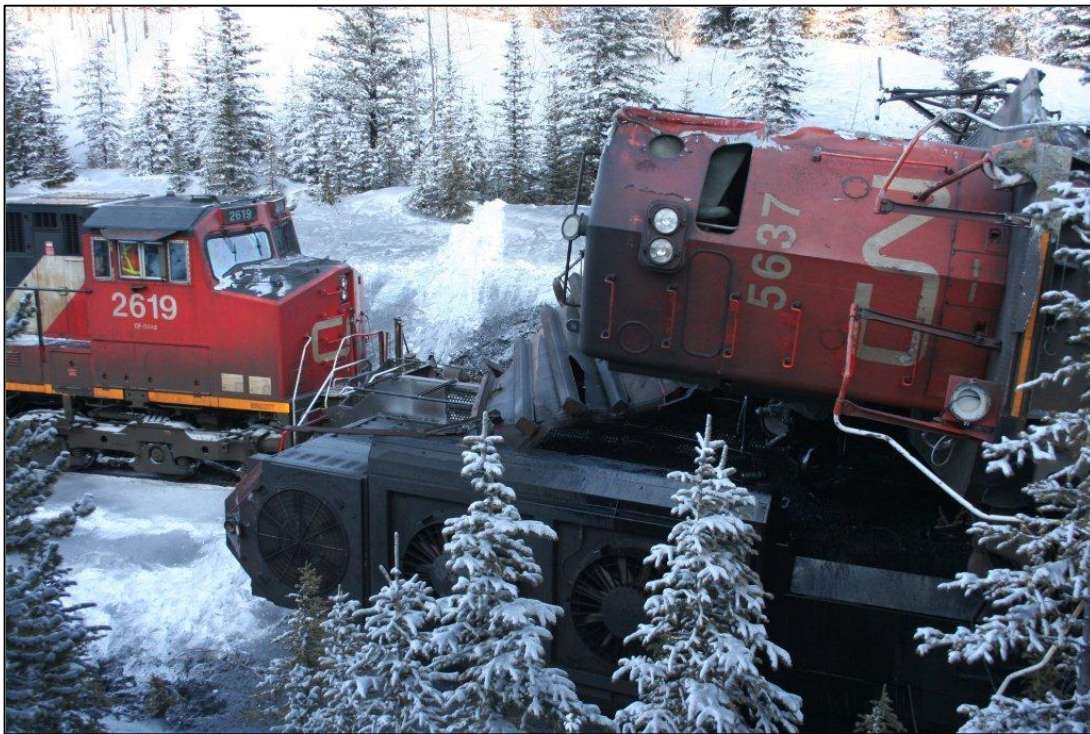
**Photo 1.** Lead locomotive (CN 5637) positioned on top of the 3rd locomotive

The estimated speed of impact of the 13 loaded coal cars with the stationary lead locomotive was 56 mph. Due to the collision, the lead locomotive (CN 5637) came to rest on top of the 3rd locomotive. Despite the high impact forces during the collision, the locomotive cab did not collapse, but rather provided a safe area for the locomotive engineer trainee who sustained serious (but non-life threatening) injuries.

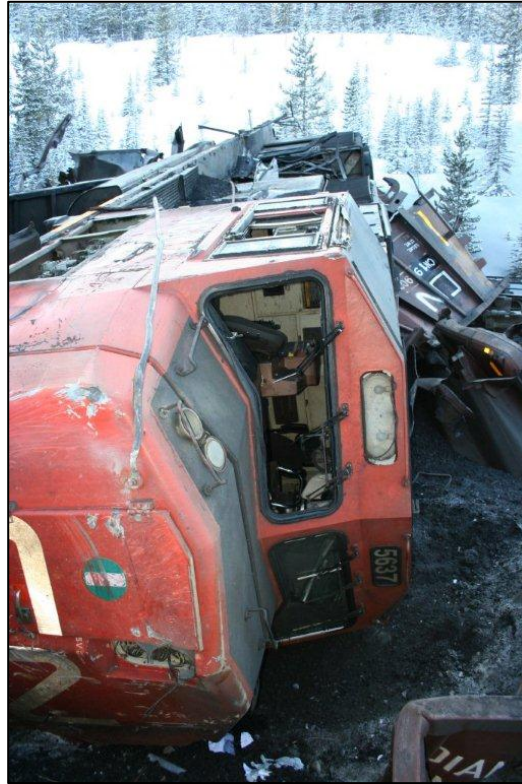
The cab of the lead locomotive was damaged but not crushed during the impact (see Photo 2). The locomotive engineer trainee was able to exit the overturned locomotive after the collision. He sustained serious, but non-life threatening, injuries and was air lifted to hospital in Hinton, Alberta. The other 2 crew members sustained minor injuries and were treated on site.

**Photo 2.** Lead locomotive from train 459

1. Despite the high impact forces during the collision, the locomotive cab on CN 5637 did not collapse, but rather provided a safe area for the locomotive engineer trainee who sustained serious (but non-life threatening) injuries.
