**RAILWAY INVESTIGATION REPORT
R12V0008**

COLLISION BETWEEN A TRAIN AND A TRACK UNIT

**CANADIAN NATIONAL RAILWAY
TRAIN A41651 13 AND
TRACK UNIT 075765
MILE 14.5, CLEARWATER SUBDIVISION
MESSITER, BRITISH COLUMBIA
14 JANUARY 2012**

Report Number R12V0008

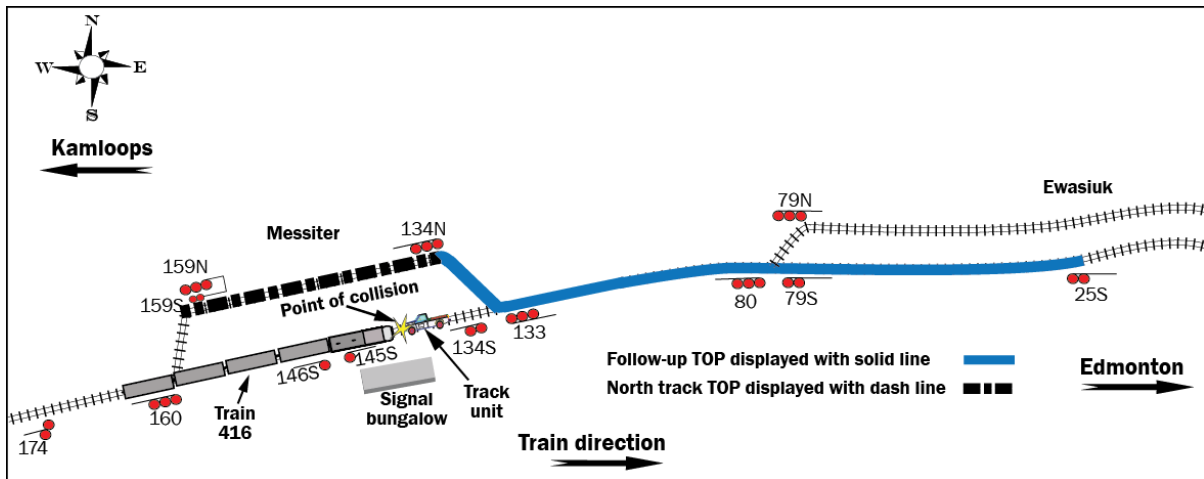
Figure 2. Site diagram

After completing the TOP, the foreman departed for Messiter, following behind train 101. At about 0353, the foreman travelled over the switch at Messiter East, which had been lined to the south track for train 101's movement. The foreman continued to Mile 14.5, where he exited the track unit⁵ to work in the signal bungalow that was located south of the track.

The foreman’s primary task that night was to repair the signal at Mile 13.3. He was familiar with the Clearwater Subdivision and aware of the location of the signal bungalow. Because he was focused on working at the bungalow, which was situated south of the tracks, his mental model was based on travelling on the south track. With this mental model, he did not pay full attention to his TOP, specifically to the second segment (for the north track). The foreman’s diminished state of alertness and his focus on the south portion of the right-of-way likely contributed to him formulating an erroneous mental model, which resulted in taking the south track instead of the north track as required at Mile 13.4.
