**RAILWAY INVESTIGATION REPORT
R13Q0012**

COLLISION AT A LEVEL CROSSING

**PASSENGER TRAIN NO. 24
OPERATED BY VIA RAIL CANADA INC.
MILE 15.62, BRIDGE SUBDIVISION
NEAR THE GARE DU PALAIS
QUÉBEC, QUEBEC
02 MAY 2013**

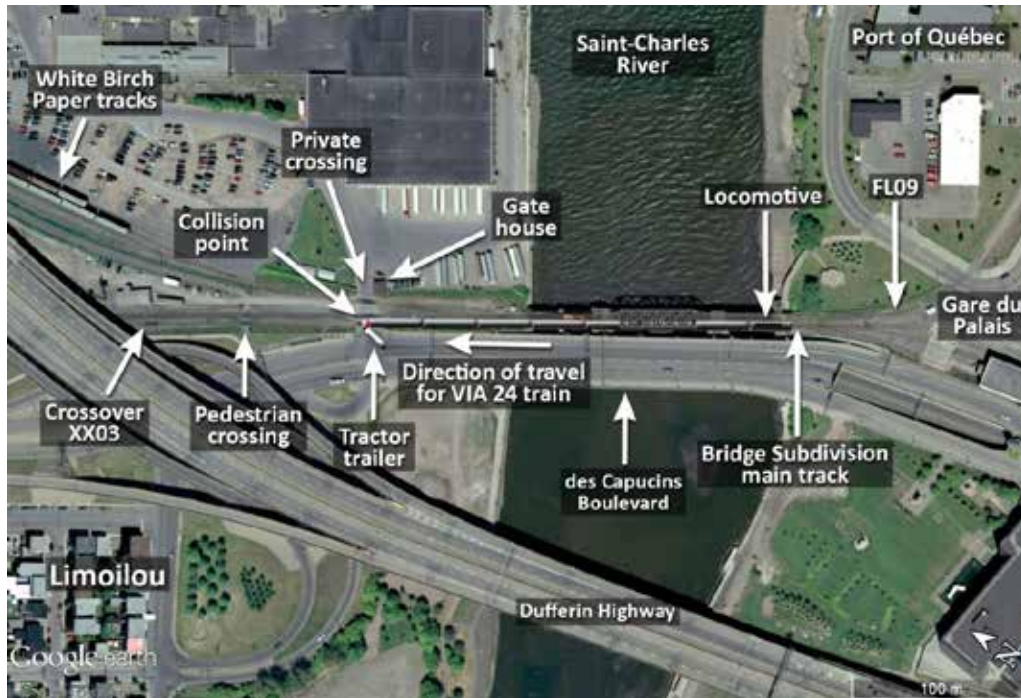
Figure 2. Collision area

The main entrance to the White Birch Paper mill is located on Boulevard des Capucins. On the access road, there is a private level crossing that crosses 3 tracks: the main track used by VIA trains; track FL09, which gives access to the Port of Québec from the Limoilou Yard; and track AL01, which leads to the White Birch Paper mill (Figure 2).

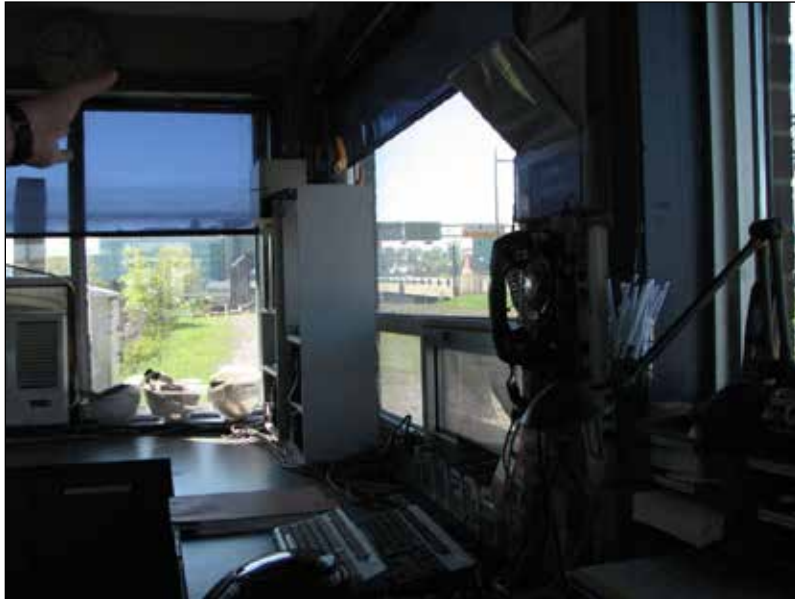
The gatehouse of the White Birch Paper mill is located on the northeast side of the entrance to the plant from Boulevard des Capucins. The guard is responsible for controlling the road vehicles going into and out of the plant and for ensuring their safety at the level crossing. The inside of the gatehouse is set up to allow the guard to monitor and control road traffic and pedestrian traffic. Large glass windows provide a view of the vehicles going into and out of the paper mill. The workstation has several pieces of communications equipment, along with various screens and knobs to control the gates, the bell, and other devices. The layout of the guard's desk and the guard's field of view are conducive to monitoring road traffic to the right. However, the field of view toward Gare du Palais is restricted by the building's pillars and several bookcases (Photo 1).

Photo 1. The obstructed view toward the Gare du Palais from inside the gatehouse.

5. With the view of the train partially obstructed, the guard was unable to detect the initial movement of the train, and did not immediately recognize the need to lower the gates and protect the level crossing.
