**RAILWAY INVESTIGATION REPORT  
R13T0122**

**MAIN-TRACK DERAILMENT**

**CANADIAN PACIFIC RAILWAY  
FREIGHT TRAIN 119-01  
MILE 112.70, PARRY SOUND SUBDIVISION  
WANUP, ONTARIO  
02 JUNE 2013**

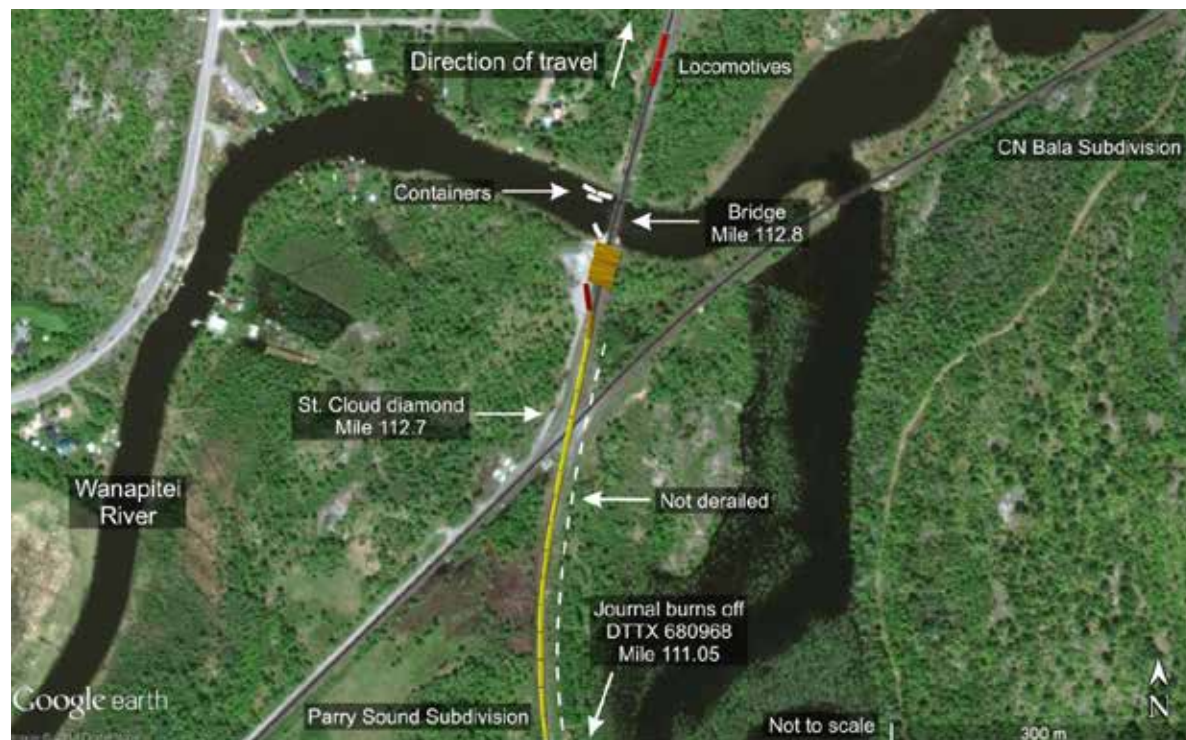
Figure 2. Derailment area diagram

the derailed cars impacted the south end of the Wanapitei River railway bridge at Mile 112.80 (Figure 2).

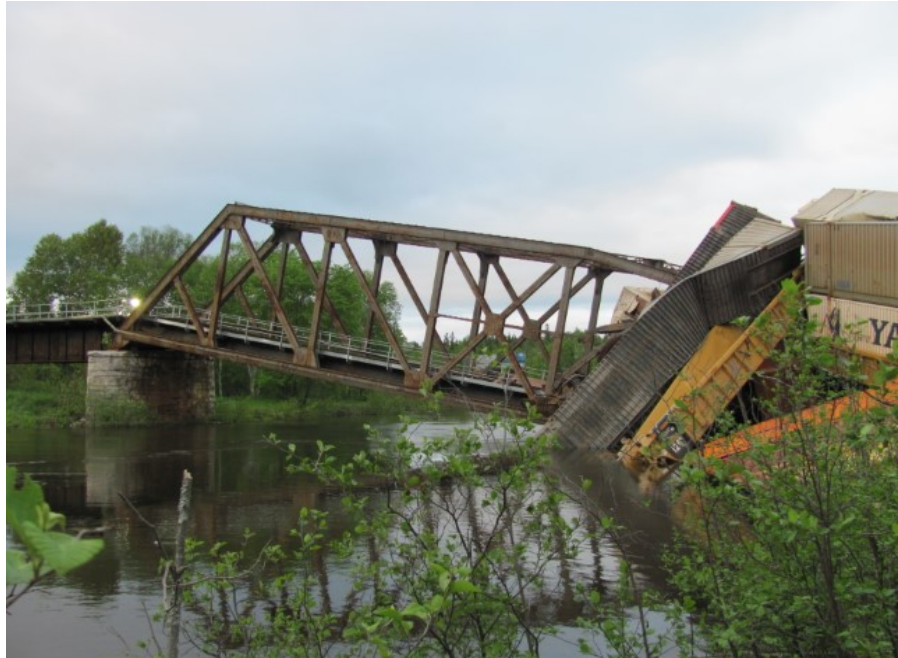
Photo 1. Collapsed south end of the railway bridge

Site examination determined that the 1<sup>st</sup> to 6<sup>th</sup> cars (involving 12 car bodies and 20 containers) had derailed. As a result of the impact from some of the derailed cars, the south end of the bridge was knocked off the abutment (Photo 1).

The south bridge abutment, bridge seat, and west wing wall were damaged extensively while the ballast wall and through truss bridge span were destroyed.

5. Some of the derailed cars impacted the bridge at Mile 112.80, knocked the south end of the bridge off the abutment, and severely damaged the bridge.

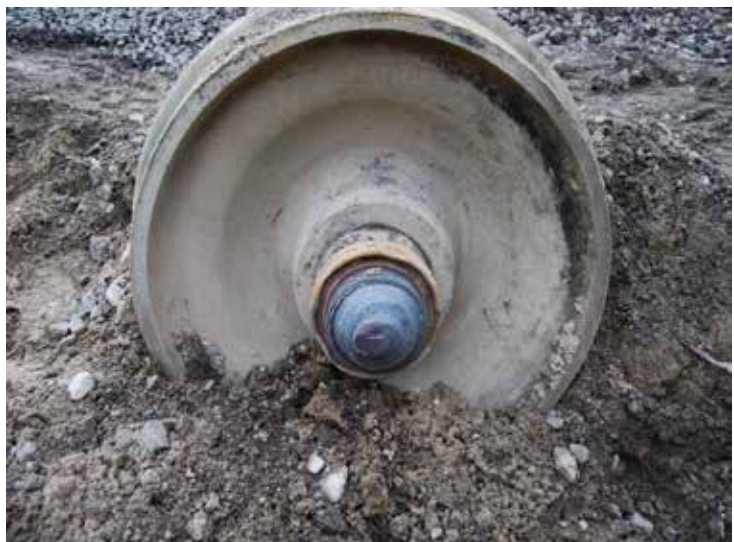
Photo 2. DTTX 680968 L3 wheel and burnt-off axle journal

On the 1<sup>st</sup> derailed car (DTTX 680968), the lead axle in the trailing truck (No. 3 position) had a burnt-off axle journal (BOJ) in the L3 position (Photo 2). The underside of the related truckside spring seat was heavily smeared and gouged.

1. The accident occurred as a result of the catastrophic failure of the L3 roller bearing and subsequent burnt-off axle journal on the lead wheelset of the trailing truck of car DTTX 680968, which was the first car behind the locomotives.

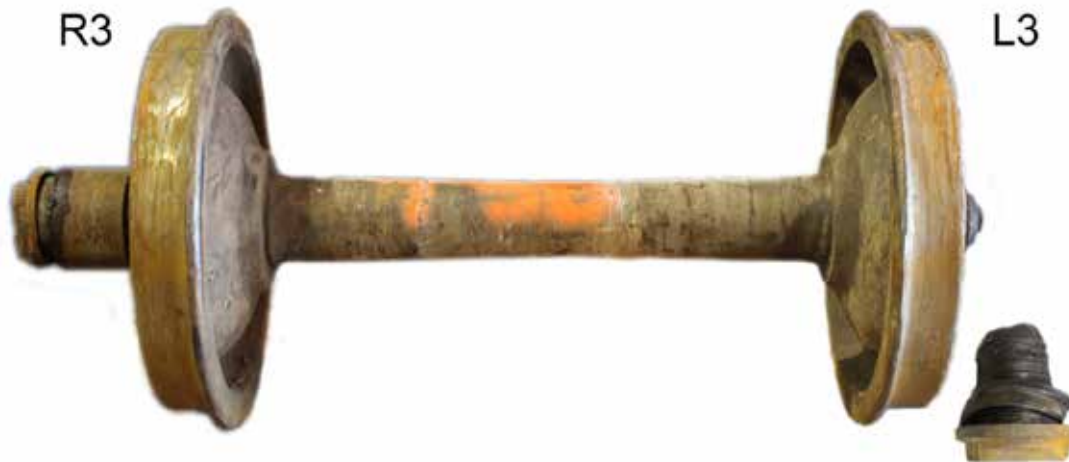
A detailed teardown examination was completed on the No. 3 wheelset from car DTTX 680968 (Photo 3) at the TSB Laboratory.

Photo 3. No. 3 wheelset as received

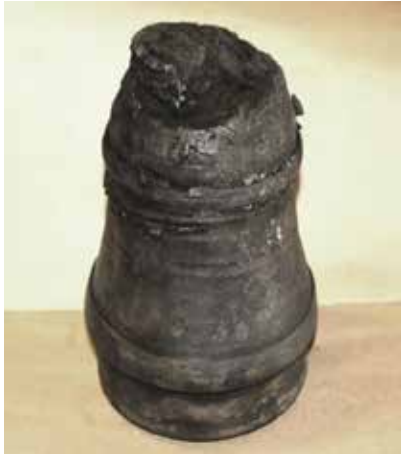
The L3 axle journal had burnt off the axle approximately 5 inches from the axle journal fillet radius. The remaining axle journal profile was typically conical in shape tapering down to a 4-inch diameter at the point of separation. The BOJ stub had been slightly elongated as it extruded outboard during failure. The separation surface features on the outboard portion of the journal were characteristic of torsional deformation.

- The cup was 29 years old.
- The remaining components were essentially destroyed and all exhibited severe heat discolouration, smearing, and plastic deformation (Photo 4, Photo 5 and Photo 6).
- Due to the severity of the damage, it was not possible to determine the precise cause of the roller bearing failure.

Photo 4. Failed burnt-off axle journal stub

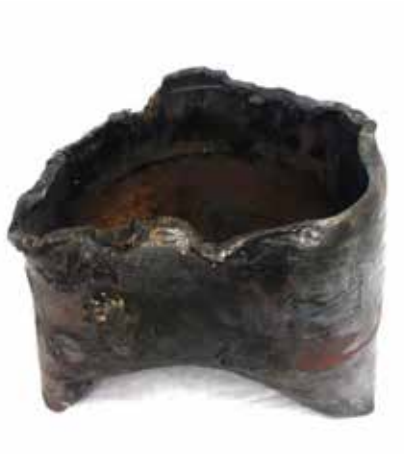
Photo 5. Outer ring (cup)

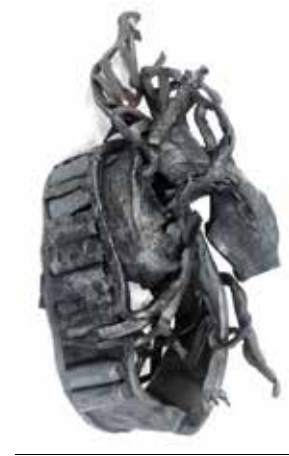
Photo 6. Outboard cone assembly
