**RAILWAY INVESTIGATION REPORT
R14C0114**

**MAIN-TRACK DERAILMENT
CANADIAN PACIFIC RAILWAY
FREIGHT TRAIN 374-230
MILE 23.40, CROWSNEST SUBDIVISION
PEARCE, ALBERTA
06 NOVEMBER 2014**

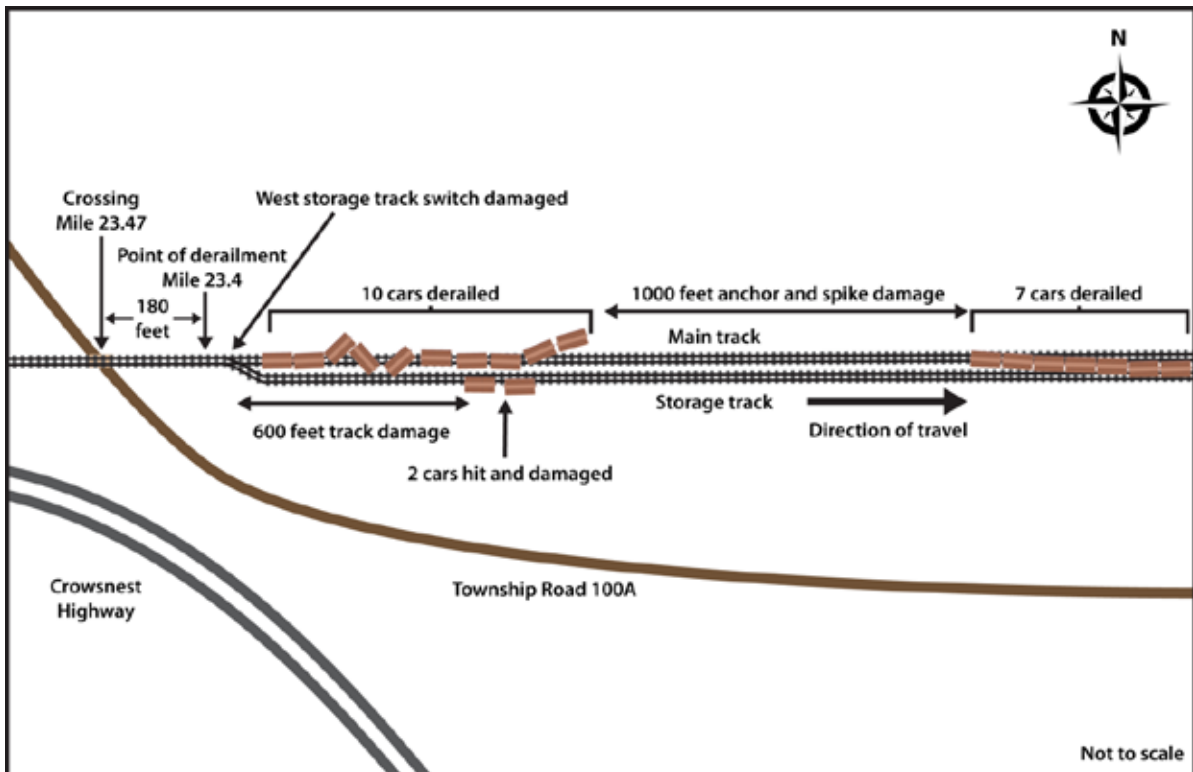
Figure 2. Derailment site diagram

The point of derailment was determined to be a broken rail near a joint in the south rail located approximately 180 feet east of the crossing at Township Road 100A (Mile 23.47) (Figure 2).

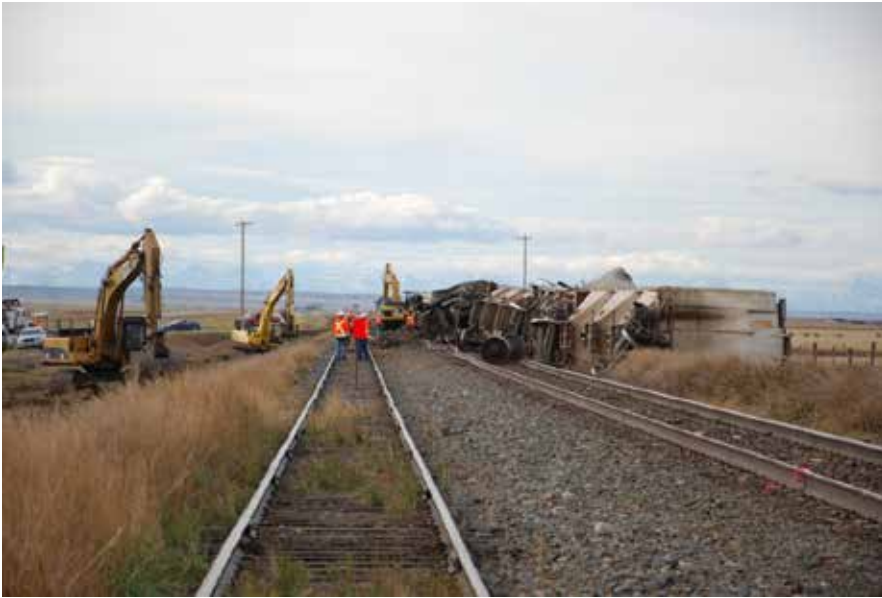
Photo 1. Derailed cars on the main track, showing storage track on left (looking west)

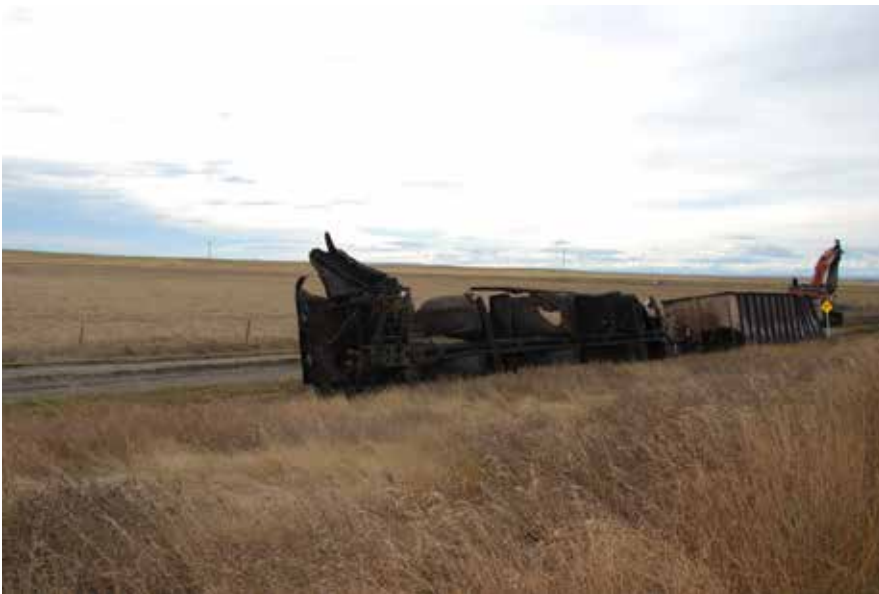
Photo 2. Coal cars destroyed in storage track (looking northeast)

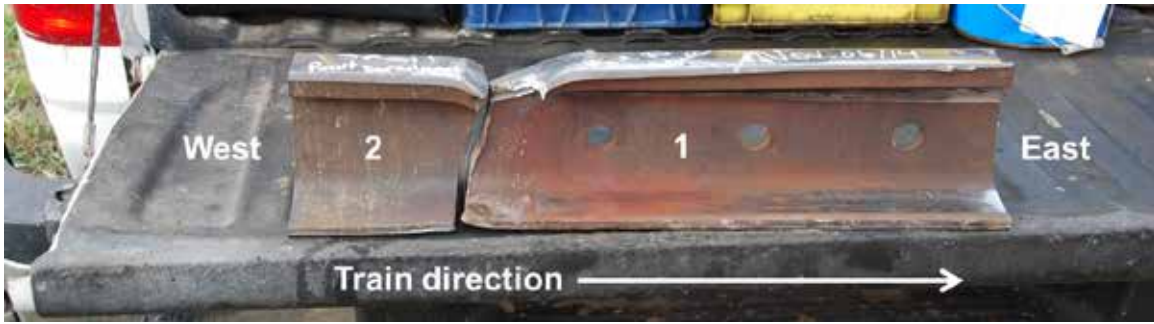
Photo 3. Recovered rail pieces

Rail piece No. 1 had a transverse fracture at its west end and a manufactured cut at the east end. The 3 holes in the web indicate that this piece was the west end of a joint. The east end of rail piece No. 2 and the west end of rail piece No. 1 were mating fracture faces.

The train derailed due to a broken rail near a rail joint. The rail batter on the west fracture face of rail piece No. 2 indicated that a piece of rail head had broken under an earlier westbound train (likely train 463-04). The wheels of eastbound train 374-230, consisting of empty grain cars, hit this rail break and was initially pounding and crushing the east fracture face of rail piece No. 1. The severe batter damage on the east end of the rail break was caused by the passage of 12 locomotive wheels and 256 wheels of 64 cars before the gauge side joint bar broke. The rail ends then separated and the tail-end 17 cars derailed.

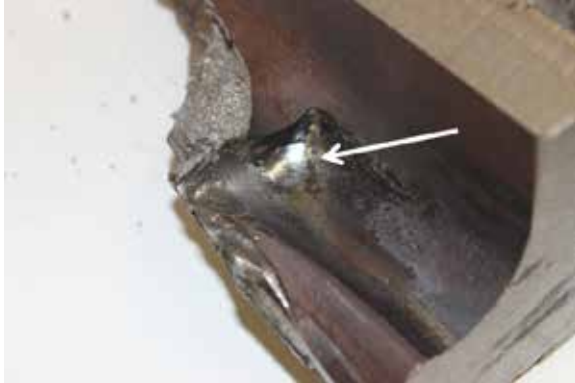
- The fracture had started in the head of the rail about 2 inches from the end of the joint.
- The fillet under the head on rail piece No. 1 had been extensively deformed by the ends of the joint bars (photos 4 and 5).

Photo 4. Deformation from joint bar contact at the fillet under the head on the gauge side of rail piece No. 1 (arrow)

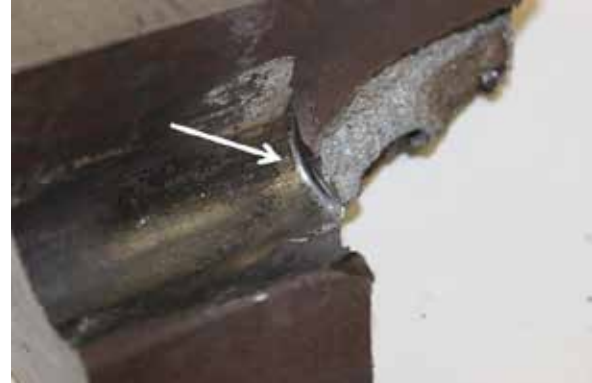
Photo 5. Deformation from joint bar contact at the fillet under the head on the field side of rail piece No. 1 (arrow)

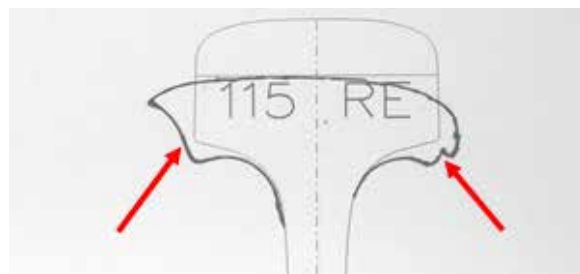
- Both rail pieces had 7/16 inches of vertical head wear. The wear on the gauge side and the field side was between +1/16 inch and +3/16 inch. For both rail pieces, the variance was due to a lip that had formed on the gauge side of the rail and to the deformation on the field side (Figure 4). As the rail head wore down, it also spread out on the gauge and field sides.

Figure 4. Profile of the occurrence rail head superimposed on the 115-lb RE new rail profile

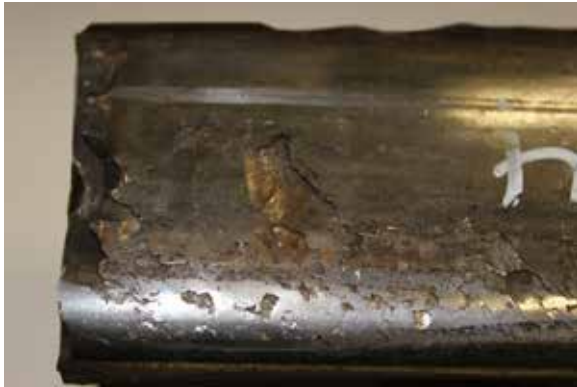
- As noted in Appendix 6 of CP's *Red Book of Track Requirements*, the vertical head wear limit for 115-lb RE rail (with zero flange wear) was 11/16 inch. The rails had not yet reached the limit at which worn rail must be removed from track.
- Wheel impact damage was present on the surfaces of both rail pieces. This impact damage was more severe on rail piece No. 1. This suggests that the rail had been broken before the occurrence and that wheels had been impacting the fracture from both directions.
- Head checks and shelling were observed on the gauge corner on both rail pieces (photos 6 and 7).

Photo 6. Head checks and shelling on rail piece No. 1

Although the previous RFD test was deemed valid, poor rail surface conditions (as shown in photos 6 and 7) are known to deflect ultrasonic signals. An emerging TDD may have escaped detection, as the defect was too small to be detected ultrasonically, or, the TDD may have developed rapidly and grown to the point of failure between the last ultrasonic test (19 September) and the date of the derailment (06 November). If rail surface defects are not removed by regular rail grinding programs, the ultrasonic signals may not adequately penetrate the rail surface to detect the development and growth of internal rail defects, increasing the risk of broken rail derailments.

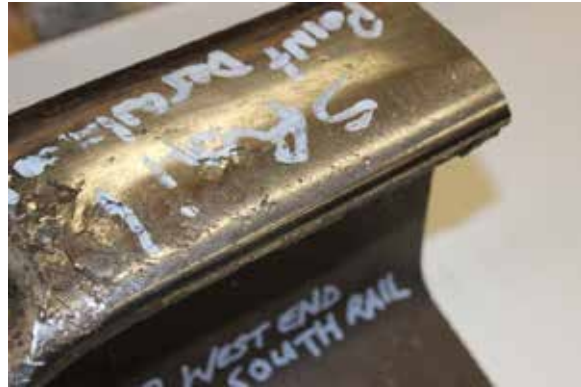
Photo 7. Head checks and shelling on rail piece No. 2

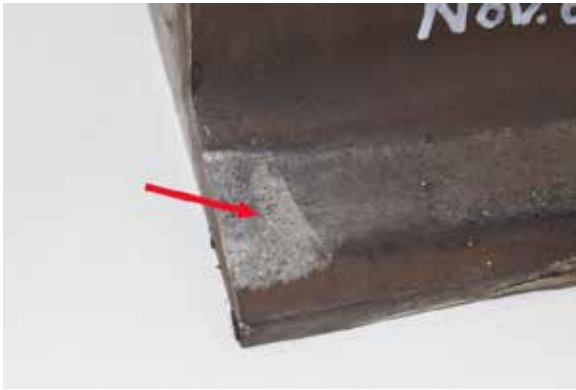
- On rail piece No.1 near the manufactured cut (east end), there was a distinct rubbing or fretting mark on the base of the rail (Photo 8) and on the fillet under the rail head on the gauge side (Photo 9). These rubbing marks suggest that the west end of the joint bar on the gauge side had broken and that the rubbing marks were likely made by the top and bottom piece of the east end of the joint bar. The head and base areas of the east end of rail piece No. 1 also exhibited polishing suggesting the rail had been rubbing against the mating rail (Photo 10).

Photo 8. Rubbing or fretting mark on the base of the rail

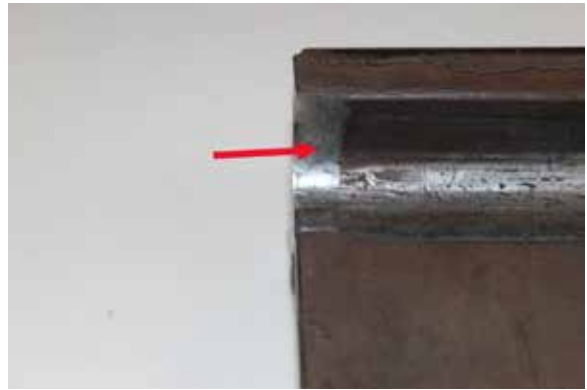
Photo 9. Rubbing or fretting mark on the fillet under the rail head

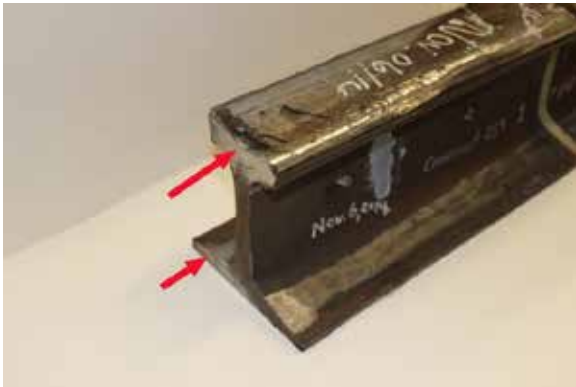
Photo 10. Polishing and rubbing on the head and base areas of rail piece No. 1 (east end)

- Rubbing marks indicated that there was significant play in the joint and that the gauge side joint bar may have been broken for some time. It could not be determined if this was contributory to the rail fracture.
- The gauge and field sides of the head were deformed outwards, most likely due to compressive loading from passing rail cars.
- Shear breaks were observed on both sides of the transverse fracture. The dark colour and burnishing observed on the shear breaks suggested that they had been present for some time.
- The rail material and hardness were typical of rail of this vintage.

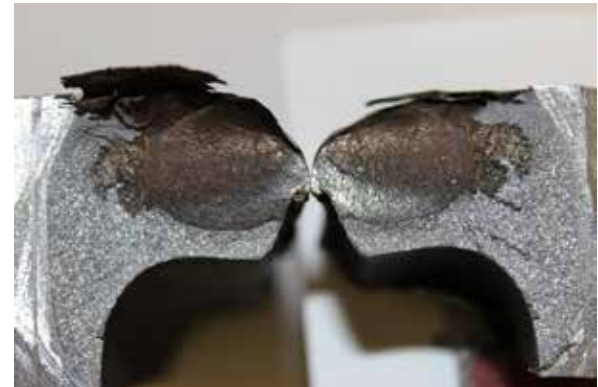
Photo 11. Transverse defect found in rail piece No. 2

- A crack indication was present about 5 ¼ inches from the cut end of rail piece No. 2. This rail piece was sectioned further, allowing the suspected crack to be opened through laboratory induced overstress. The transverse defect is shown in Photo 11.
- The crack had initiated from a head check on the gauge side of the head and had progressed in fatigue.
- After turning down into the head, the transverse crack had progressed to approximately 17% of the current head area.

Although the fracture features in the rail head had been obliterated by post-separation impact damage, a transverse detail defect, found adjacent to the rail fracture, had progressed to approximately 17% of the existing head area. This transverse defect had initiated from the head checks and shelling on the gauge side of the head. Therefore, the rail had likely been broken by the preceding westbound train due to a transverse detail defect. Critical size for the transverse detail defect was reached when the remaining rail head area, which was nearing its wear limits, could no longer support the load, resulting in the sudden and complete failure of the rail.
