**RAILWAY INVESTIGATION REPORT
R15H0005**

**MAIN-TRACK DERAILMENT
CANADIAN PACIFIC RAILWAY
FREIGHT TRAIN 118-10
MILE 42.0, NIPIGON SUBDIVISION
DUBLIN, ONTARIO
13 JANUARY 2015**

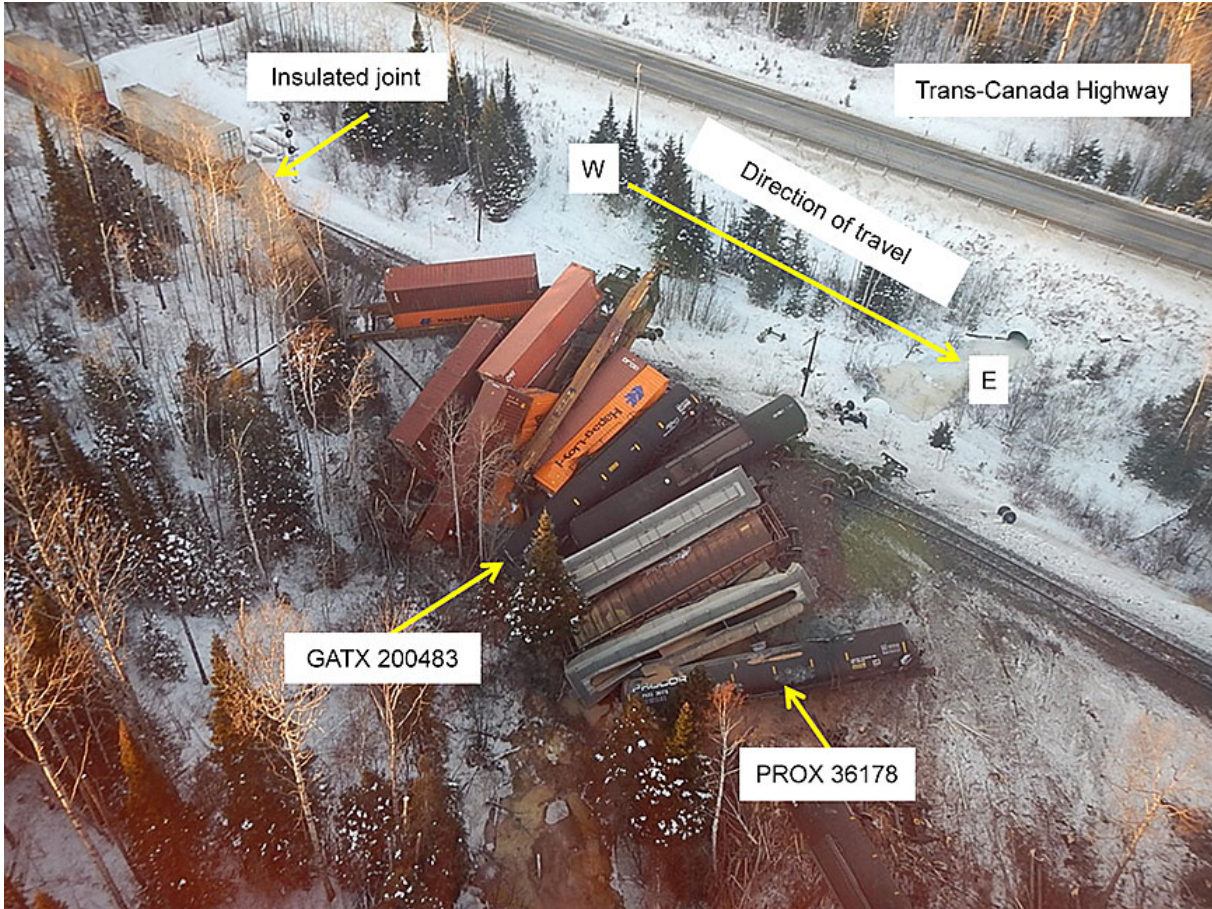
- The 21st car (PROX 36178), a DG tank car loaded with odourized propane, came to rest down an embankment, on its side. The car was the first to jackknife. The top of the car had experienced an impact in the area of the manway: it was dented around the manway reinforcement pad, and the shell of the tank at the manway was deformed. The manway nozzle was pushed down into the tank. The cover of the protective housing was deformed, and the manway gasket was damaged. Product had been released from the car. A portion of the tank car – containing the manway, jacket, reinforcement, and tank shell – was removed from PROX 36178 and forwarded to the TSB Laboratory for detailed examination.

Figure 2. View of derailed cars just east of the insulated joint (Source: Canadian Pacific Railway)

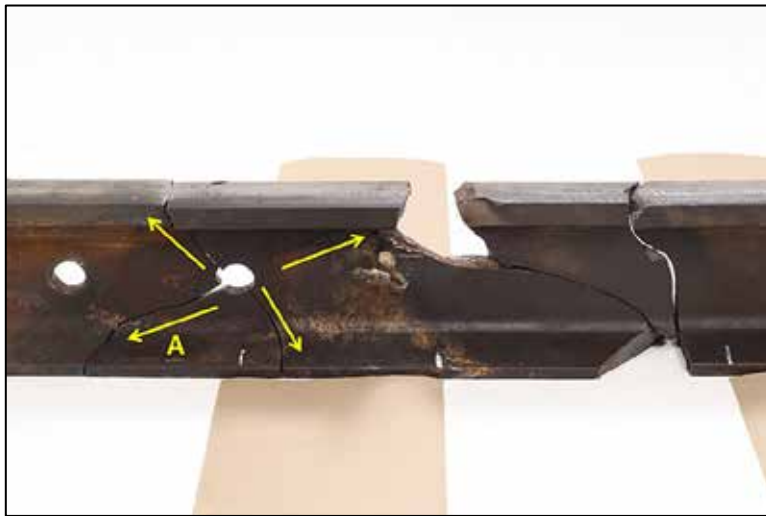
Figure 4. Bolt hole fractures. Arrows indicate direction of crack propagation. Placement of brown construction paper is representative of tie spacing. The bolt hole that is the origin of primary Fracture A is located near the edge of a tie.

- Fracture A originated near the bottom of the eastern-most bolt hole and extended diagonally downward and westward from the bolt hole. The fracture surface of the base portion of Fracture A exhibited the most significant post-failure damage, indicating that it was likely the primary fracture, which had remained undetected. The other 3 fractures were likely secondary fractures.

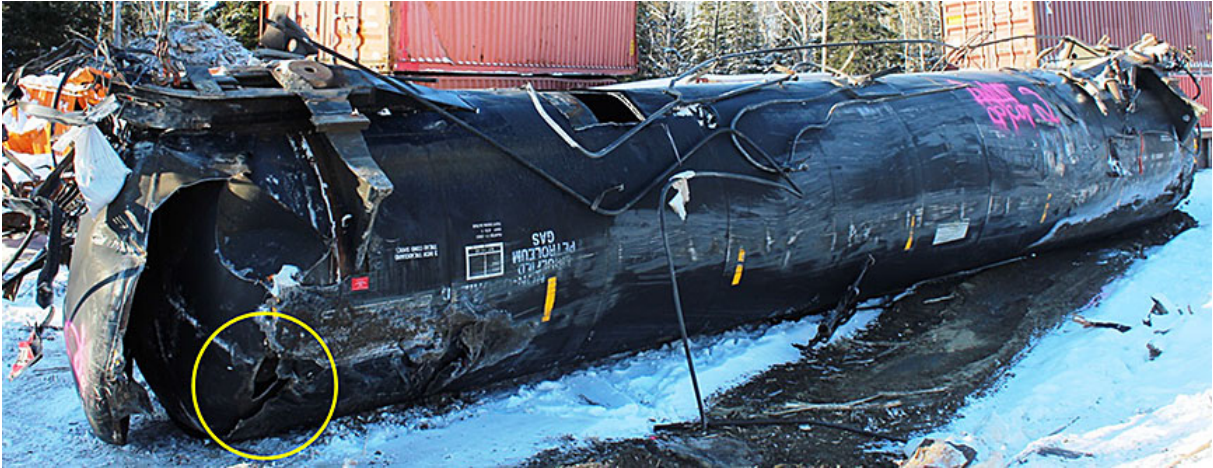
- The fracture initiated in the A-end head to shell weld and propagated in brittle mode into the head.
- Two small ductile tears extended on either side of the puncture origin into the shell.
- The object responsible for the puncture tore through the jacket and slipped under the edge of the head shield (Photo 5). This resulted in a significant localized impact at the A-end head-to-shell weld.

Photo 5. Puncture to tank GATX 200483
