RAILWAY INVESTIGATION REPORT R15H0013

Main-track train derailment

Canadian National Railway Company
Freight train U70451-10
Mile 111.7, Ruel Subdivision
Gladwick, Ontario
14 February 2015

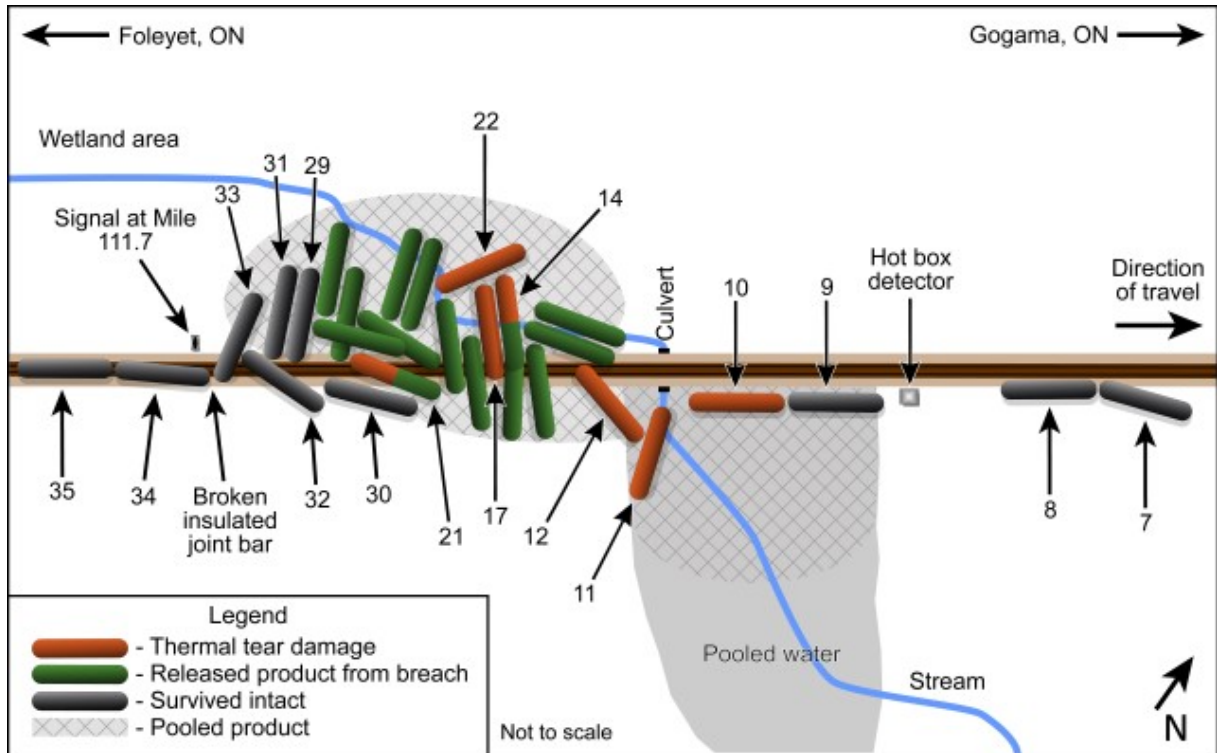
Figure 2. Accident site diagram (Note: numbered tank car positions are accurate; positions of unidentified tank cars were approximated)

The 7th through 35th tank cars had derailed (Figure 2). The 7th and 8th cars from the head end (VMSX 310740 and VMSX 311903) came to rest on their side at the east end of the derailment site, south of, and roughly parallel to, the track structure. Both cars had sustained minor damage and had separated from their trucks, but neither car released product. A gap of about 200 feet separated the 8th car and the 9th car.

The 9th to the 12th cars came to rest to the south of the track, roughly parallel to the track structure, where melting snow and product had pooled to form a small pond. The 13th to 33rd cars sustained more significant damage and came to rest in various positions west of the pond in a pileup that extended westward for about 700 feet. The last 2 derailed cars, the 34th and 35th cars from the head-end, were derailed but were not damaged, and had remained upright near the track at the west end of the derailment. About 900 feet of mainline track was destroyed.

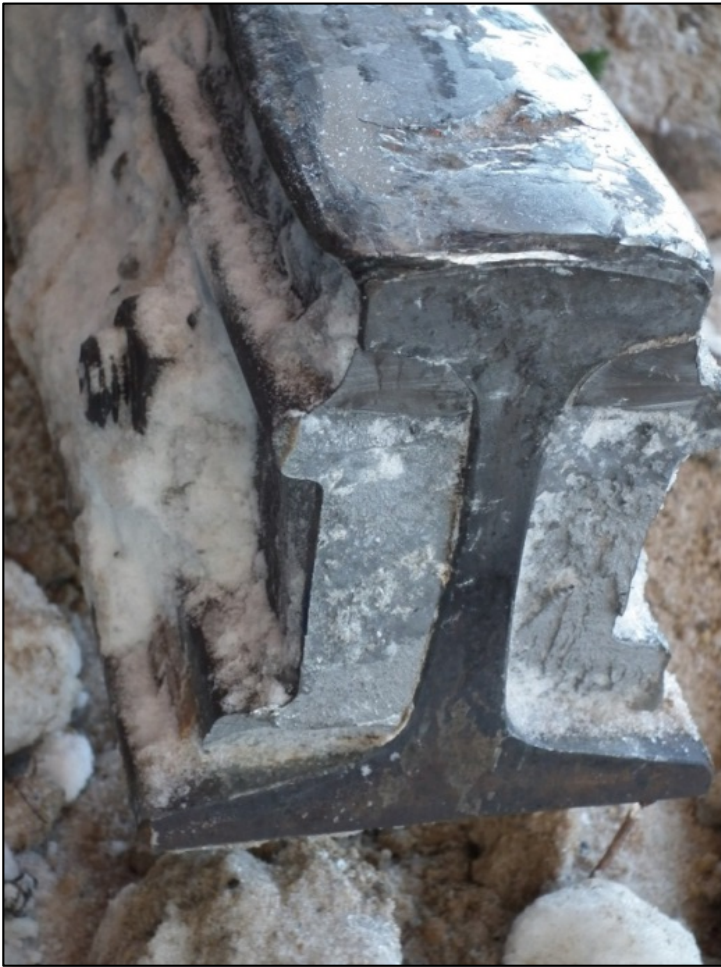
Photo 1. West portion of insulated joint assembly containing broken joint bars and intact rail recovered from the site

Approaching the derailment site from the west, no impact marks were observed on the track infrastructure. At the west end of the derailment site, a broken insulated joint was observed in the south rail, near the signal mast at Mile 111.7 (Photo 1).

Both joint bars had broken into 2 pieces. The east portion of the joint assembly was not located, while the west portion of the joint bars remained attached to the rail. Rail end batter (REB) was observed on the head of the portion of rail that remained within the joint. The top of each remaining portion of joint bar exhibited beach marks, which are indicative of fatigue failure. Information written on the web of the rail indicated that a Sperry rail flaw test, conducted on 18 January, had identified a 3.5 mm REB condition at Mile 111.7.

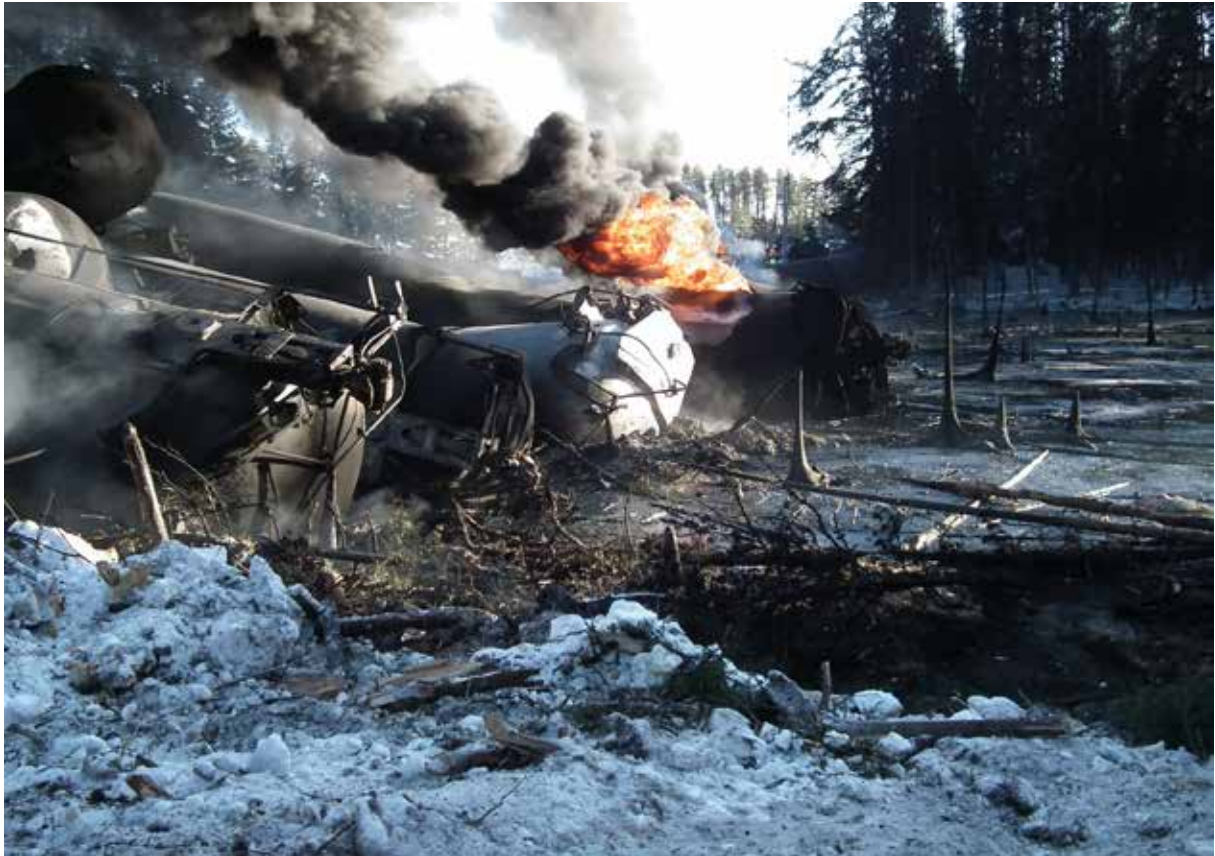
Photo 2. Derailment site with tank car burning from thermal tear (16 February 2015)

Immediately following the derailment, fire erupted and engulfed many of the tank cars that had been breached. As the fire continued to burn, 7 tank cars ruptured (due to thermal tears) and released more crude oil to the environment (Photo 2).

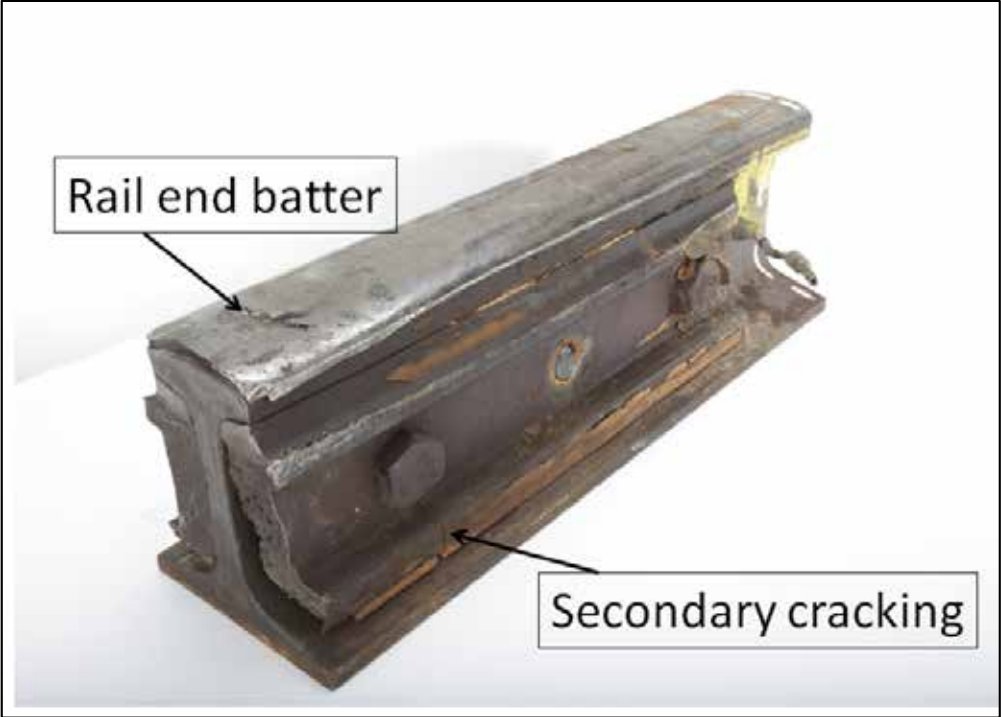
Figure 4. Gauge-side view of west portion of the insulated joint (Note: The arrows indicate the rail end batter on the running surface and the secondary cracking.)

- Little if any of the insulating glue remained between the top of the joint bars and the underside of the rail head.
- Secondary cracks were observed at the bottom of each joint bar below the bolt hole closest to the fracture, and on the gauge-side joint bar at the outboard lower corner of the bar. The secondary cracks displayed fatigue cracking.
- The rail head had also showed crushing, primarily to the field side, for approximately 200 mm from the rail end.
- The joint bar material met the specified strength requirements.

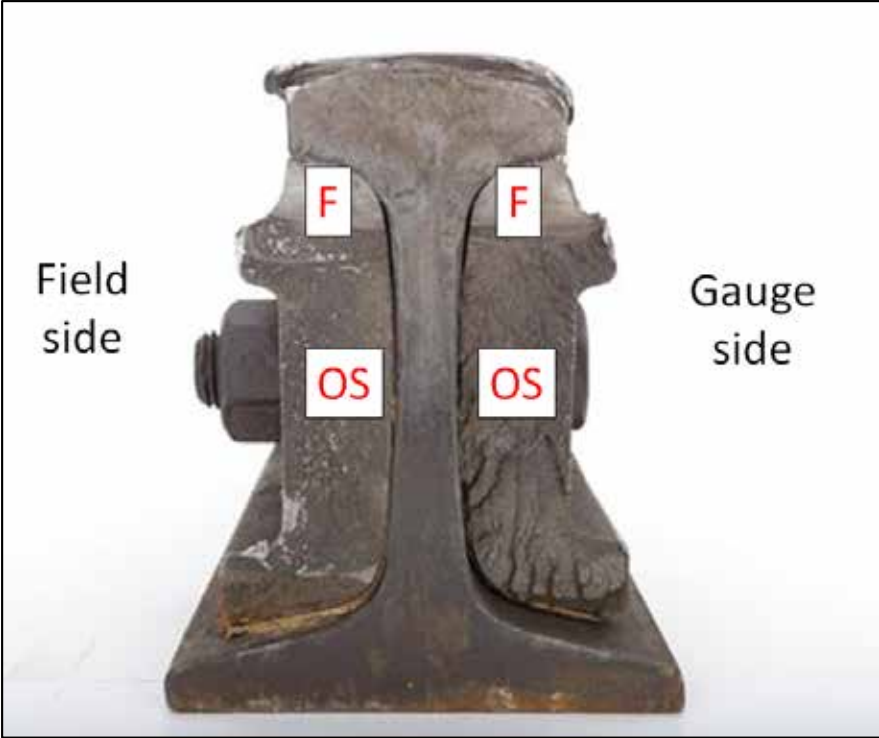
Figure 5. End view of broken joint showing field- and gauge-side joint bars with fatigue (F) and overstress (OS) zones
