**RAILWAY INVESTIGATION REPORT
R15V0003**

**MAIN-TRACK TRAIN DERAILMENT
CANADIAN PACIFIC RAILWAY
FREIGHT TRAIN 199-10
MILE 76.7, MOUNTAIN SUBDIVISION
STONE CREEK, BRITISH COLUMBIA
13 JANUARY 2015**

Railway Investigation Report R15V0003

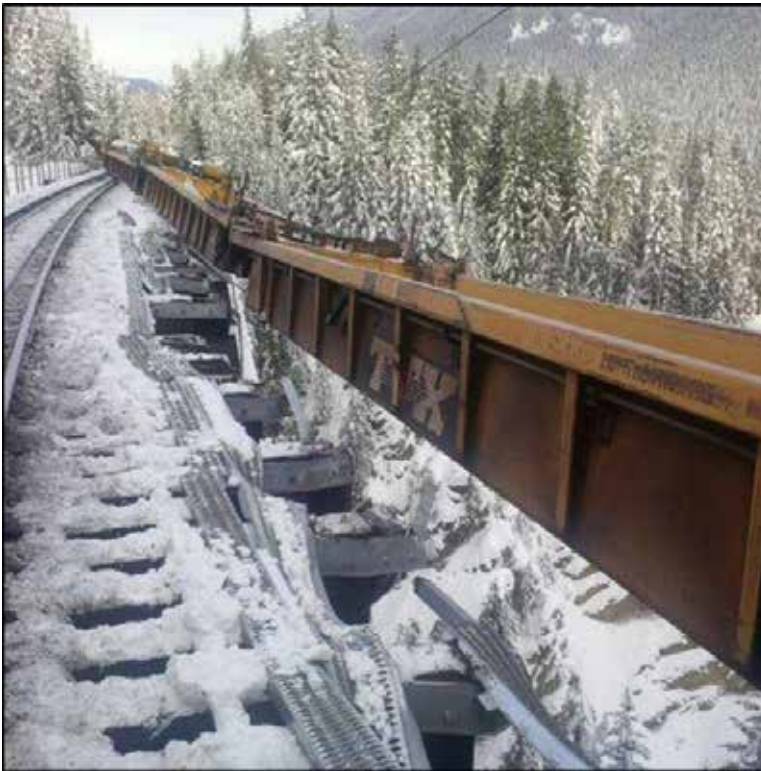
determined that 6 platforms from 2 empty intermodal flat cars had derailed on the Stoney Creek Bridge. The crew advised the RTC of the situation. There were no injuries, and no dangerous goods were involved.

Photo 1. Derailed cars on the Stoney Creek Bridge (view looking west)
(Source: Canadian Pacific Railway)
