Rail Transportation Safety Investigation Brief R17W0199

MAIN-TRACK DERAILMENT

Canadian Pacific Railway
Freight train 669-161
Mile 90.21, Sutherland Subdivision
Blucher, Saskatchewan
15 September 2017

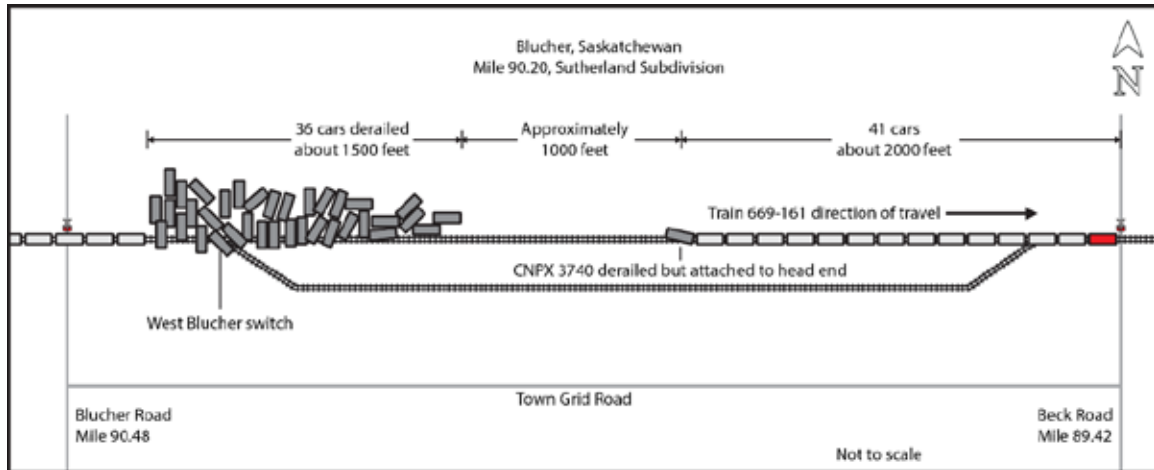
(Mile 89.40). The first derailed car was the 41st car from the head end (CNPX 3740). The car remained attached to the head-end portion of the train and was missing its trailing truck. The truck had become dislodged during the derailment and was later located in the vicinity of the west storage track switch. The following 36 derailed cars (42nd to 77th cars from the head end) came to rest in various positions adjacent to the storage track, within a distance of about 1500 feet (Figure 2). Many of the derailed cars were breached and had released potash. About 2500 feet of track was damaged or destroyed.

Figure 2. Derailment site showing disposition of cars

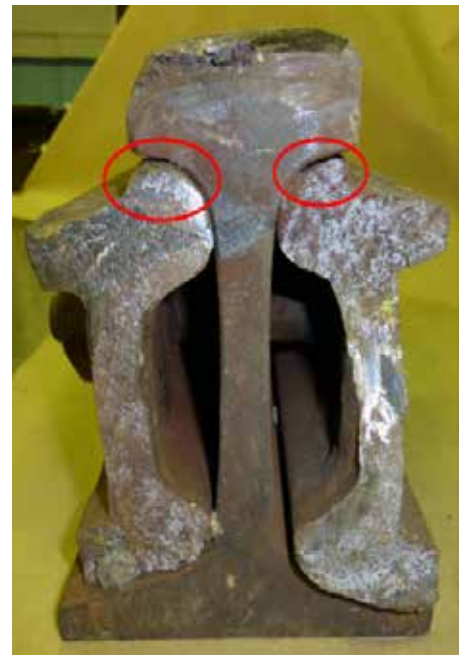
During site restoration, half of a rail joint was recovered; the other half could not be located. The recovered portion of the joint had rail-end batter on the east-end rail head and fatigue cracking in the joint bars (Figure 3). It was determined that the joint was likely located in the south rail, about 30 feet west of the west storage track switch, near Mile 90.21.

The damage observed on site suggests that the south rail joint near Mile 90.21 initially failed beneath the lead locomotive and the 41st to 77th cars from the head end subsequently derailed.

Figure 3. East-end view of the south rail joint. Signs of fatigue are circled in red.

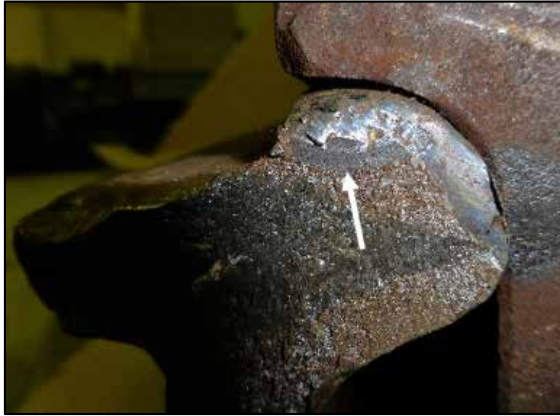
Both joint bars from the recovered portion of the joint displayed fatigue fractures that extended from the upper fishing surface on the top of both joint bars (i.e., the mating surface between the top of the joint bars and the underside of the rail head). Fatigue cracking had propagated vertically downward for up to about 10% of the cross-sectional area of both joint bars (figures 4 and 5). Once the fatigue fractures reached a critical size, the remaining joint bar cross-sectional area could no longer support the load, sustained an overstress rupture, and failed under the train.

Figure 4. Gauge-side joint bar with fatigue identified by arrow

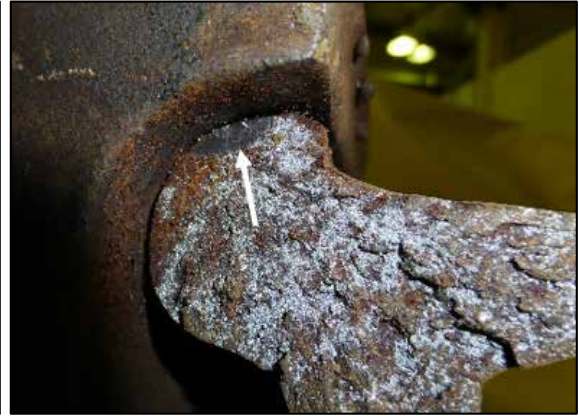
Figure 5. Field-side joint bar with fatigue identified by arrow
