## **RAIL TRANSPORTATION SAFETY INVESTIGATION REPORT R18E0007**

### **UNCONTROLLED MOVEMENT OF ROLLING STOCK**

Canadian National Railway Company  
Freight train L76951-10  
Mile 0.5, Luscar Industrial Spur  
Leyland, Alberta  
10 January 2018

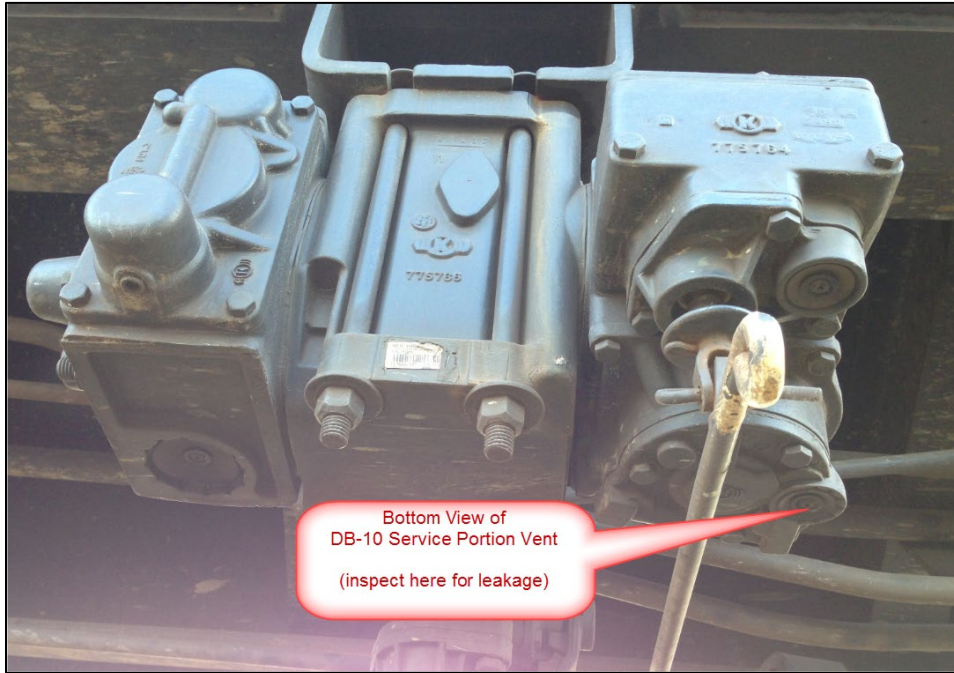
Figure 7. Bottom view of DB-10 service portion showing the bottom cover exhaust port  
(Source: New York Air Brake)

On 25 October 2013, the AAR issued Circular Letter C-12027 concerning cold-temperature malfunctions during service brake applications (Appendix C). At that time, testing had determined that worn rubber seals (O-rings) from the bottom cover exhaust port of the DB-

10 service portions (Figure 7) could shrink during extreme cold temperatures. This shrinkage of rubber seals could then result in auxiliary reservoir leakage and lead to a localized, unintended release of a car's service brake application.

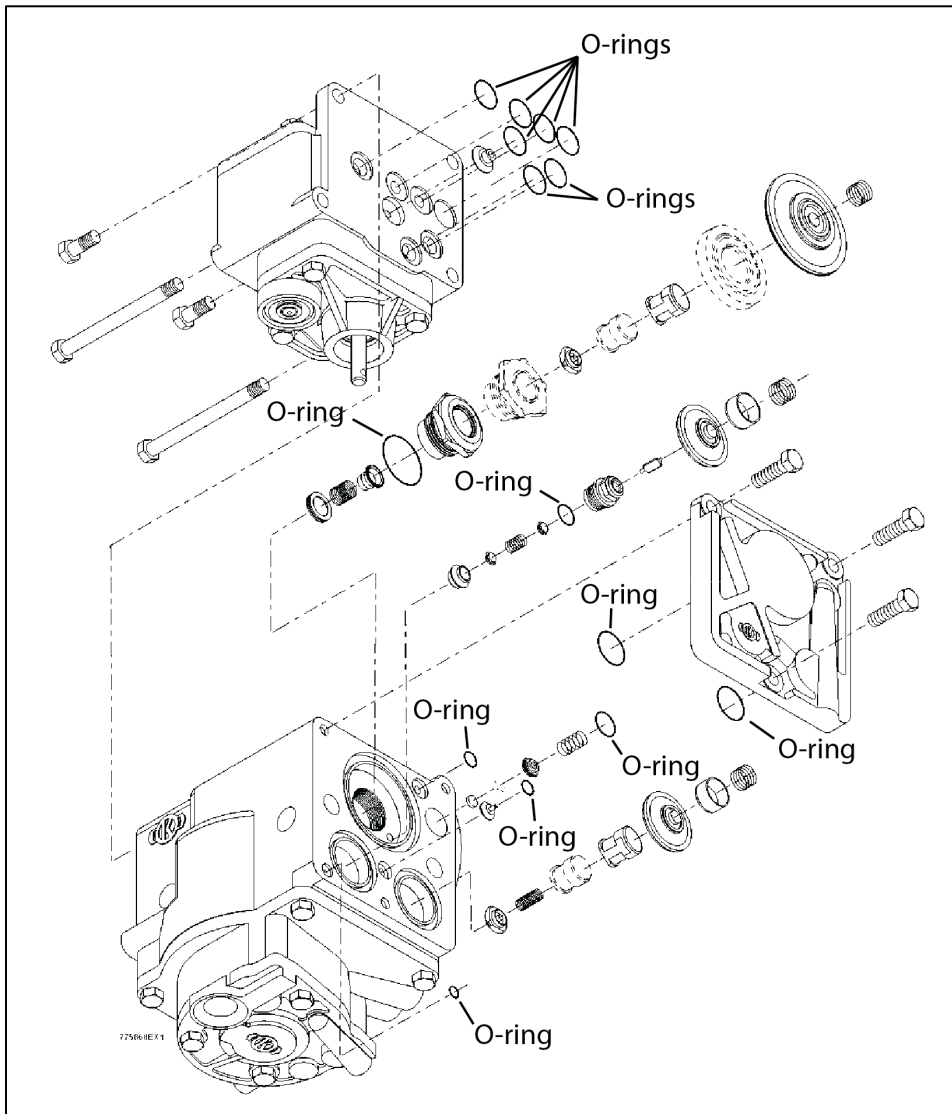
Figure 8. DB-10 service portion (Source: New York Air Brake, with TSB annotations)

The location of rubber seals in the DB-10 service portion is shown in Figure 8.

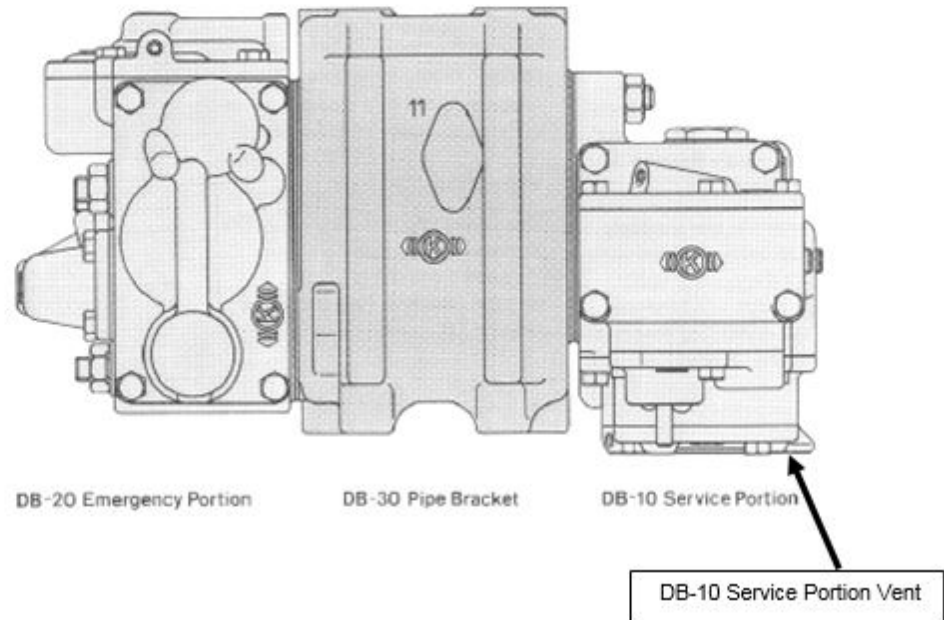
## General Letter: Cold Temperature DB-10 Auxiliary Reservoir Leakage

NYAB has been investigating concerns from several railroads regarding low temperature air brake operating issues which could cause train delays in yards and terminals: at a train level, evidence of the symptom begins with increased Brake Pipe air flow from the controlling (Lead) locomotive after a brake application has been initiated. This increased head end air flow is caused by leakage from the bottom cover exhaust port of the DB-10 Service Portion on the brake control valve.

### **Recommended Corrective Action**

Any valve portion experiencing one or more of the described symptoms should be removed from service as soon as practical and refurbished per New York Air Brake Maintenance Specification NYR-332.
