# Rail Transportation Safety Investigation Report R18E0138

## MAIN-TRACK DERAILMENT

Canadian National Railway Company  
Freight train G83342-24  
Mile 24.30, Wainwright Subdivision  
Landis, Saskatchewan  
26 September 2018

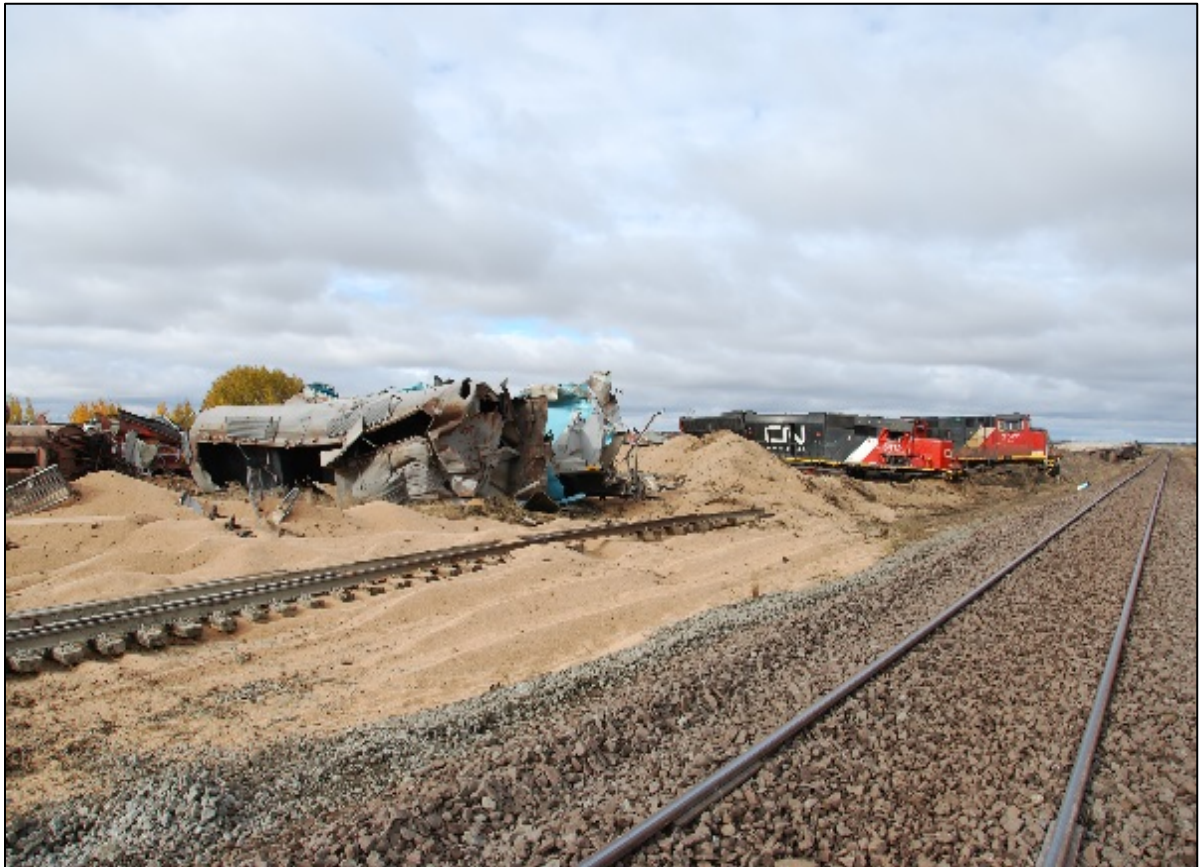
At about 0915, while operating at 51 mph through Landis, Saskatchewan, the train experienced an undesired emergency brake application. After coming to a stop and upon inspection, the crew determined that the 2 mid-train remote-controlled locomotives, in positions 79 and 80,<sup>2</sup> and 41 covered hopper cars loaded with canola seeds, in positions 52 to 92, had derailed in various orientations along the right-of-way (Figure 2). The point of derailment was determined to be Mile 24.30 of the Wainwright Subdivision.

**Figure 2. Derailment site, looking south (Source: TSB)**

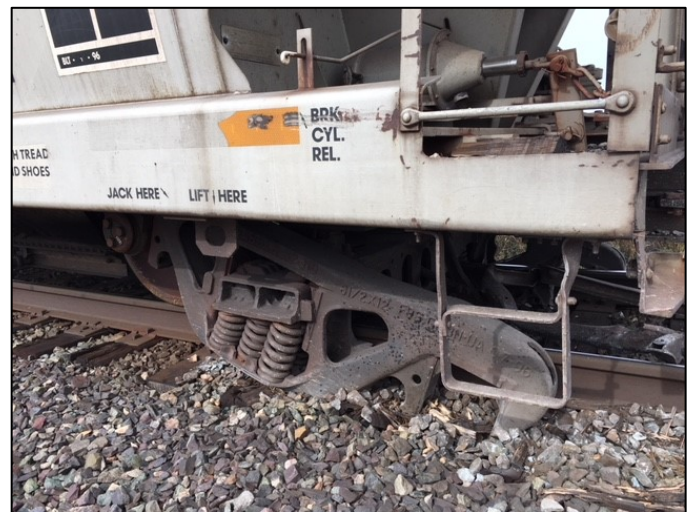
During site examination, it was noted that covered hopper car CEFX 350816 was the first car to derail. It remained upright with the A-end on the rail and the B-end derailed; its number 1 axle and wheels were missing (Figure 3). A broken axle from car CEFX 350816 (Figure 4) was discovered to the north of the track, about 300 feet from the east switch for the Landis Producer Co-op track. The other half of the axle/wheel set was not recovered.

Figure 3. Car CEFX 350816 with number 1 axle and wheels missing (Source: CN)

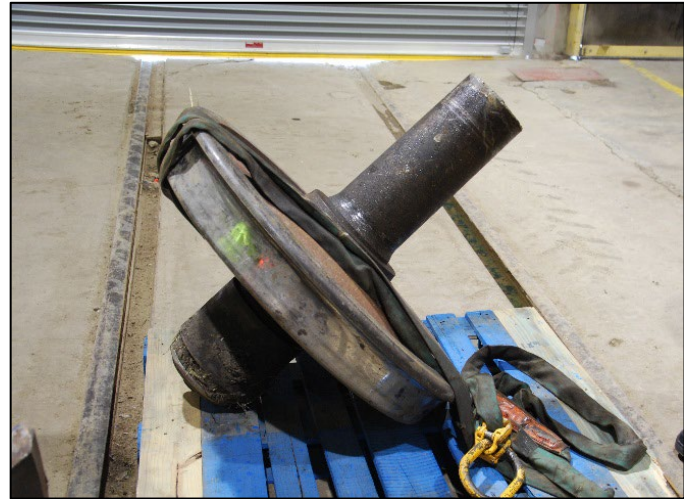
Figure 4. Broken axle with wheel from car CEFX 350816 (Source: TSB)

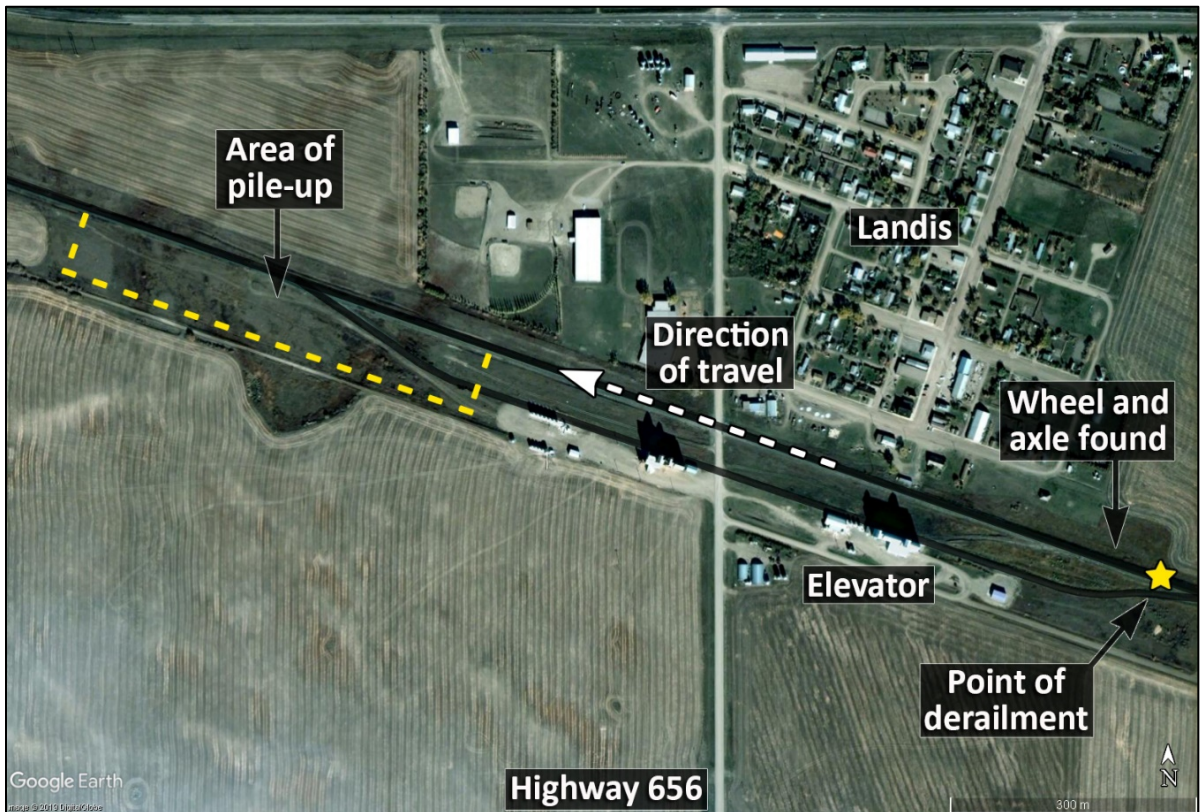
Starting about 20 feet west of the east switch for the Landis Producer Co-op track, there were fresh abrasion marks on the ties between the rails, suggesting that the axle broke at this location. Following the broken axle and derailment of this wheel set, the trailing truck on car CEFX 350816 was dragged for approximately 4000 feet to where the main derailment pile-up was located (Figure 5).

Figure 5. Point of derailment and main derailment pile-up (Source: Google Earth, with TSB annotations)

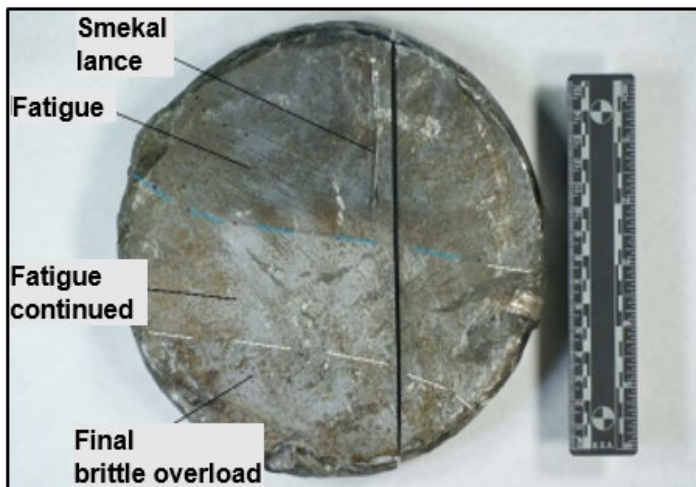
- It is likely that the axle failure was due to high cyclic fatigue<sup>6</sup> that had initiated at 2 adjacent sites on the axle surface from rotational bending.

- Initiation of the failure was likely due to contact as indicated by the contact/galling damage noted on the outside surface of the axle.
- Post-fracture contact damage and corrosion had obscured the primary and secondary fatigue-initiation sites on the outside surface of the axle. Therefore, the original axle surface features, prior to failure, could not be assessed.

- Corroded fatigue striations were present near the secondary fatigue-initiation site, confirming high cyclic fatigue as indicated by macroscopic “beach marks” and a single Smekal (fracture) lance<sup>7</sup> (Figure 6).

- The fatigue crack propagated across about 80% of the axle cross-section until the remaining intact metal ligament could no longer support the operating stresses, resulting in the final catastrophic axle failure.

Figure 6. Broken axle from car CEFX 350816 (Source: SGS MSi Testing & Engineering Inc.)

Metallurgical analysis of the axle indicated that the failure mechanism was likely initiated by surface damage sustained by the reconditioned axle. CN determined that this damage may have been caused by a defective indexer<sup>8</sup> at a customer loading facility.

CN is currently implementing and issuing guidance to its customer facilities for the inspection and maintenance of indexers to prevent axle damage.
