RAIL TRANSPORTATION SAFETY INVESTIGATION REPORT R18V0127

CROSSING ACCIDENT

Canadian National Railway Company
Freight train Q10521-21
Mile 71.13, Yale Subdivision
Chilliwack, British Columbia
26 May 2018

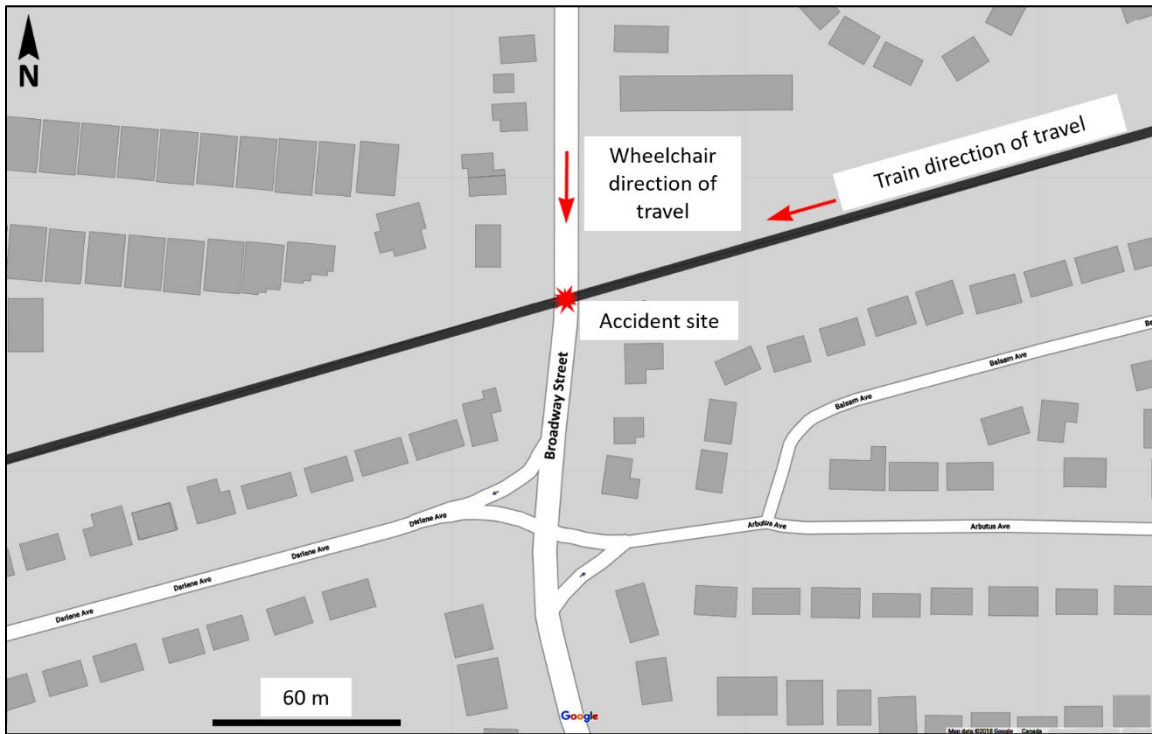
Figure 2. Accident site at Broadway Street public crossing (Source: Google Maps, with TSB annotations)

When the train was about $\frac{1}{4}$ mile from the Broadway Street public crossing (Mile 71.13), the crew observed an object on the track at the crossing. The crew could not initially identify the object, but it soon became apparent that a pedestrian⁴ in a motorized wheelchair⁵ was on the crossing. As the train approached the crossing, the grade crossing warning system activated and the crew began to sound the horn.

Two motorists from 2 southbound vehicles that had stopped at the crossing saw the immobilized wheelchair, exited their vehicles, and attempted to help the pedestrian, but were unable to move the pedestrian to safety in time.⁶ The train, travelling at about 47 mph, struck the immobilized wheelchair (Figure 2). The train brakes were placed into emergency about 7 seconds after the collision. The pedestrian, who was still in the motorized wheelchair, was fatally injured. One of the 2 motorists trying to help the pedestrian was also struck by the train and sustained serious injuries.

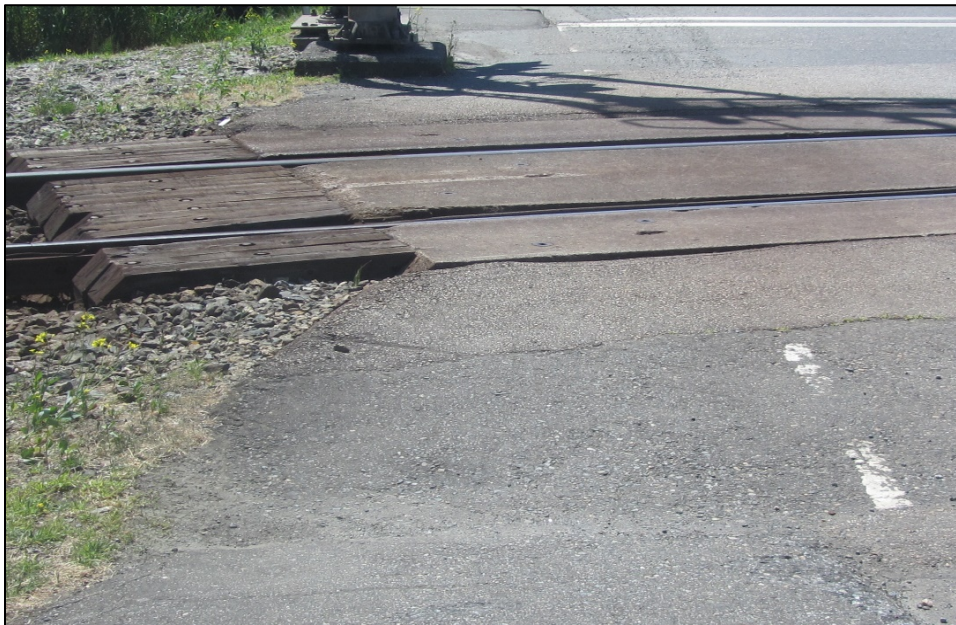
Figure 3. Extension to the crossing surface at the Broadway Street public crossing (Source: TSB)

The Broadway Street public crossing is located at Mile 71.13 of the Yale Subdivision. It is equipped with a grade crossing warning system consisting of flashing lights, bell, and gates. The crossing is single track with a concrete crossing surface and wooden ties affixed to either end of the concrete to extend the crossing surface as required under the *Grade Crossings Standards (GCS)*, Part B, section 3.1 (Figure 3).

Part C, Figure 5-1(b), of the GCS indicates that the sidewalk crossing surface should extend at least 0.5 m past the sidewalk (Figure 4). The crossing was compliant with the GCS at the

time of the occurrence, even though it was not required to be compliant until November 2021.

On 05 September 2018, TC issued a letter of concern to CN indicating that a recent widening of the sidewalk on the west end of the crossing had resulted in the crossing surface not extending 0.5 m beyond the sidewalk. TC indicated that this would have to be corrected by November 2021. TC also expressed concern over the faded pathway markings and areas where the crossing surface had cracked and could present a tripping hazard.

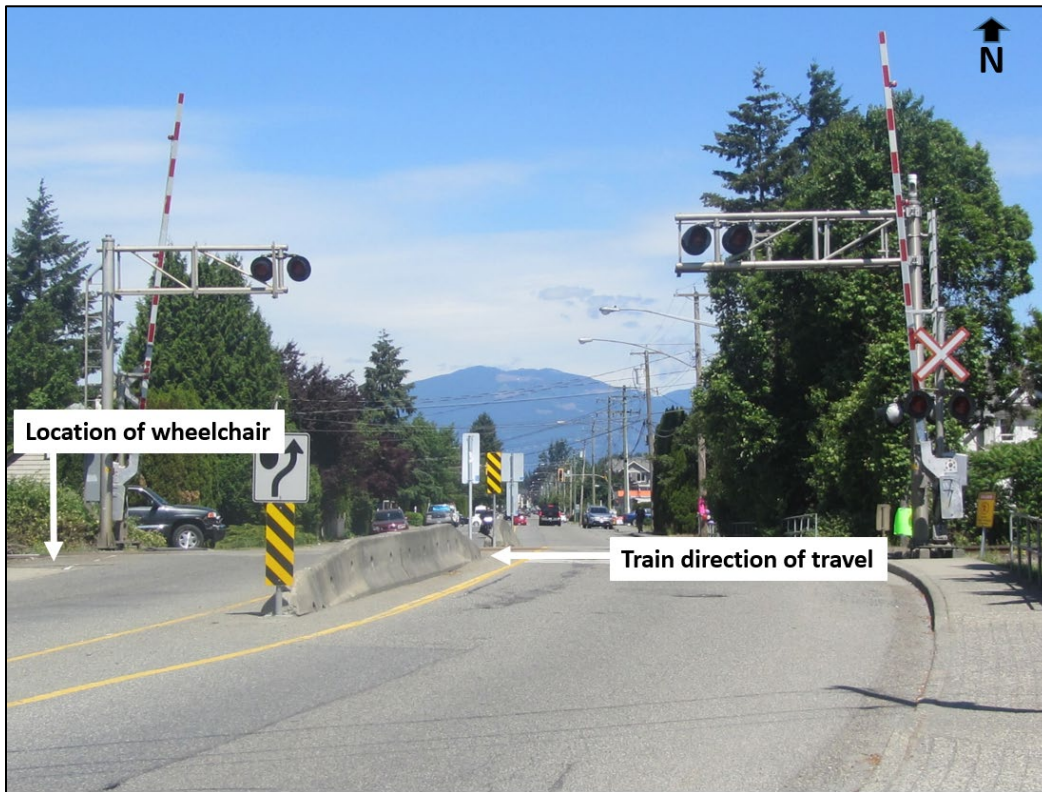
Figure 5. Street view of Broadway Street public crossing, looking north (Source: TSB)

Broadway Street is a 2-lane asphalted road with the lanes divided by concrete abutments in the area of the crossing (Figure 5). The lanes are approximately 11.3 m (37 feet) wide curb-to-curb, bordered with a sidewalk on either side. The road has a north-south orientation and crosses the railway track at an angle of 74 degrees. At the time of the occurrence, the average annual daily traffic count was 9010 vehicles,⁹ and the average annual daily railway movement count¹⁰ was 40. The cross-product¹¹ for the crossing was 360 400. The posted road speed in the area of the crossing was 50 km/h.

- There were narrowed sidewalks at the crossing signal masts due to their close proximity to the road, causing pedestrians to veer towards the road.
- There were narrowed road approaches due to the median barriers, causing the vehicular traffic to veer towards the sidewalks.
- The combination of these two characteristics created a hazardous situation where a pedestrian might be struck by a moving vehicle as they veered around the crossing signal masts.

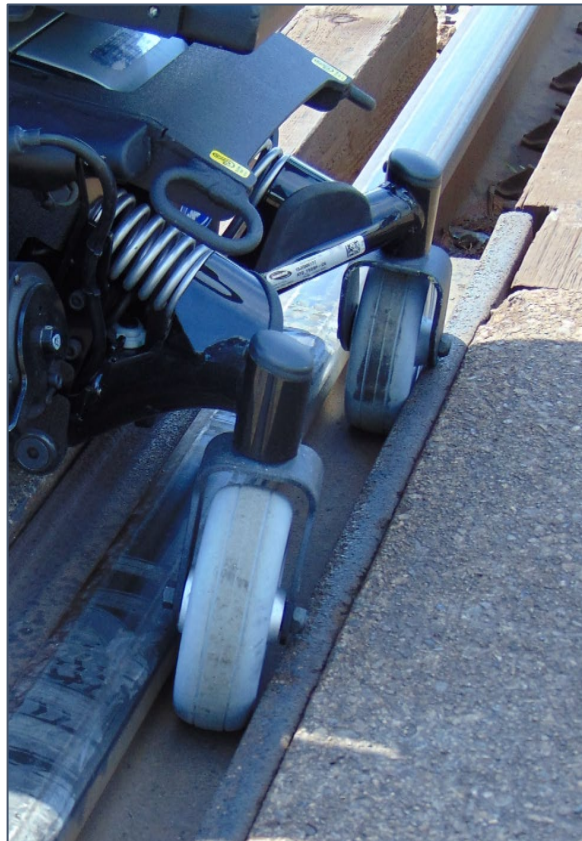
Figure 6. Rear caster wheels of exemplar wheelchair lodged in the flangeway gap at the occurrence crossing (Source: Royal Canadian Mounted Police)

The flangeway gap is a space that runs parallel to the inside of each rail at the crossing (Figure 6). It provides space for the flange of the wheels on a train to safely cross the intersecting roadway. However, it is also an area where assistive devices can become trapped, or where shoes, canes, walkers, or bicycle tires can get caught.

If crossing surfaces are uneven, flangeway gaps can pose an even greater challenge to users of assistive devices. Specifically, the caster wheels on wheelchairs can rotate when the surface level changes. If this occurs at the crossing, the caster wheels can drop into the flangeway gap, immobilizing the wheelchair.

As specified in the GCS, a flangeway gap of up to 4.75 inches (120 mm) is allowed. However, for crossings that have a sidewalk designated by a road authority for use by persons using assistive devices, the maximum flangeway gap is reduced to 2.95 inches (75 mm). Reduced

flangeway gaps are also applicable to the crossing surface extensions at designated crossings. However, according to the GCR, the requirements for reduced flangeway gaps at designated crossings do not come into effect until 2021.

At the occurrence crossing, measurements of the flangeway gap were taken at 8 locations (Table 2).

* At the approximate location where the wheelchair became immobilized.

In North America, several companies have been developing and testing flangeway gap fillers. These gap fillers are designed to reduce the risk of small wheels or objects becoming stuck in the flangeway gap, and to provide a smoother surface and help prevent the creation of tripping hazards. These products allow the flangeway to be much narrower and shallower, while still providing a safe passage for railway traffic. When a train or track unit passes over the track, the wheel flanges displace the flangeway gap filler. Once the wheels have passed through the flangeway, the gap filler returns to its previous position.

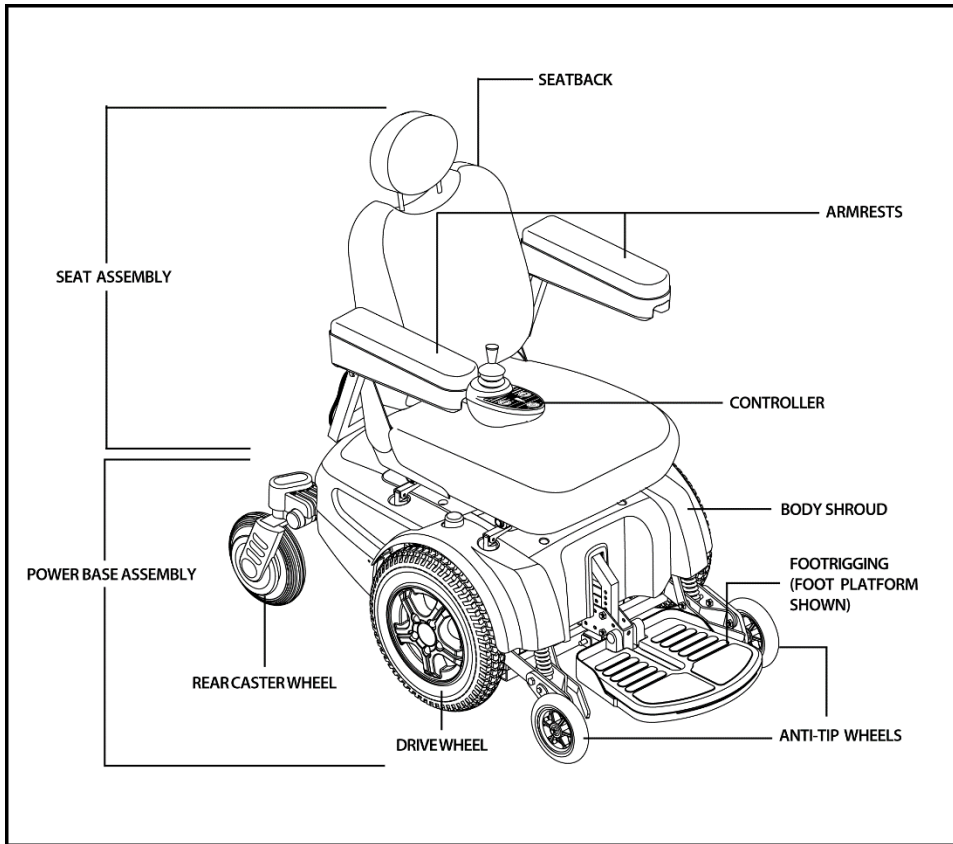
Figure 7. Schematic of the motorized wheelchair from the owner's manual (Source: third party, with permission)

As a result of the accident, the motorized wheelchair was extensively damaged to the point where it could not be determined whether there had been a mechanical failure. However, there was no indication that the motorized wheelchair had been defective before the accident. Video footage from the signal bungalow camera of the pedestrian operating the motorized wheelchair just prior to the accident indicated that the motorized wheelchair was responding appropriately to the joystick control commands. In addition, the pedestrian had been charging the battery for the motorized wheelchair each night.

pedestrian operating the motorized wheelchair just before the accident showed that the device was responding appropriately to the joystick control commands. In addition, a regular practice of the pedestrian was to ensure that the wheelchair's battery was charged each night. Therefore, the mechanical condition of the motorized wheelchair likely did not play a role in this accident.
