Rail Transportation Safety Investigation Report R19C0094

MAIN-TRACK TRAIN DERAILMENT AND DANGEROUS GOODS RELEASE

Canadian Pacific Railway
Freight train 469-01
Mile 17.88, Aldersyde Subdivision
Barons, Alberta
02 September 2019

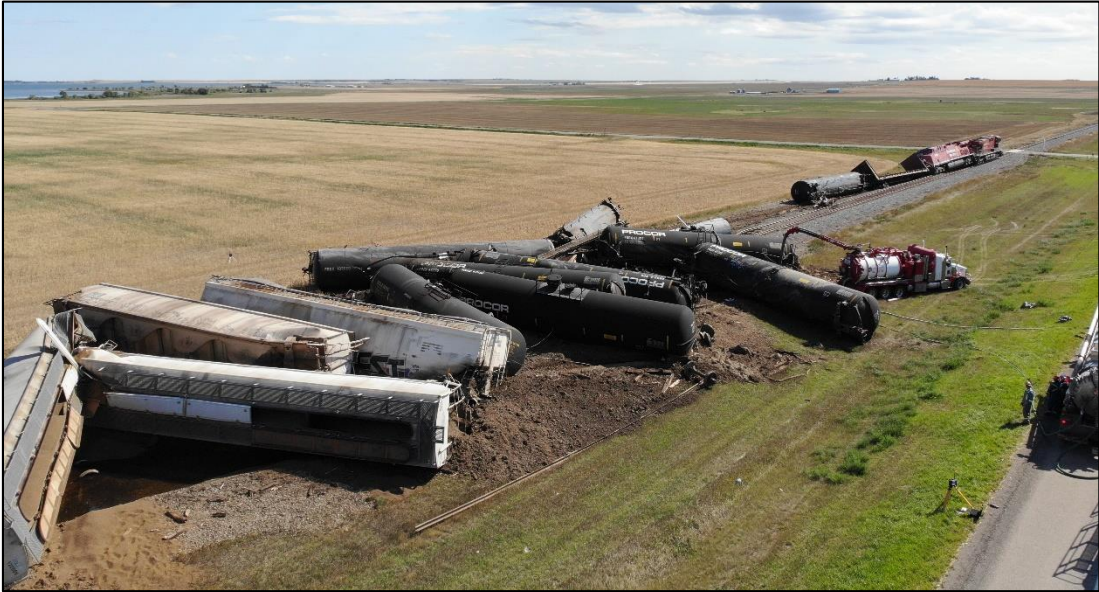
The derailment site was located immediately adjacent to Highway 23 in a rural area between Barons and Nobleford, Alberta. The derailed rolling stock came to a rest on both sides of the track (Figure 2). The site was secured and all access points to the site were controlled.

Figure 2. Aerial view looking southeast showing derailed rolling stock (Source: Canadian Pacific Railway)

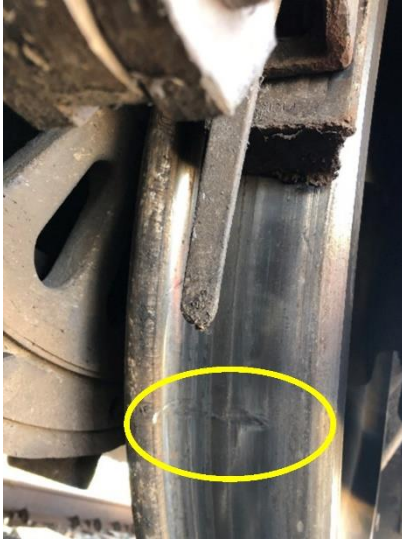
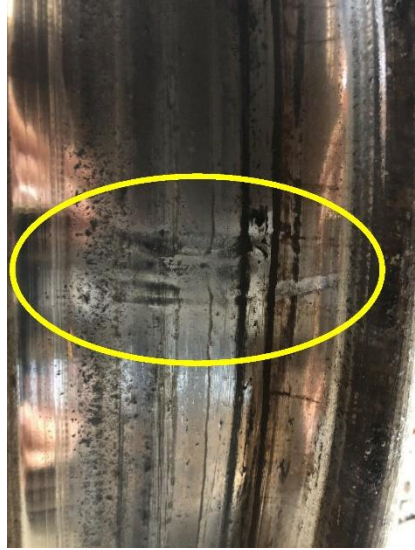
Visual inspection of the wheel tread surfaces on the lead locomotive, which had not derailed, revealed imprint scuff marks on the L4, L5, and L6 wheels that had been travelling along the east rail (figures 3 and 4). This is consistent with the wheel tread surface contacting a fracturing or fractured rail surface on the east rail.

Figure 3. Scuff mark on the tread of wheel L5 on the lead locomotive (Source: TSB)

Figure 4. Scuff mark on the tread of wheel L6 on the lead locomotive (Source: TSB)

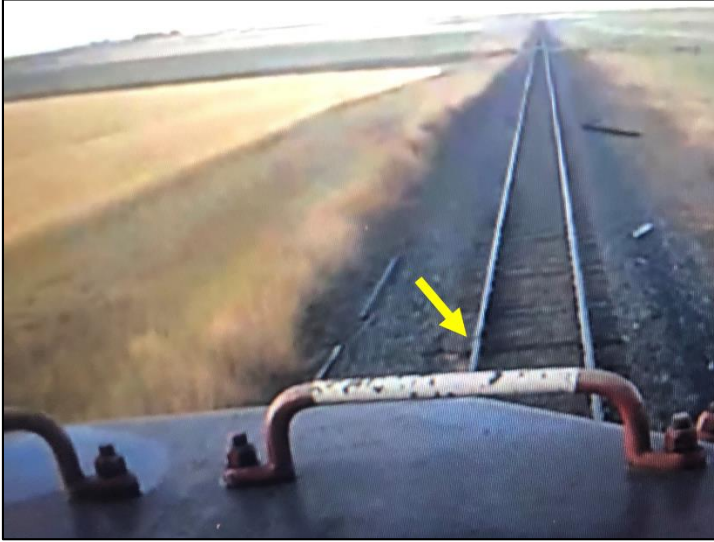
The lead locomotive was equipped with a forward-facing camera and video-recording equipment. A post-derailment review of the video data revealed a fracture in the east rail (Figure 5).

Figure 5. Forward view showing rail fracture

Note: Track materials in the photo are from a previous track repair. (Source: Canadian Pacific Railway video)

In this occurrence, although rail inspections had been performed as required, the pre-existing detail fractures went undetected. Although the circumstances behind the rail fracture seen in the forward-facing video could not be determined, it is likely that an undetected pre-existing detail fracture had progressed to failure under a previous train.

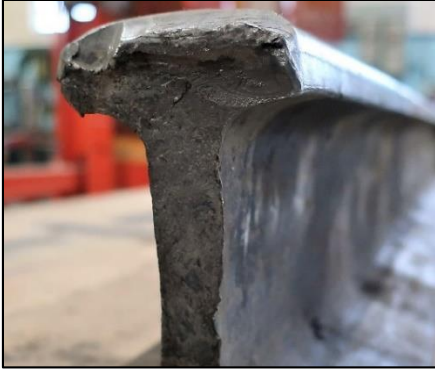
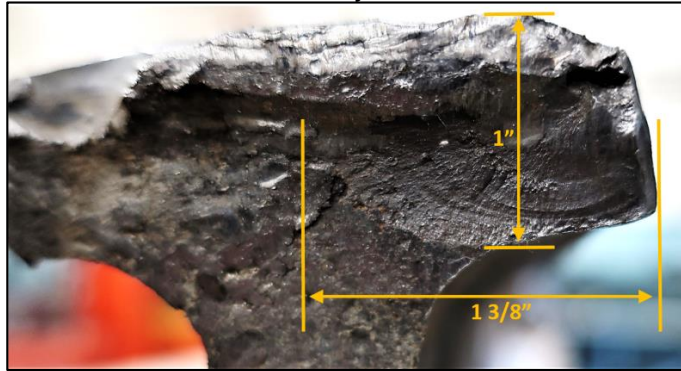
The analysis revealed that 2 fracture surfaces exhibited pre-existing detail fractures, one of which measured 1 inch deep by $1\frac{3}{8}$ inch wide and accounted for approximately 40% of the rail head cross-section (figures 6 and 7). It was also noted that the running surface displayed continuous heavy checking and cracking on the gauge corner; this is known to obscure UT test results. Several fracture surfaces examined displayed impact damage consistent with train 469-01's southbound direction of travel.

Figure 6. Cross-section of the rail
(Source: Canadian Pacific Railway)

Figure 7. Close-up showing the dimensions of the detail fracture, representing 40% of the rail head cross-section
(Source: Canadian Pacific Railway)

Detail fractures are part of a group of fatigue defects known as transverse defects—where the plane of the crack is perpendicular to the rail's running direction. Detail fractures are a common type of fracture caused by rolling contact fatigue due to high traffic density and loading. These fractures grow beneath a rail's surface and can only be detected by ultrasonic or induction/ultrasonic inspection. Defect growth rates are unpredictable.

The detectability of a detail fracture within a fatigue condition depends on the size and orientation of the transverse component and can be influenced by rail surface conditions⁹ such as the presence of grease or dirt on the rail head, head checking, and internal shelling. Therefore, pre-existing detail fractures may be difficult to detect and have an unpredictable growth rate, particularly when rail is worn. Positive identification of the defect cannot be made until the rail is broken because the longitudinal separation or seam in a detail fracture is often not exposed. Failure can occur before the defect becomes visible and generally results in a complete break of the rail.

Immediately following this occurrence, to identify and protect against any defective rail, rail flaw detection testing was conducted on the newly repaired rail at the derailment site. Additional rail flaw detection tests were conducted from 06 to 13 September 2019 on over 81 miles of the Aldersyde Subdivision. This resulted in 26 rails being replaced within 7 days of testing to address a variety of defects, including 11 defective field welds, 7 bolt hole cracks, 5 transverse defects or detailed fractures, 2 vertical split heads, and 1 head and web separation.
