RAIL TRANSPORTATION SAFETY INVESTIGATION REPORT R19M0018

MAIN-TRACK TRAIN DERAILMENT

VIA Rail Canada Inc.

Mile 15.27, Canadian National Railway Company Newcastle Subdivision

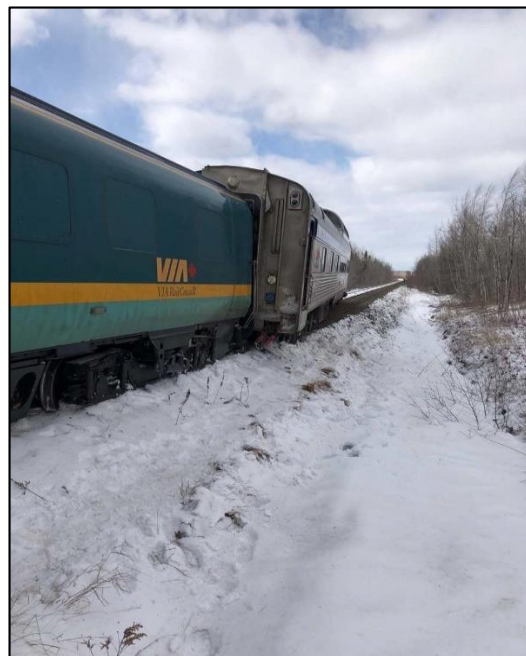
Upon inspection, the operating crew determined that the last 2 passenger cars had derailed upright and remained coupled to the train (Figure 3). There had been no train-initiated or occupant-initiated emergency brake application.

Figure 3. The last 2 VIA passenger cars, derailed upright (Source: Canadian National Railway Company)

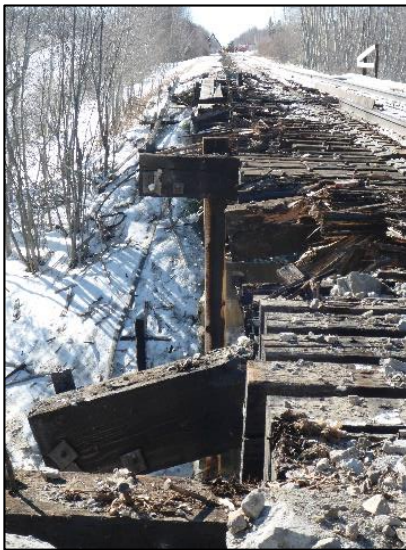
At Mile 14.9 of the CN Newcastle Subdivision, there was an open-deck steel bridge. The bridge was 133.5 feet in length, with 2 stone abutments, 2 stone piers, and a concrete bridge seat. On the bridge, the track consisted of 100-pound rail, with 100-pound guard rails (also called Jordan rails)³ installed at a 9-inch offset. The stone abutment on the northwest side of the bridge had sustained impact damage from one of the derailed cars. About 100 ties and the guard rails had also sustained damage during the occurrence (figures 4 and 5).

Figure 4. Bridge deck damage
(Source: TSB)

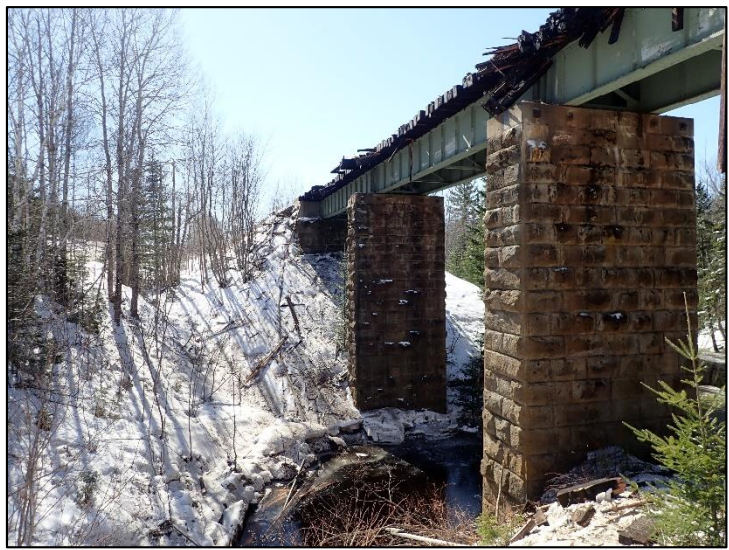
Figure 5. Bridge at Mile 14.9 with damaged ties (Source: TSB)

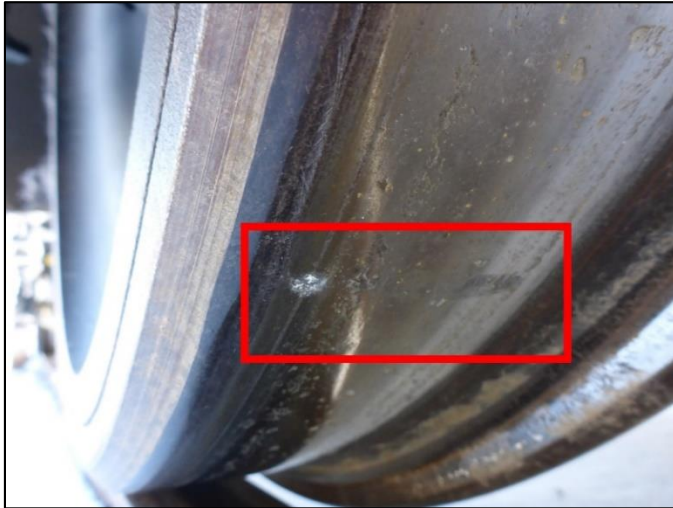
The remainder of the train had not derailed. All wheel sets from the 2nd to the 12th cars had impact marks on the north-side wheels, likely from contact with the broken rail (Figure 6). These markings were progressively less visible on the wheel sets of the cars

Figure 6. Impact mark on wheel of the 10th car (Source: TSB)

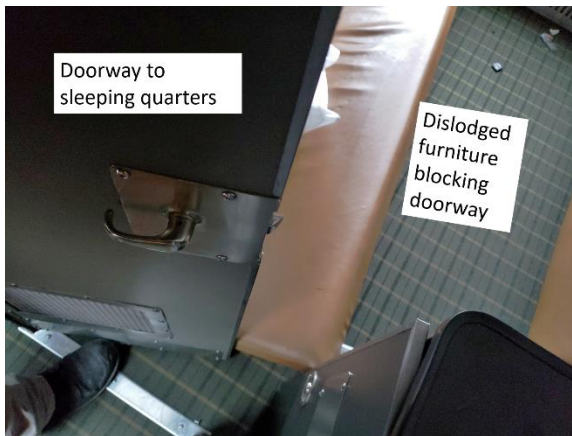
The interior of the 14th car (VIA 8711) had sustained damage. Loose items such as coffee machines and folding chairs were displaced within the car. Folding benches and armchairs were dislodged, blocking a doorway to the sleeping quarters (Figure 7). Ceiling panels had partially dislodged over the panoramic seating area (Figure 8).

Figure 7. Blocked doorway on VIA 8711 (Source: TSB)

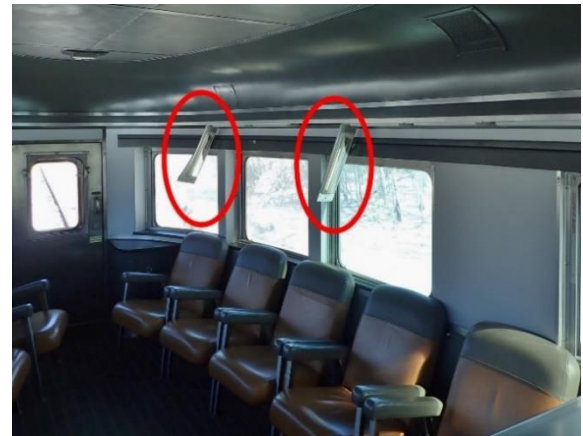
Figure 8. Partially dislodged ceiling panels on VIA 8711 (Source: TSB)

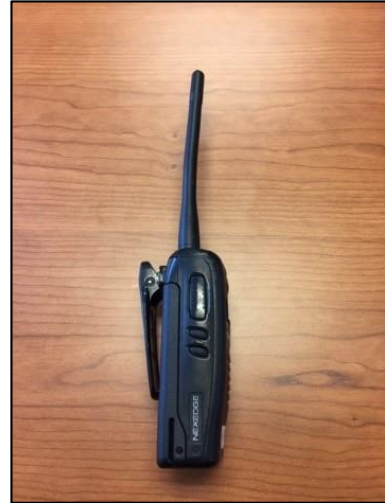
In this occurrence, the OTS employee located in the 14th car had his portable radio clipped to his belt using the integrated plastic belt clip. The car's derailment created significant dynamic forces, which caused the radio to unclip from the employee's belt, fly out of reach, and lose its battery. This left the employee with only the cellular telephone and no means of immediately communicating with the operating crew.

Figure 9. Portable radio used by VIA (Source: VIA Rail Canada Inc.)

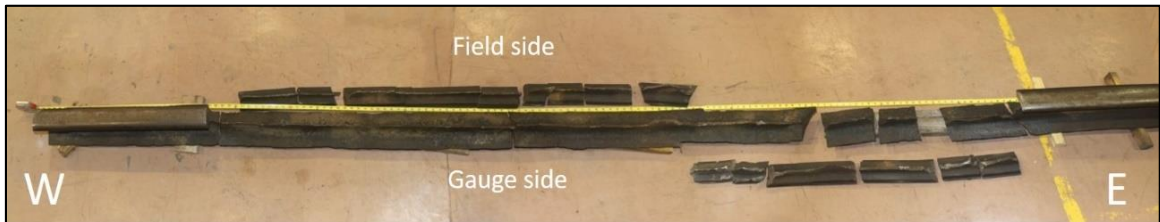
In this occurrence, a section of rail head, approximately 119 inches in length was missing from the north side of the Lakeville Road crossing (Mile 15.27). This section of rail had broken into several pieces during the derailment, the majority of which was recovered in the vicinity of the crossing. Approximately 7 inches of the rail base, 12 inches of the rail head, and some segments of the web could not be found. The recovered broken rail pieces were sent to the TSB Engineering Laboratory in Ottawa for detailed examination (Figure 11).

Figure 11. Recovered rail fragments (Source: TSB)

The thinning of the rail web, which affected the ability of the rail to withstand vertical and lateral loads, was the result of corrosion. Rail corrosion occurs when carbon steels react to environmental conditions, resulting in oxidization. Carbon steels have lower corrosion rates in dry open atmospheres but the rate of corrosion increases in the presence of moisture, chlorides, or saline environments.

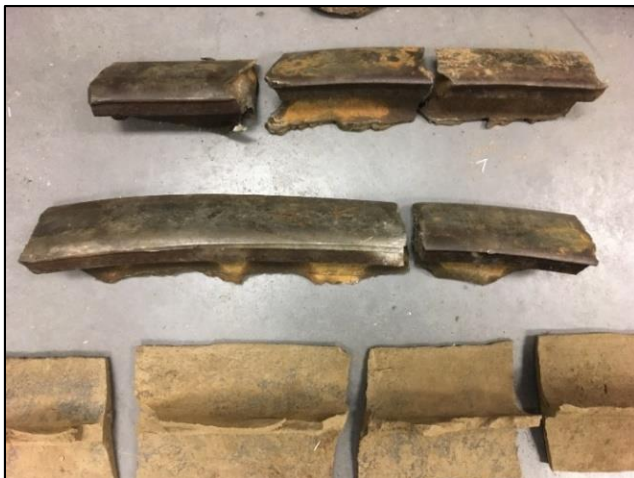
- Of the multiple rail pieces recovered, 1 piece, located between 40 and 46 inches from the easternmost fracture point of the rail, had a deep gouge on the field side.
- All rail fragments exhibited severe generalized corrosion, particularly on the web and base of the rail.
- Significant material loss had occurred (Figure 12). The rail web had corroded to about 0.16 inch (4 mm) at its thinnest point near the centre of the crossing, which was less than one third of its original thickness of 0.56 inch (14.28 mm) (Figure 13).
- The web of the broken rail was approximately 0.43 inch (11 mm) thick at its eastern extremity and approximately 0.28 inch (7 mm) thick at its western extremity.

Figure 12. Fragments of recovered rail (Source: TSB)

Rail fragments recovered from the occurrence site exhibited severe generalized corrosion, particularly on the web and base. The laboratory examination did not identify any pre-existing internal defects in the recovered fragments. However, the rail web had corroded to approximately 4 mm at its thinnest point, less than $\frac{1}{3}$ of its original thickness.

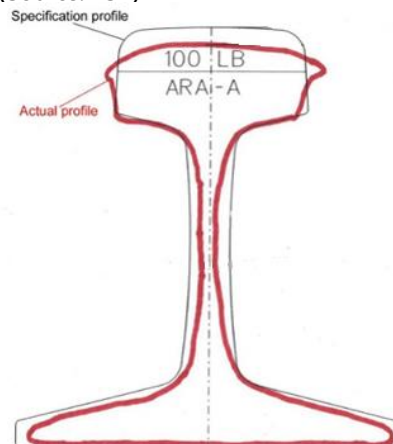
Figure 13. Profile overlay of occurrence rail (Source: TSB)

Such a significant loss of web material due to corrosion affected the ability of the rail to withstand the dynamic vertical and lateral loads associated with wheel-rail interaction. The web of the rail that fractured had thinned due to corrosion to a point where it could no longer support normal train forces.
