Rail Transportation Safety Investigation Report R19M0028

CROSSING ACCIDENT

Canadian National Railway Company
Train A40711-29
Mile 27.73, Bedford Subdivision
Oakfield, Nova Scotia
29 July 2019

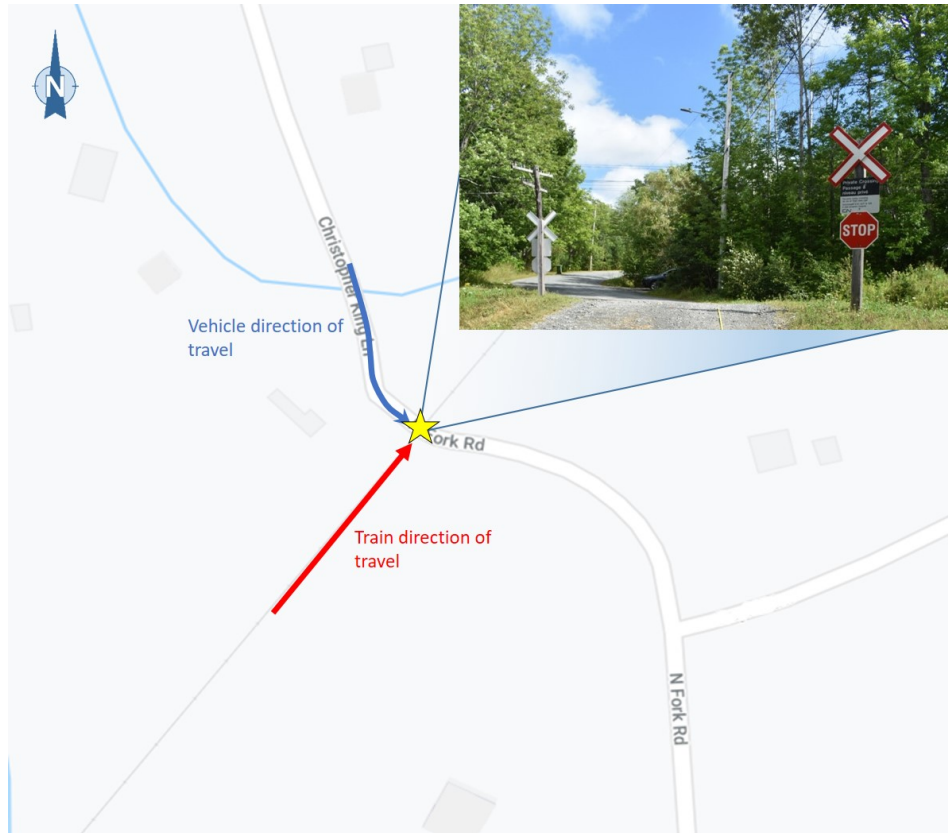
At approximately 1135,¹ the train approached the private crossing at Mile 27.73 in Oakfield, Nova Scotia, at a speed of 51 mph. The lead locomotive headlights were on full power and its ditch lights were activated. The locomotive horn was not activated, and there is no requirement for trains to whistle at the approach to private crossings. At about the same time, a passenger vehicle with 2 occupants travelling southward on Christopher King Lane was approaching the crossing at a speed of approximately 20 km/h (Figure 1).

Figure 1. Map of occurrence location, showing the vehicle and train directions of travel, with inset image showing the stop sign for vehicles travelling southward on Christopher King Lane (Source: Google Maps, with TSB annotations)

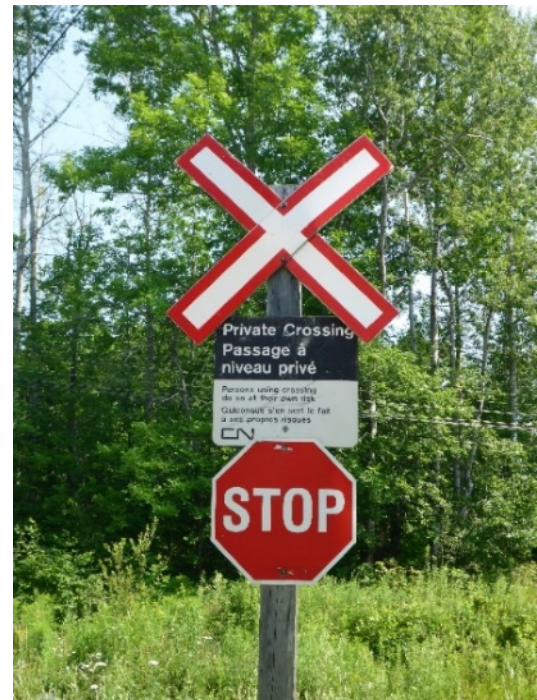
Grade crossings can be equipped with different types of protection systems. These include automated warning systems³ and passive signs. Although not required under the GCR, some private grade crossings are equipped with a stop sign, an SRCS, and a private crossing sign (Figure 2). Vehicles approaching such crossings are expected to perform a full stop at the crossing and to proceed only when it is safe to do so.

Figure 2. Standard railway crossing sign and stop sign (Source: TSB)

To ensure safety at private grade crossings that are protected by passive stop signs, it is important that all motor vehicle drivers obey posted traffic signs.

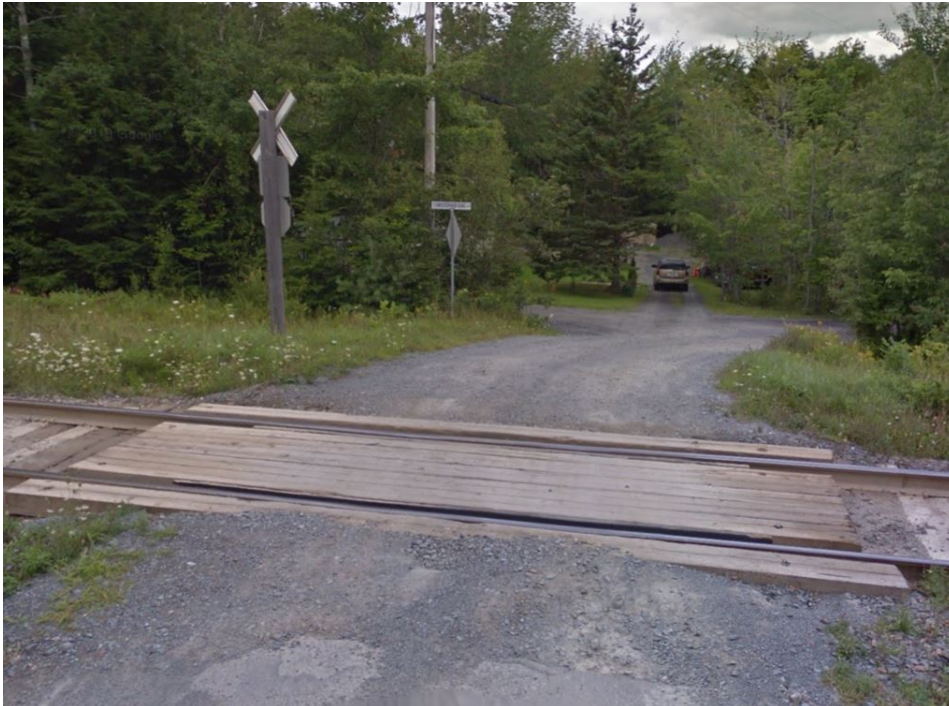
At the private crossing (Mile 27.73), the road south of the crossing (North Fork Road) is a provincial road, while the road north of the crossing (Christopher King Lane) is a single-lane private gravel road that leads to 7 residences. Christopher King Lane traverses the railway track at approximately 90 degrees. The crossing surface is made up of wood planks. Passive warning signs (reflectORIZED SRCS and stop sign) are attached to a wooden post that is positioned 13.5 feet south of the centre of the crossing (Figure 3). The crossing surface and reflectORIZED SRCS meet TC's applicable regulatory provisions. The speed limit for vehicles in the vicinity of the crossing is 30 km/h.

Figure 3. Crossing surface looking north (Source: Google Maps Street View)

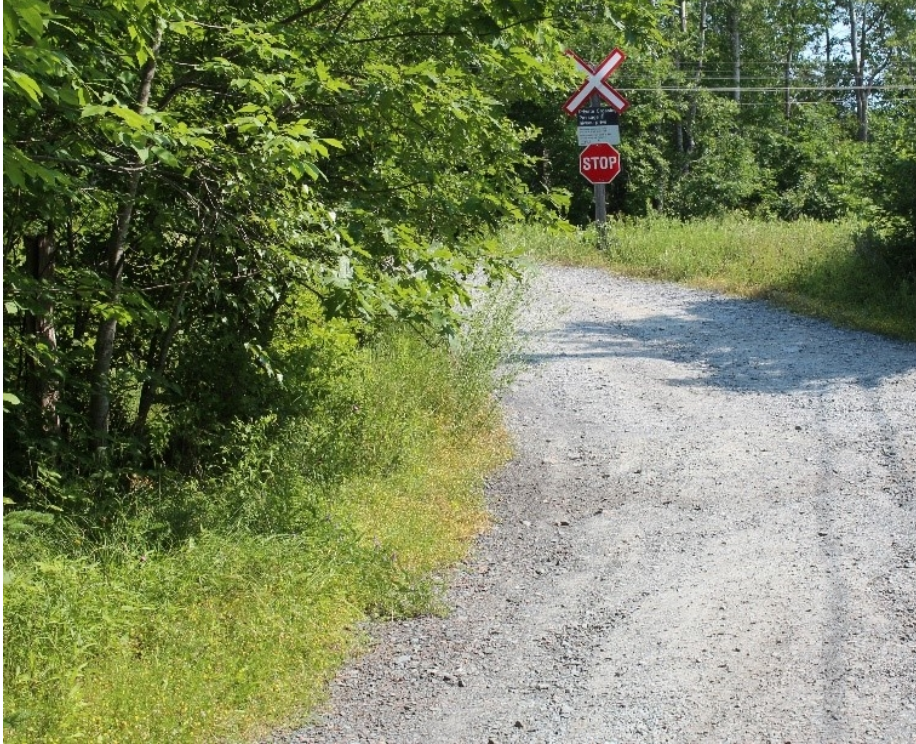
When approaching the crossing, southbound vehicles on Christopher King Lane are required to navigate a curved section of the road that is lined with trees. The road at this approach has an ascending gradient of approximately 13% within 8 m of the nearest rail (Figure 4). As this crossing is equipped with a stop sign, the sightlines along the railway right-of-way (measured from the stop position) meet TC's regulatory requirements.

Figure 4. Southward approach to crossing (Source: TSB)

During site examination, it was noted that after southbound vehicles stop at the crossing, some vehicles had difficulty pulling away due to the presence of gravel and the road's gradient. In the winter, the presence of snow and ice could further exacerbate this situation.

With approximately 9000 private crossings along federally regulated rail lines in Canada,⁶ it is important for railways and private crossing owners to consider the effect of roadway grade, curvature, surface, and sightlines on the ability to comply safely with crossing signage, or to consider adding grade crossing warning systems.

In addition, the physical design of private grade crossings, including their road approaches, plays a role in enabling motorists to navigate these crossings safely.
