## Rail Transportation Safety Investigation Report R20D0013

### CROSSING COLLISION

Réseau de transport métropolitain  
Commuter train EXO 182  
Mile 9.91, Canadian Pacific Railway Parc Subdivision  
Montréal, Quebec, Ahuntsic-Cartierville borough  
18 February 2020

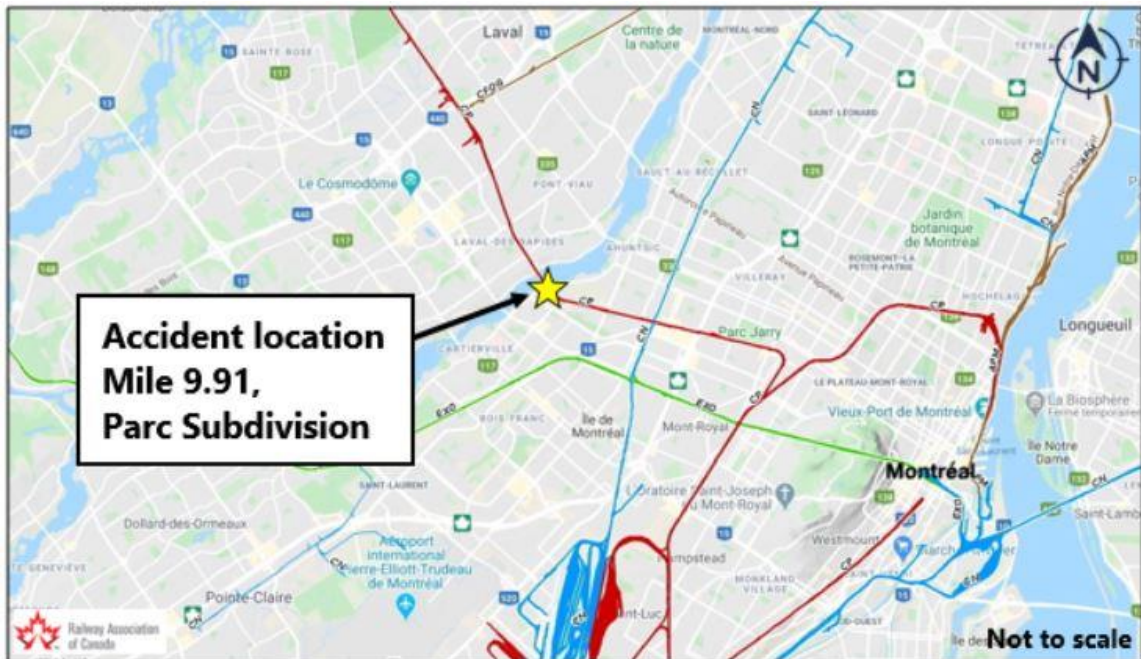
Figure 1. Accident location (Source: Railway Association of Canada, *Canadian Railway Atlas*, with TSB annotations)

The train, travelling east on the south main track, crossed the bridge at Perry Island and was heading toward Bois-de-Boulogne Station (Mile 8.90). At approximately 0922,<sup>2</sup> the train approached the public crossing at Gouin West Boulevard (Mile 9.91) at a speed of 44 mph (Figure 1).

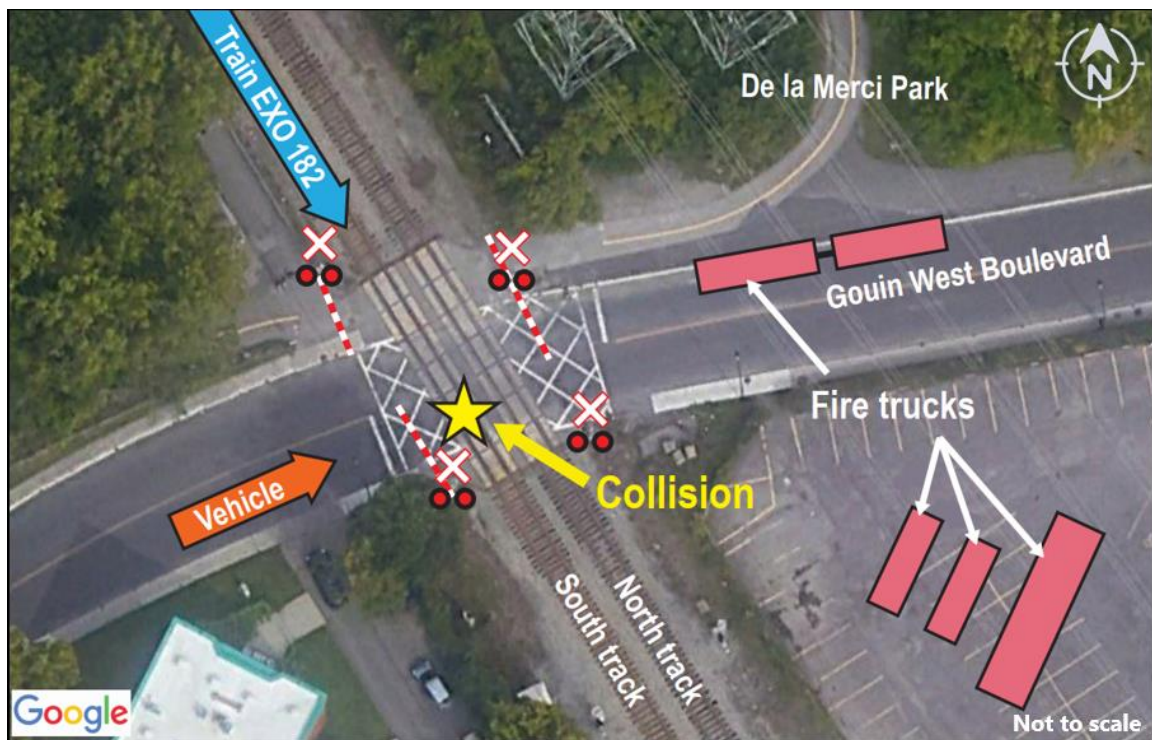
Figure 2. Site diagram (Source: Google Maps, with TSB annotations)

The collision occurred at a public crossing equipped with automatic warning devices (flashing lights, bells, and gates) that were activated. The car was hit behind the left centre pillar and was pushed about 25 m southeast of the crossing. The train remained on the tracks and did not sustain any mechanical damage. No fuel was spilled (Figure 2).
