Rail Transportation Safety Investigation Report R20W0031

MAIN-TRACK TRAIN DERAILMENT

Canadian National Railway Company
Train X35041-18
Mile 108.25, Fort Frances Subdivision
Emo, Ontario
18 February 2020

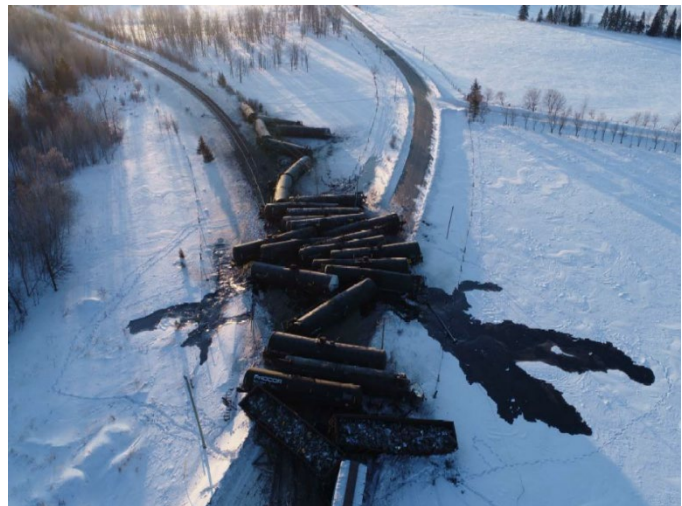
Figure 2. Aerial view of the derailment site (Source: Canadian National Railway Company)

The 48th to 51st cars remained upright on the rails and attached to the head end of the train. The train separated behind the 51st car and came to a stop, creating a gap of about 1500 feet between the 51st and 52nd car. The trailing 52nd to 80th cars derailed predominantly toward the high side (the south side) of the curve. The tank cars located in the 75th and 76th positions and the 4 non-DG cars located in the 77th to 80th positions remained upright.

The 52nd to 74th cars, which were carrying petroleum crude oil, came to rest in various positions scattered over a distance of approximately 1000 feet (Figure 2). Six cars released a total of 84 464 U.S. gallons (319 731 L) of product.

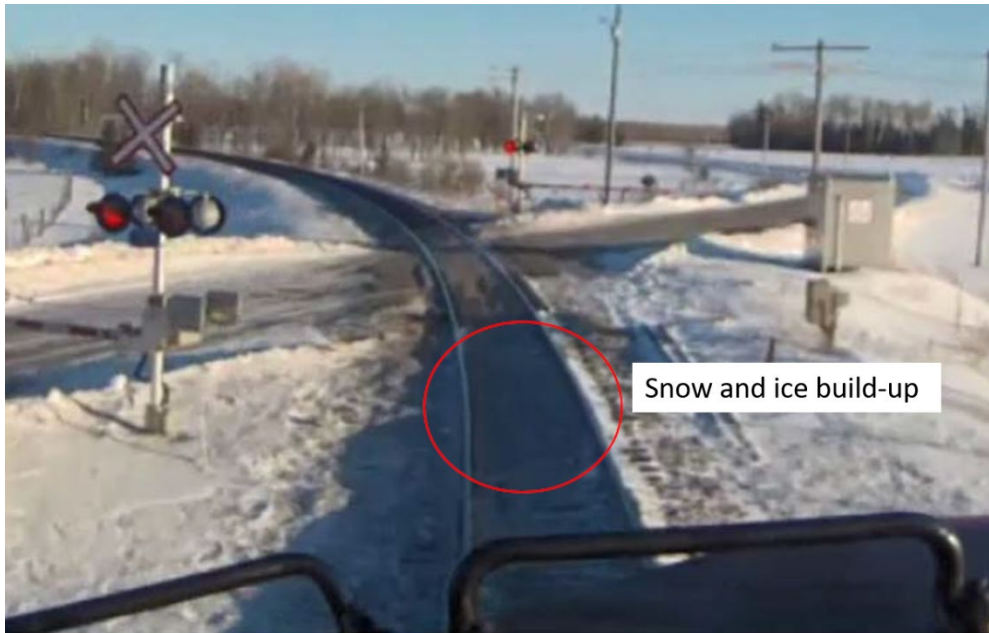
Figure 3. Image from the forward-facing video from train 118 (Source: Canadian National Railway Company)

In the area of Mile 108.25, just west of the crossing (Mile 108.22) snow and ice build-up was observed adjacent to the high rail (the south rail), which can occur during winter operations. Closer examination revealed that the snow and ice had built up between the underside of the rail base and the tie plate rail

seats. This caused the rail to become unseated from the tie plate and left the rail susceptible to gauge spreading under the load of the train, which led to the derailment. This is a phenomenon commonly referred to in the rail industry as "ice jacking".

Earlier in the day at about 1600, the previous eastbound CN train, Q11831-16 (train 118), safely traversed the occurrence site during daylight hours when the ambient temperature was -14 °C. A review of the video from the forward-facing camera on the lead locomotive of train 118 revealed the

presence of snow and ice build-up just before and adjacent to the high rail (the south rail) in the vicinity of the suspected initial point of derailment at about Mile 108.25 (Figure 3). Any accumulation of snow along the rail base can mask a build-up of ice between the underside of the rail base and tie plate rail seats, which makes ice-jacking difficult to detect.

Following the occurrence and CN's incident investigation, CN clarified inspection expectations in its ETS to require zone and production gangs that are doing work on one rail to inspect both rails to ensure that they comply with track standards and that no hazards exist.
