# RAIL TRANSPORTATION SAFETY INVESTIGATION REPORT R20W0102

## **MAIN-TRACK TRAIN DERAILMENT**

Canadian Pacific Railway Company  
Freight train 320-227  
Mile 12.8, Ignace Subdivision  
Near Ignace, Ontario  
25 May 2020

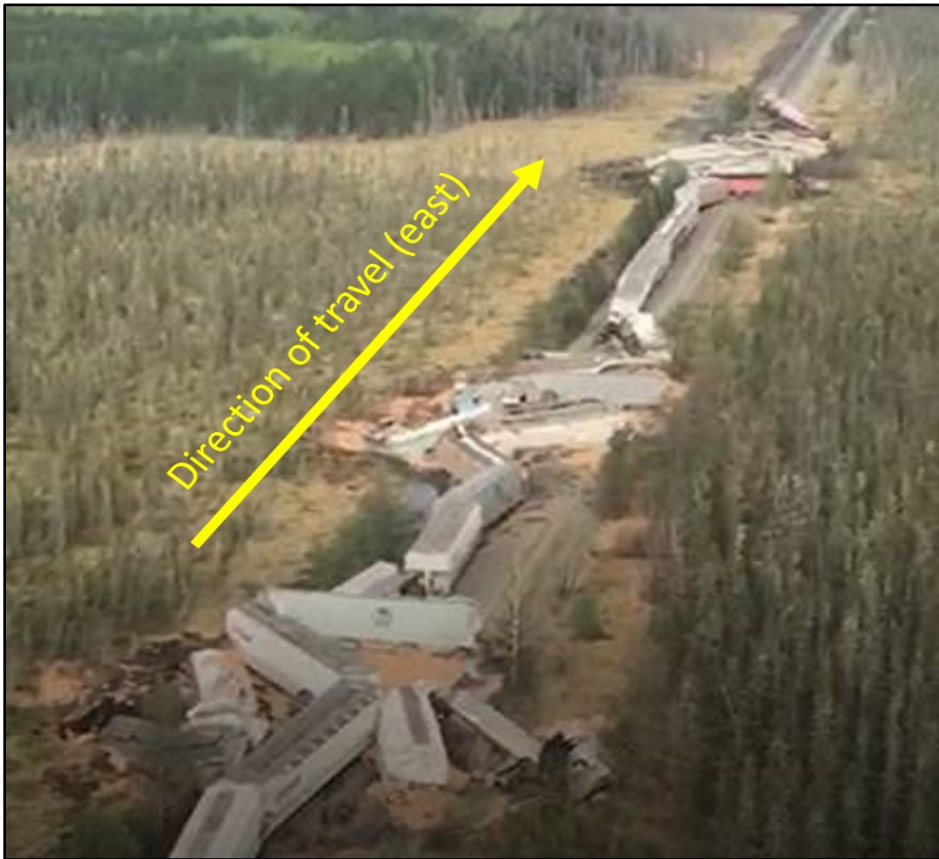
Figure 2. Occurrence site showing the 2 pile-ups of derailed cars (Source: Canadian Pacific, with TSB annotations)

The train had separated after the 26th car, and there was a gap of about 30 car lengths between this car and the 2 pile-ups of derailed cars. The first pile-up consisted of 28 cars (positions 27 to 54), and the second pile-up consisted of 25 cars (positions 59 to 83). Between these, 4 cars had remained on the track and had not derailed (Figure 3).

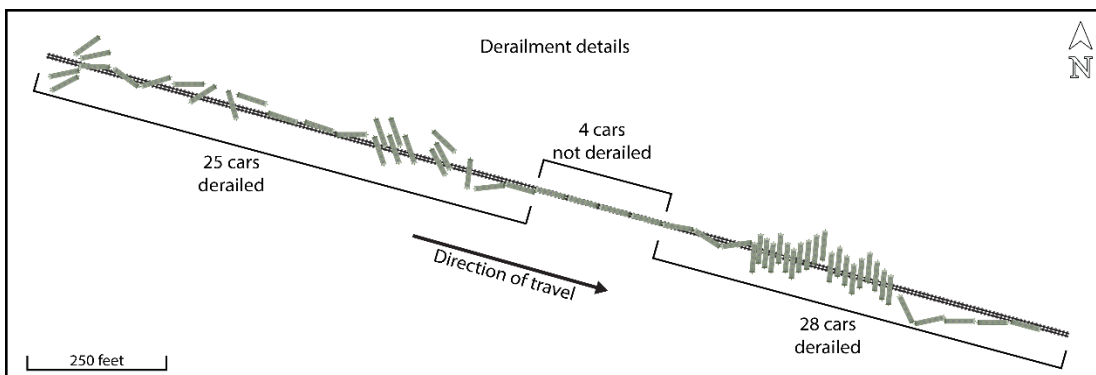
Figure 3. Site diagram showing the position of the derailed cars (Source: TSB)

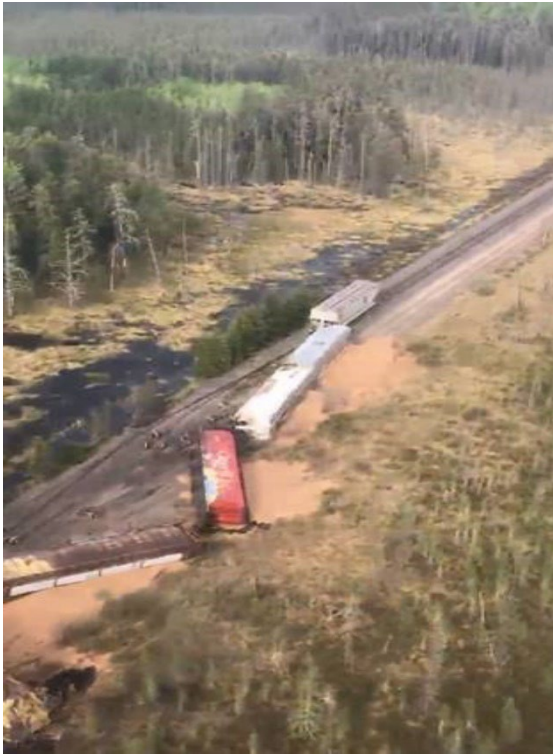
Due to excessive rainfall in May 2020, there was standing water on the north (left) side of the track in the immediate vicinity of the 2 pile-ups (Figure 4). An equalization culvert, which was located in the area, was in good condition.

Figure 4. Water accumulation beside the north track  
(Source: Canadian Pacific)

The poor drainage conditions at the derailment location caused water to accumulate adjacent to and under the track. The accumulated water resulted in frost heaving during winter freezing of the roadbed, differential track cross-level measurements, and the need for frequent shimming and surfacing to maintain track alignment, surface, and profile.

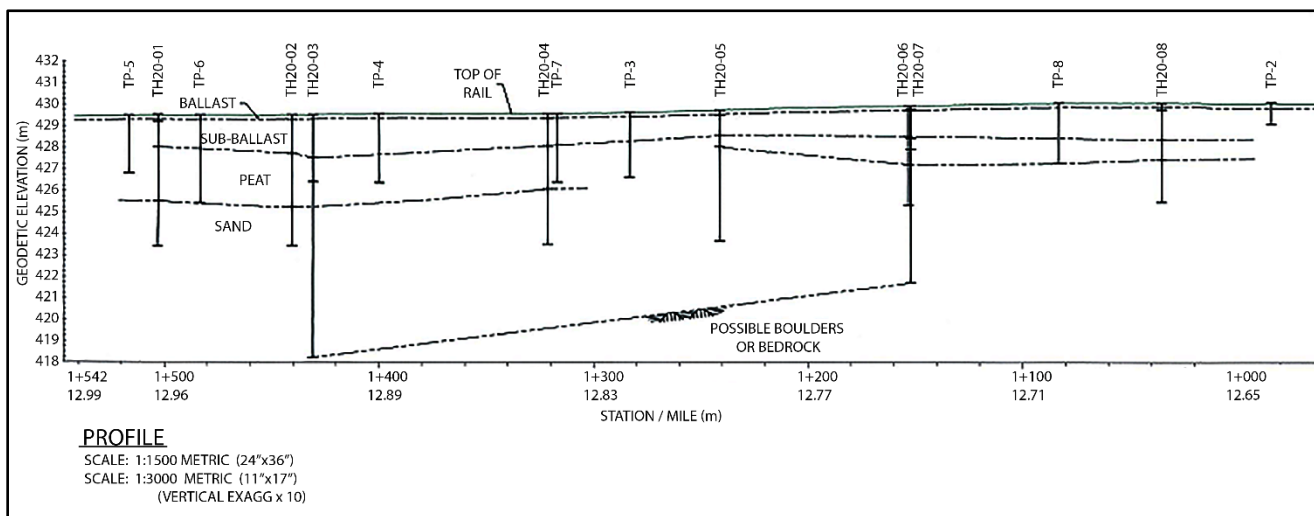
Figure 5 shows the location where 8 test holes were drilled and where test pits were dug between Mile 12.67 and Mile 12.99, as well as the soil profile at those locations.

Figure 5. Schematic showing the location of test holes and test pits, and the soil profile at these locations (Source: Canadian Pacific)

- The ballast layer was 0.3 m deep and made of a mixture of fine-grained and coarse-grained gravel. The gravel was grey, dry, and compact.
- The sub-ballast layer was 1.2 to 1.5 m deep and consisted of poorly graded sand (rated SP-SM according to the Unified Soil Classification System), which was black and brown, wet, loose, and fine-grained. It also contained traces of silt (16% in the second test hole) as well as a mixture of fine-grained and coarse-grained gravel. Starting at a depth of 0.5 to 0.8 m, there was some free water, indicating that the water table was very high in the area of the derailment.

- Beneath the ballast and sub-ballast layers, peat was encountered at a depth of 1.5 to 2.0 m. It was generally brown to dark brown, saturated, and loose. The thickness of the peat ranged from 0.5 to 1.7 m from Mile 12.67 to Mile 12.80, and from 1.1 to 2.6 m from Mile 12.80 to Mile 12.90. Different types of peat were found in the samples, depending on the location of the test holes:

- In the upper portion of some of the samples, there was coarse-fibrous peat crisscrossing fine-fibrous peat. The plant structure was recognizable. This peat was predominantly fibrous, with slight-to-moderate decomposition.
- In the upper to mid-portion of some of the samples, at a depth ranging from 1.3 to 3.0 m, the peat contained recognizable woody particles held within predominantly non-woody, fine-fibrous peat. The woody particles were pieces of the corduroy road<sup>9</sup> originally laid on the peat during the construction of the railway.
- In the bottom portion of some of the samples, at a depth of about 1.3 to 3.0 m, the peat was amorphous, with very high to nearly complete decomposition. Nearly no plant structures were recognizable.
- Moisture content was determined to be 102% to 145% in fibrous peat and 381% in amorphous peat.

An examination of 8 geotechnical core samples taken in the area of the derailment (about Mile 12.8) indicated that the sub-ballast layer was made of poorly graded sand, which was black and brown, wet, loose, and fine-grained, with up to 16% silt. Material with more than 10% silt and clay is not considered free-draining and may have low bearing capacity, especially if saturated by a high water table. In the area of the derailment, starting at a depth of 0.5 to 0.8 m, there was some free water, indicating that the water table was very high. Peat was encountered beneath the sub-ballast layer. Peat, a naturally occurring organic soil, is characterized by high water content, poor drainage, and high compressibility, which result in reduced strength of the peat fibres.

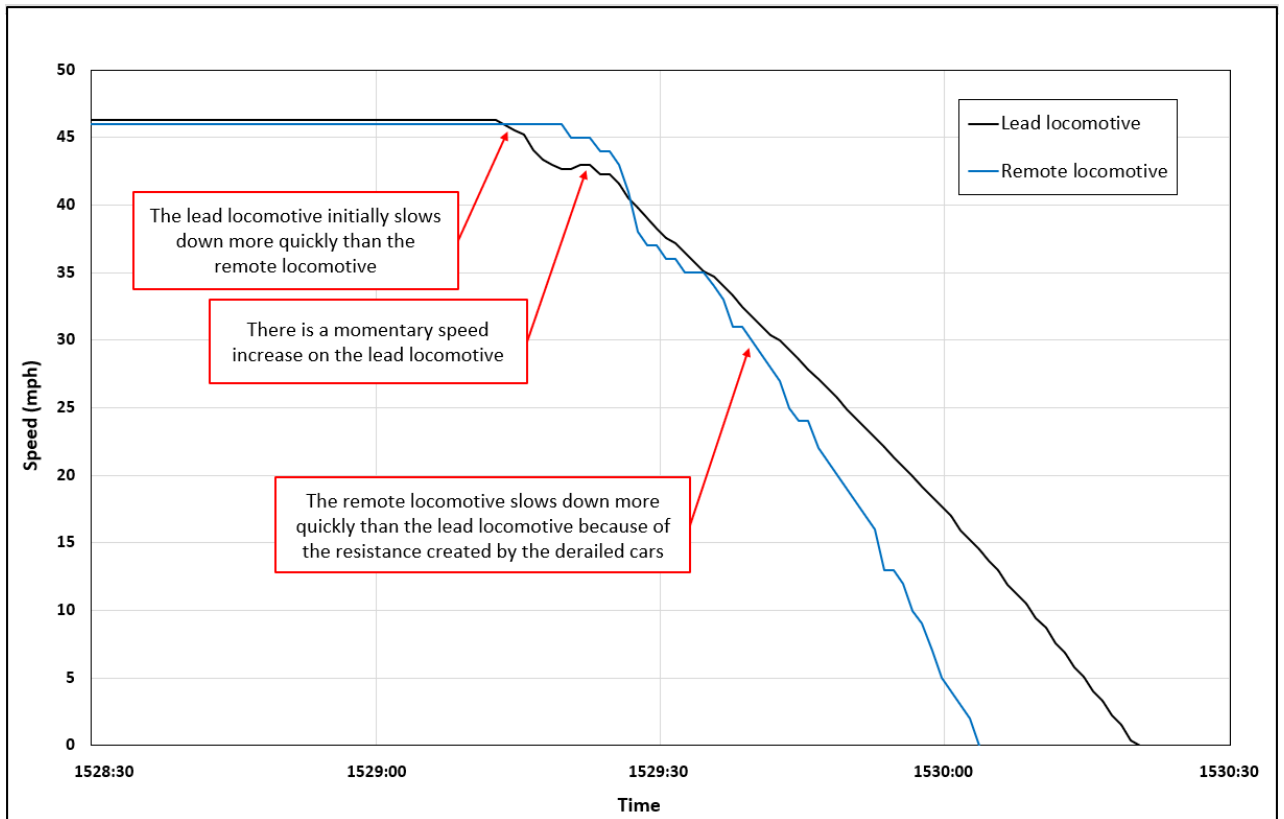
Figure 6. Graph showing speed profiles for the lead and remote locomotives during the derailment (Source: TSB, based on data from the locomotive event recorders)
