RAIL TRANSPORTATION SAFETY INVESTIGATION REPORT R21H0087

CROSSING COLLISION

VIA Rail Canada Inc.
Passenger train No. 53
Mile 11.75, Smiths Falls Subdivision
Richmond, Ontario
30 June 2021

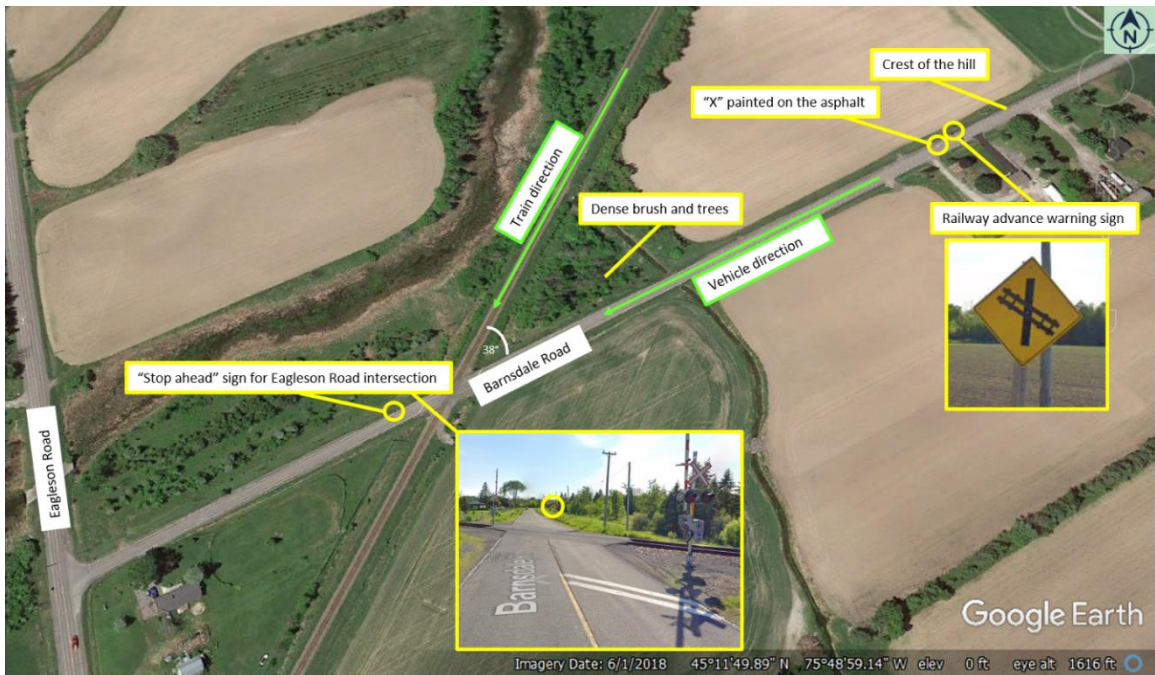
A “Railway crossing ahead” sign and pavement markings (railway advance warning sign and “X” painted on the asphalt) on Barnsdale Road are located 1150 feet and 1125 feet, respectively, northeast of the crossing (Figure 2).⁷

This crossing was designed to give drivers an approach warning time of 35 seconds, 10 seconds greater than the minimum of 25 seconds required.⁹ However, because of the hill, a vehicle driver

receives only about 18 seconds of warning (with the crossing in full view) if travelling at the posted speed limit of 80 km/h.

Because of the angle of the track and the dense brush and trees between the road and the track, a train approaching from the northeast is not visible to road users approaching from the east. Due to the visual cues provided by the warning system, which included gates, there were no sightline requirements, in accordance with section 22 of the *Grade Crossings Regulations*.

Figure 2. Aerial view of the Barnsdale Road crossing showing the direction of travel of the train and the vehicle, with inset photos of the railway advance warning sign and the "Stop ahead" sign for the Eagleson Road intersection (Source of main image: Google Earth, with TSB annotations. Source of inset images: Google Street View)
