RAIL TRANSPORTATION SAFETY INVESTIGATION REPORT R22D0106

NON-MAIN-TRACK DERAILMENT

Canadian National Railway Company
Train M32621-11
Mile QM 192.1, CSX Transportation Montreal Subdivision
Near Huntingdon, Quebec
11 December 2022

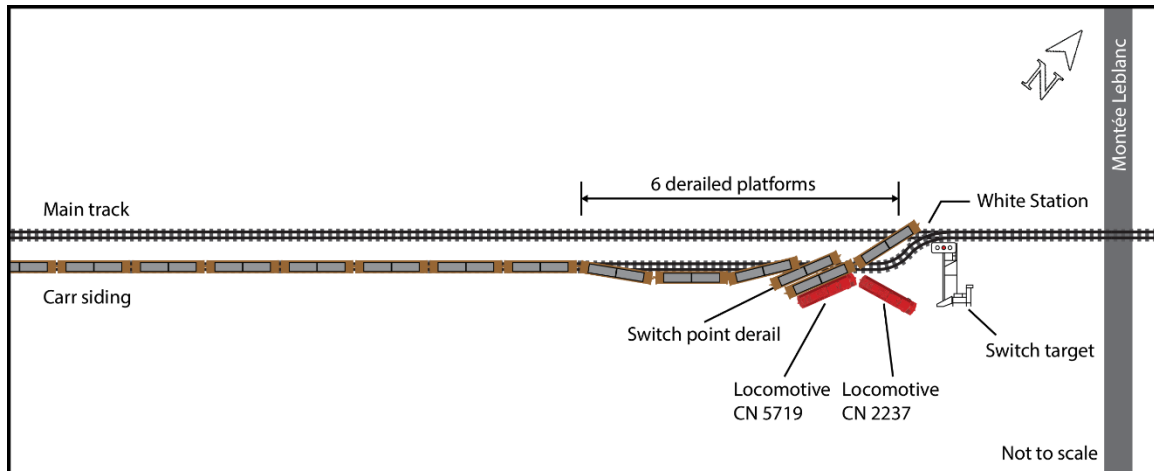
Figure 3. Derailment site (Source: TSB)

After the conductor had obtained authorization from the RTC to occupy the main track, which is governed by the occupancy control system (OCS),² the LE on train CN M326 left the cab of the lead locomotive (CN 2237) to go to the second locomotive (CN 5719) to check that the multiple-unit operating controls were correctly set. On his return, he moved the reverser handle to the forward position, released the independent brake and placed the throttle in notch 1. He then entered the dual-tone multi-frequency (DTMF) sequence³ on the locomotive railway radio, intending to line the radio-controlled switch⁴ from the main track to White Station⁵ in the position that would permit the train to enter the main track. The switch target light then went from red to green, and an audio confirmation message from the power-assisted switch (PAS) system⁶ was transmitted over the railway radio. At approximately 1912, while travelling at 22 mph, the train derailed when it passed over the switch point derail⁷ north of the siding (Figure 3). At that time, a train-initiated emergency brake application occurred.

Train CN M326 derailed while leaving the Carr siding, when it passed over a switch point derail linked to a radio-controlled switch system as it prepared to enter the main track at about 22 mph.

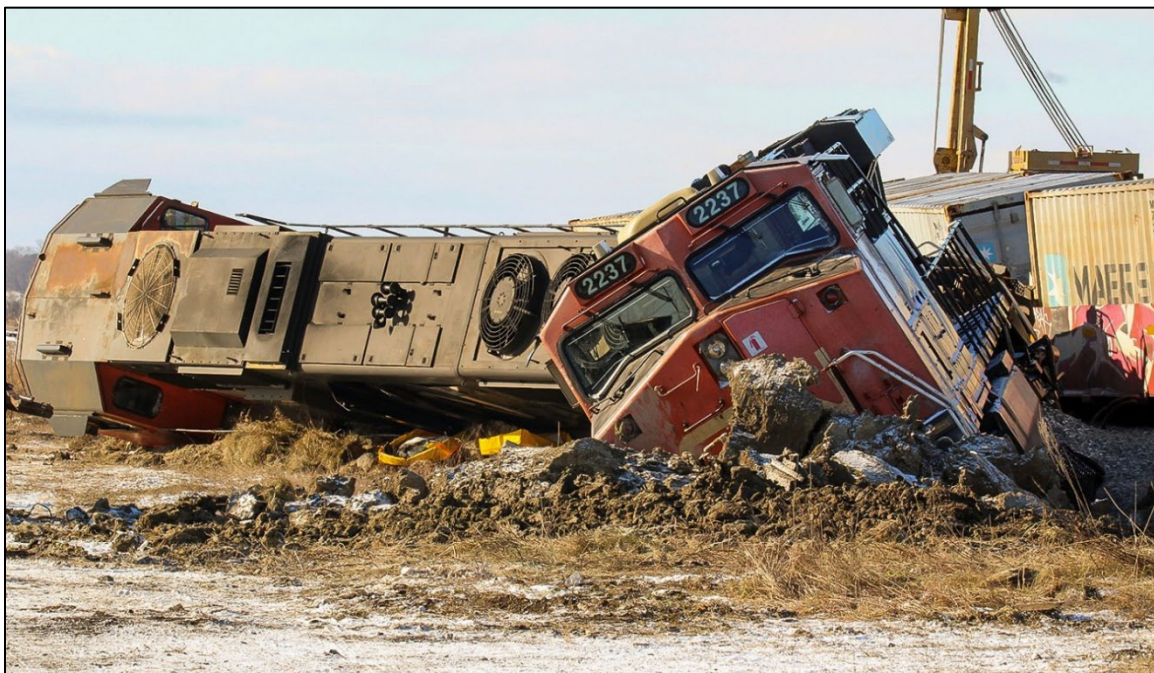
Figure 4. Derailed lead locomotives (Source: Érick Ouellet, photographer)

As a result of the derailment, lead locomotive CN 2237 partially sank into the ground on the east side of the track, in a 45-degree inclined position. Locomotive CN 5719 rolled onto its side (Figure 4).

The coupler head behind locomotive CN 5719 broke, and the first five-pak car came to rest straddling part of the main track. Five intermodal platforms derailed, as did the truck on the first platform of the second five-pak car.

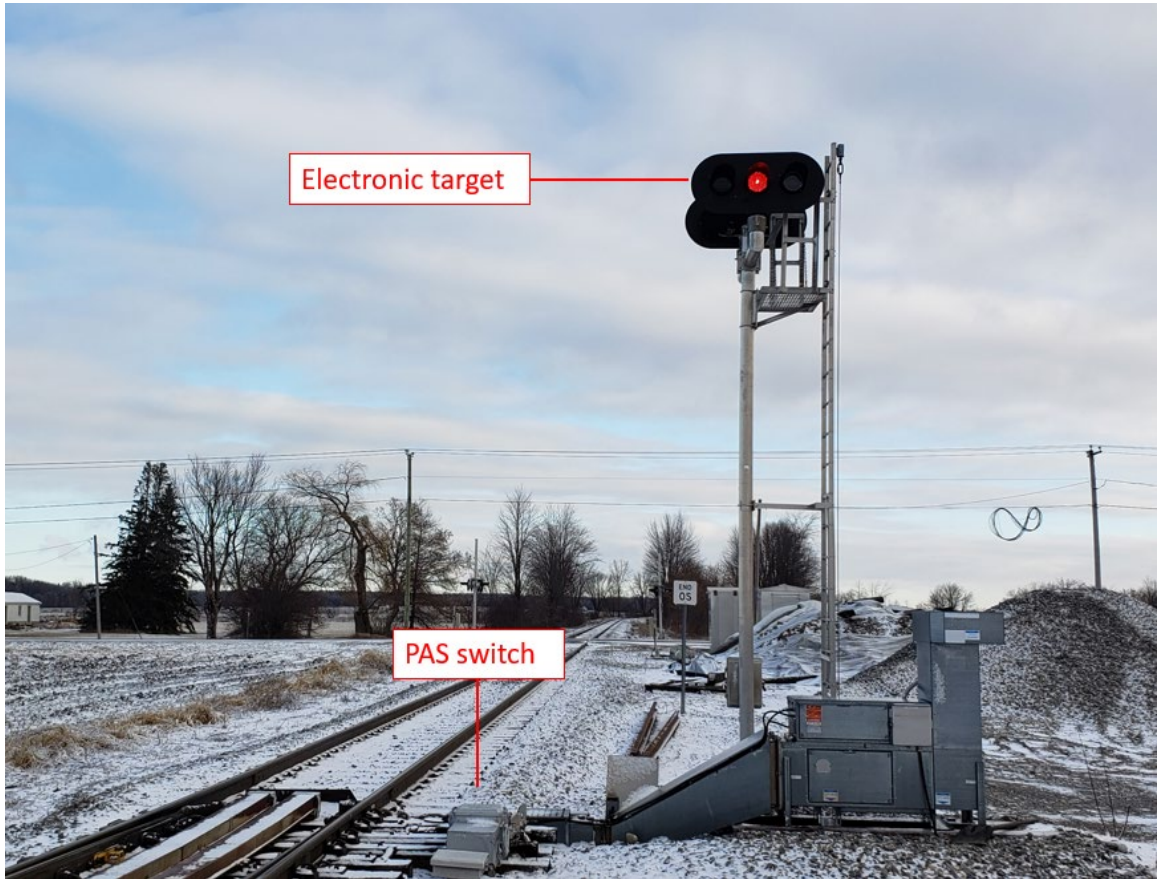
Figure 6. Switch and electronic target at the north end of the Carr siding (Source: TSB)

In 2015, CSXT commissioned 3 PAS systems on its Montreal Subdivision, notably at each end of the Carr siding. These are dual-control switches¹⁴ linked to an interface enabling them to be controlled by radio from the locomotive cab or using a portable railway radio. Visual indication of the switch position is provided by an electronic target with a coloured light (Figure 6).

In accordance with standard railway operating practices in Canada, main-track switch targets are considered a visual reference that, in addition to indicating the switch’s position, assist the train crew in determining the exact location of the switch.

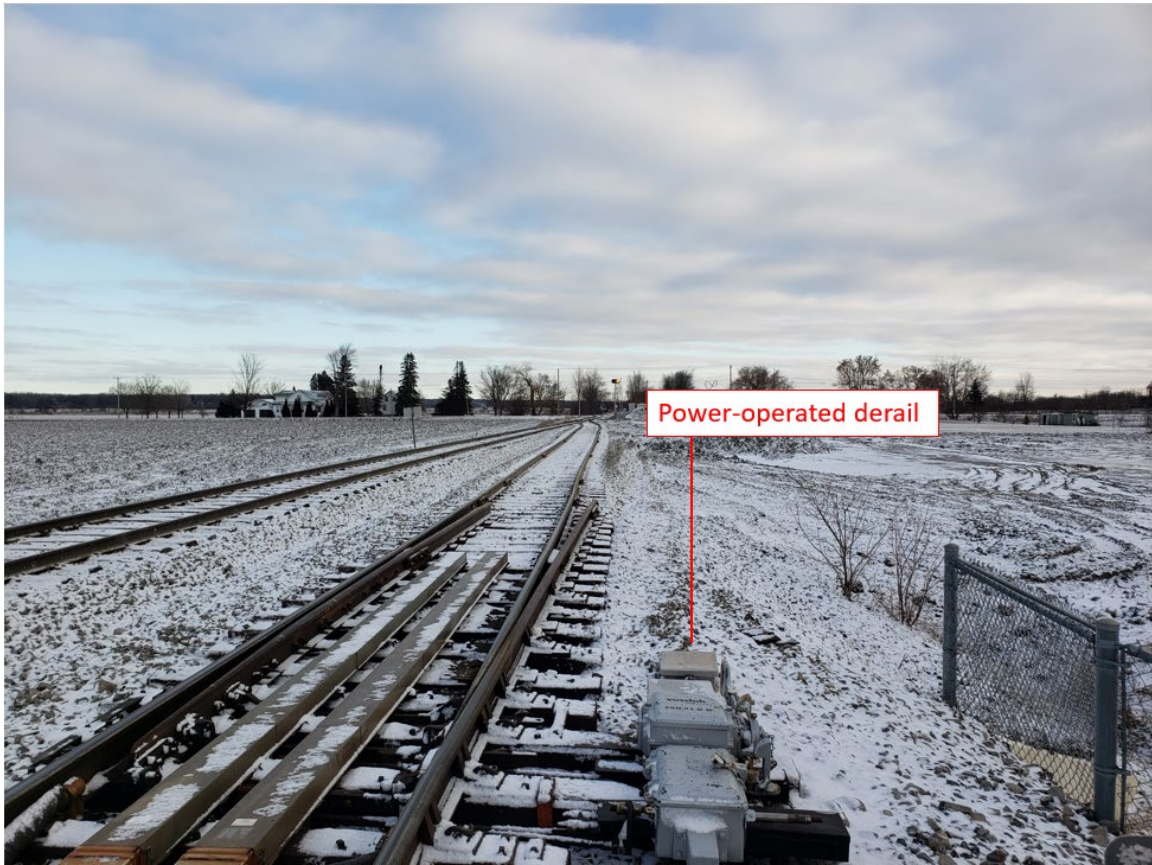
Figure 7. Carr siding derail at White Station (Source: TSB)

The Carr siding is equipped with power-operated derails at both ends. These are double-point derails located beyond the fouling point on the main track, some 450 feet from the switch, and fitted with switch heaters (Figure 7).

These derails, which are linked to the PAS system, protect the main track from any uncontrolled movement of rolling stock, in compliance with CROR Rule 112(a)(i). When the switch is lined in the normal position, or when it is “out of correspondence,” the derail is in the derailing position (Table 2).

- there is no sign indicating the presence of derails;
- the special instructions in effect at the time of the occurrence did not mention the presence of derails; and
- the derails are not equipped with a separate target to indicate whether they are in the derailing or non-derailing position.

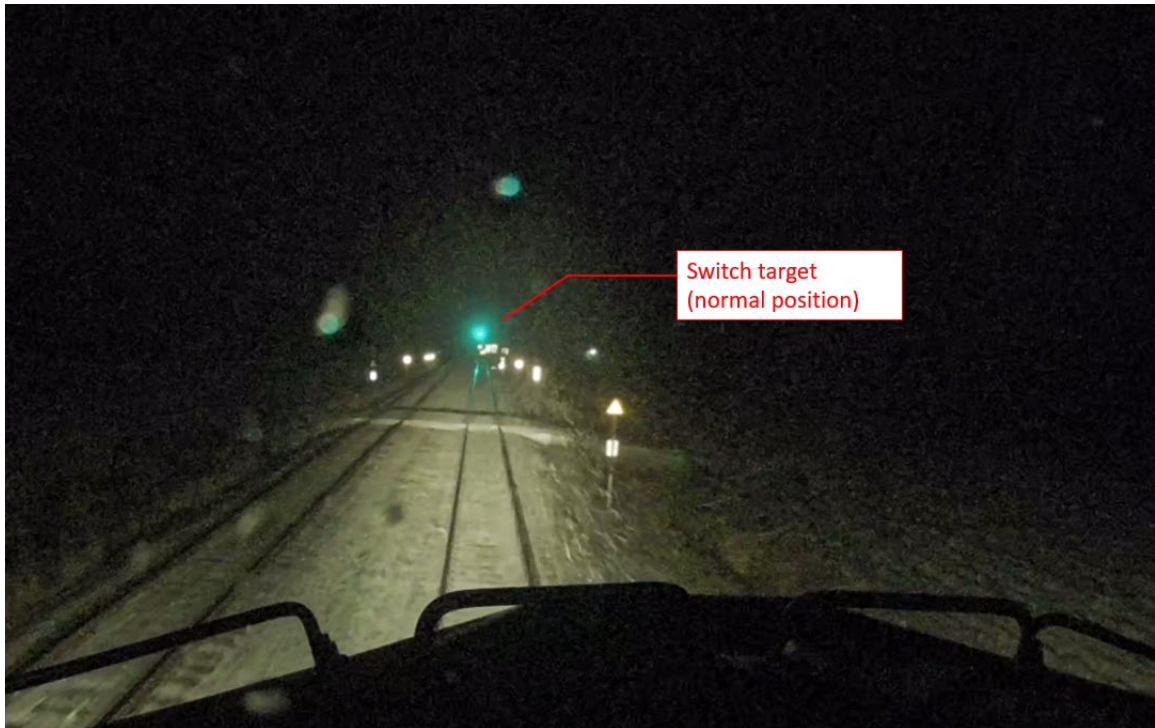
Figure 9. Image from the locomotive's forward-facing video camera recording (Source: CN, with TSB annotations)

In this occurrence, once the switch moved to the normal position, the electronic switch target light, which had turned green, was clearly visible (Figure 9) but it was impossible to distinguish the position of the derail switch points.
