RAILWAY OCCURRENCE REPORT
R98M0029

MAIN TRACK RUNAWAY, COLLISION AND DERAILMENT

MATAPÉDIA RAILWAY COMPANY
CANADIAN NATIONAL TRAIN NO. A402-21-24
MILE 105.4, MONT-JOLI SUBDIVISION
MONT-JOLI, QUEBEC
24 SEPTEMBER 1998

Report Number R98M0029

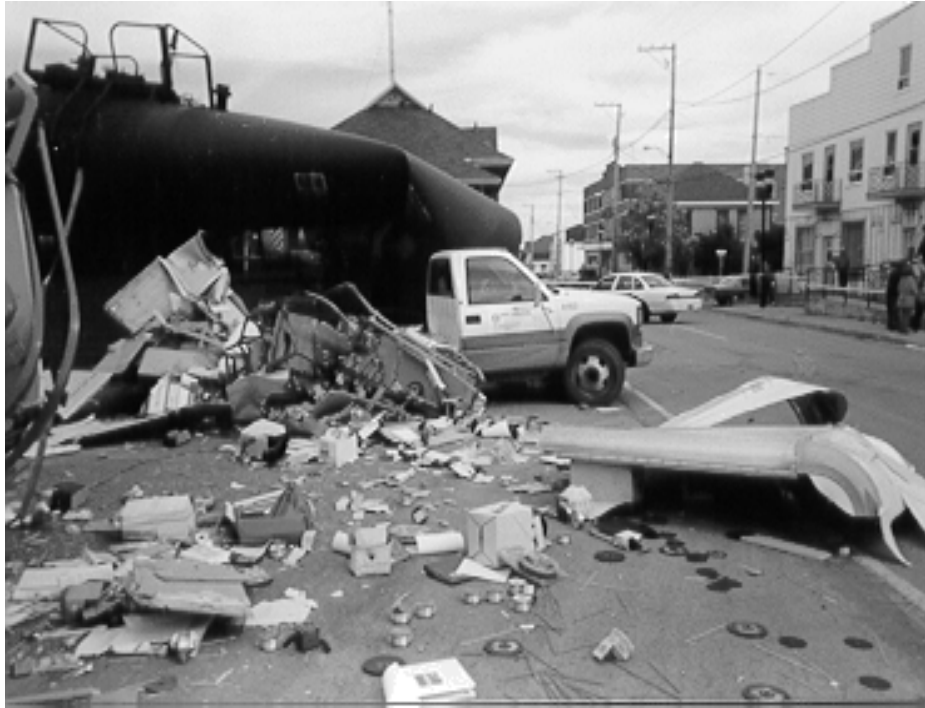
At approximately 1240, both CN and MRC employees heard a loud noise. They determined that the portion of the train that the CN crew had left at Mile 106 had rolled eastward down the hill and collided with the four MRC locomotives in front of the station.

A tank car, which was crushed and opened by the impact, spilled some residual content into the parking lot and onto the street. A commercial truck, owned by Air Liquide Canada Inc., carrying cylinders of compressed gas, was crushed (Figure 1). The employees in the vicinity of the station immediately left. The police and fire department cordoned off the area and determined that the product from the tank car was non-hazardous (molasses) and that the compressed gas cylinders were not damaged. The police and fire department also coordinated and controlled the clean-up operation. The derailed cars came to rest close to commercial and residential properties in the centre of the town. The location, size and noise of the accident attracted significant local interest and media coverage.

Figure 1 - View of accident scene looking east with station and local businesses in the background

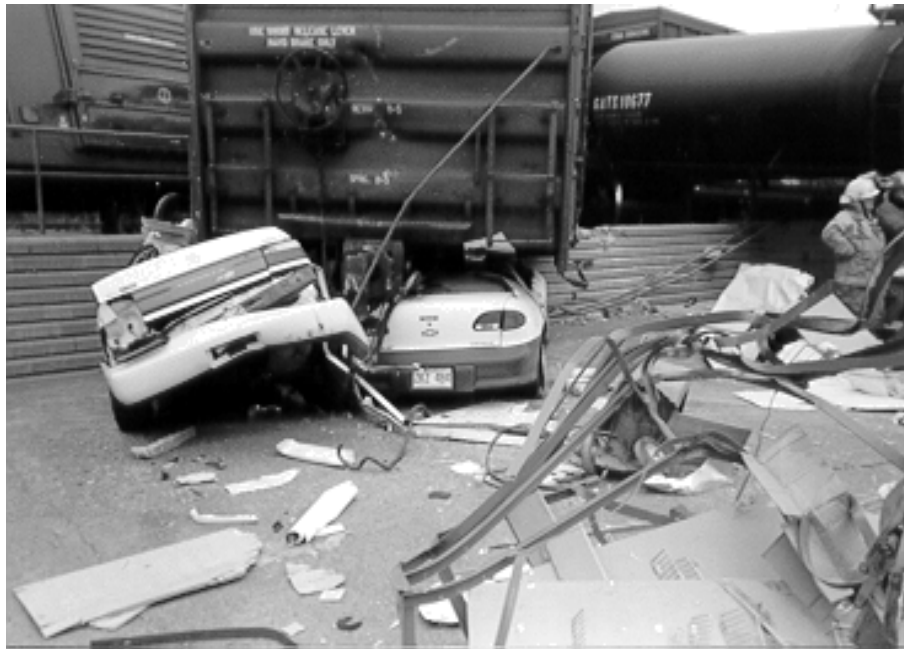
Four automobiles parked in the station parking lot were destroyed by the derailed rail cars (Figure 2). There was extensive damage to the station platform safety railing, and several hundred feet of main and yard tracks, including 78 feet of rail and 34 railway ties that required replacing.

Figure 2 - Two of the four automobiles damaged in the accident

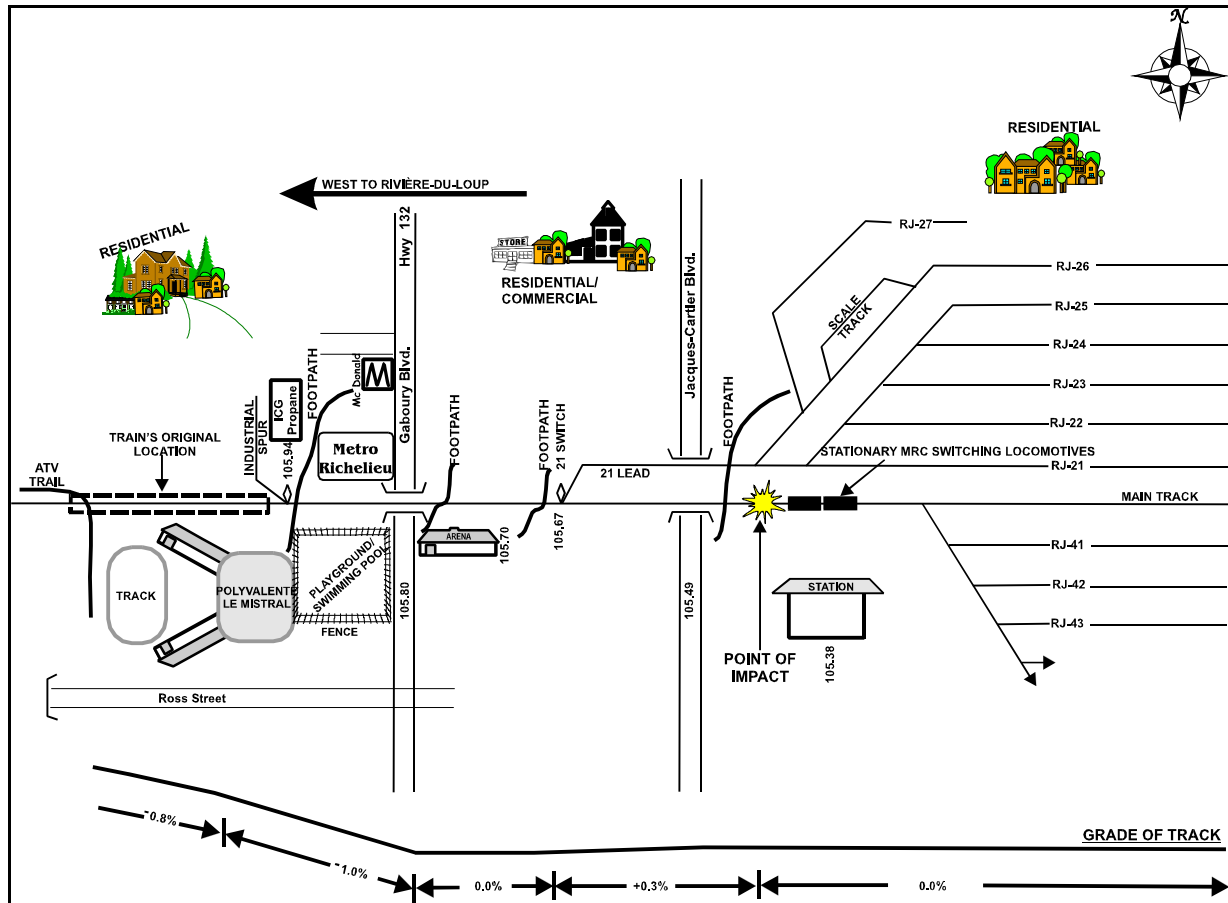
Figure 4 - Schematic showing details of occurrence site area

The MRC Mont-Joli Subdivision consists of single main track with an authorized timetable speed of 65 mph for passenger trains and 50 mph for freight trains. The track structure in the area of the occurrence consists of 115-pound jointed rail on 14-inch double-shouldered tie plates, secured by four spikes per tie, anchored every third tie. At the location where the train was left, there was a 1.0 per cent descending grade, from west to east. The lead cars were sitting on a one per cent grade and the remaining cars were on a 0.8 per cent grade (see bottom of Figure 4 for details).

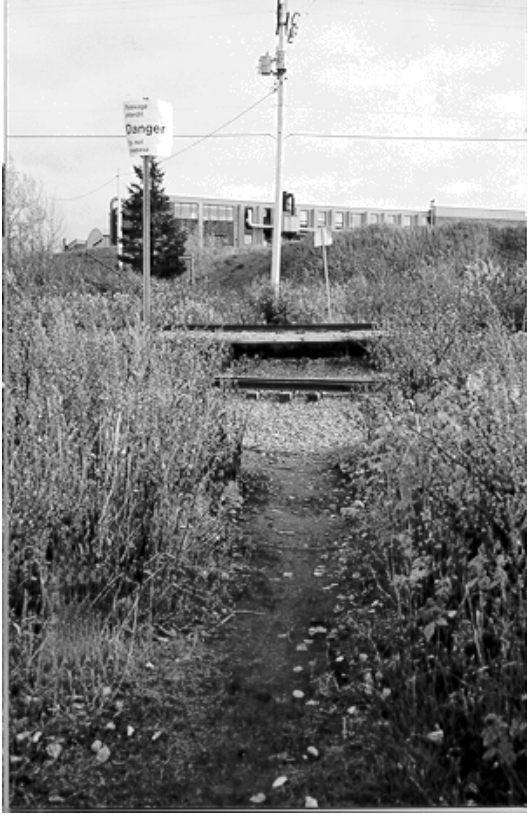
Well-worn footpaths traversing the tracks were observed leading into the grounds of the recreational facilities on the east and west sides of Gaboury Boulevard, and into the grounds of the high school. The most frequented footpath was located at the north-east corner of the school

yard which crosses the track at the industrial spur switch at Mile 105.94 (Figures 5 and 6). There were also several footpaths in the area of the west lead switch for yard track RJ-21, and near the Jacques-Cartier Boulevard overpass³.

Figure 5 - View of pathway leading to the school, crossing both the industrial lead track and the main track

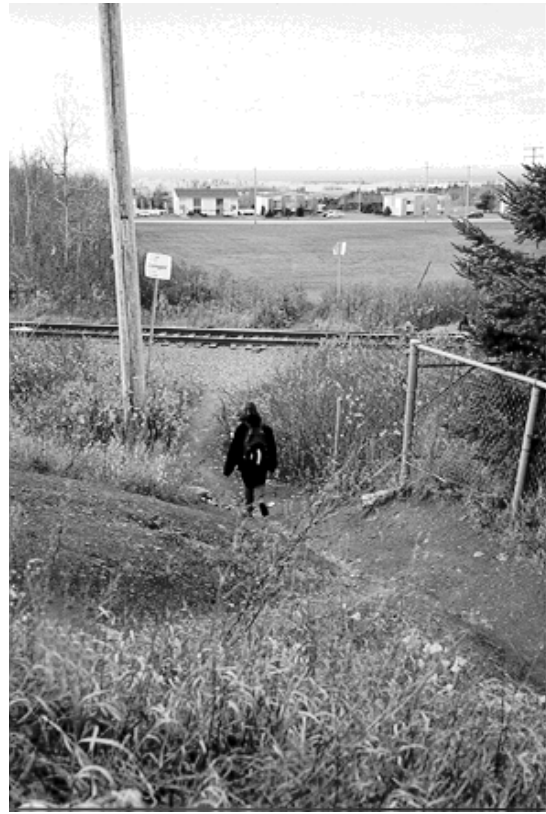
Figure 6 - View of pathway leading away from school property looking north toward the main track

Trespassing activity was highest to and from the high school property before school, at lunch time, and after school, with the vast majority of the trespassers being students. Train 402 usually arrived in the Mont-Joli area around the lunch hour, stopping on the tracks near the high school. There were reports of students being observed crossing between cars and walking alongside the train when the train was blocking the footpath.
