RAILWAY INVESTIGATION REPORT

R99H0007

DERAILMENT/COLLISION

VIA RAIL CANADA INC.

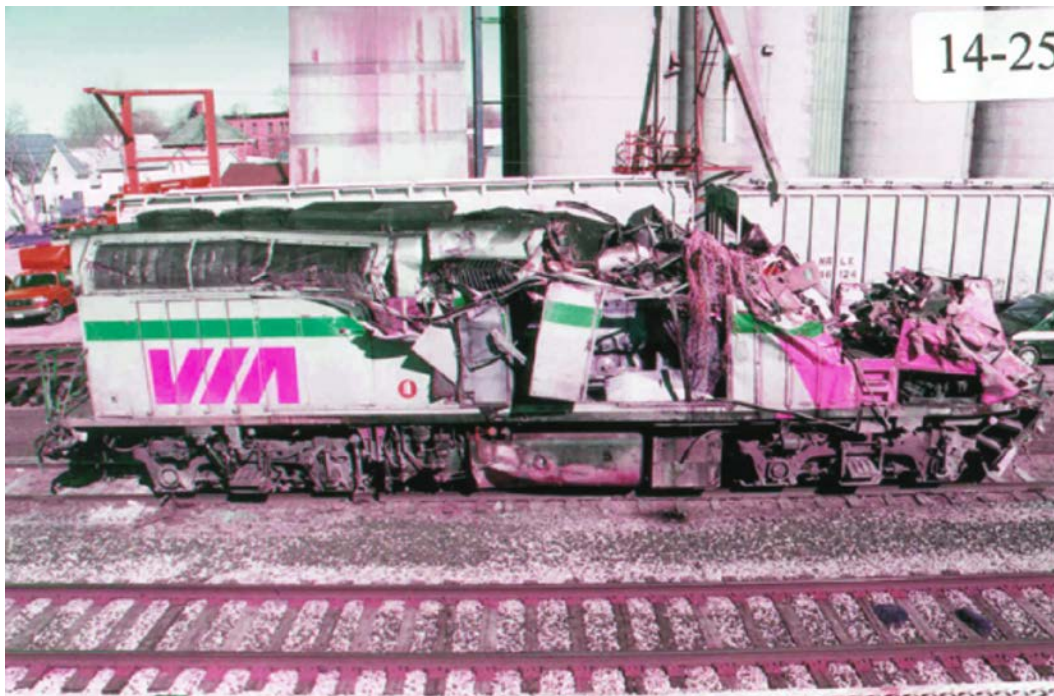
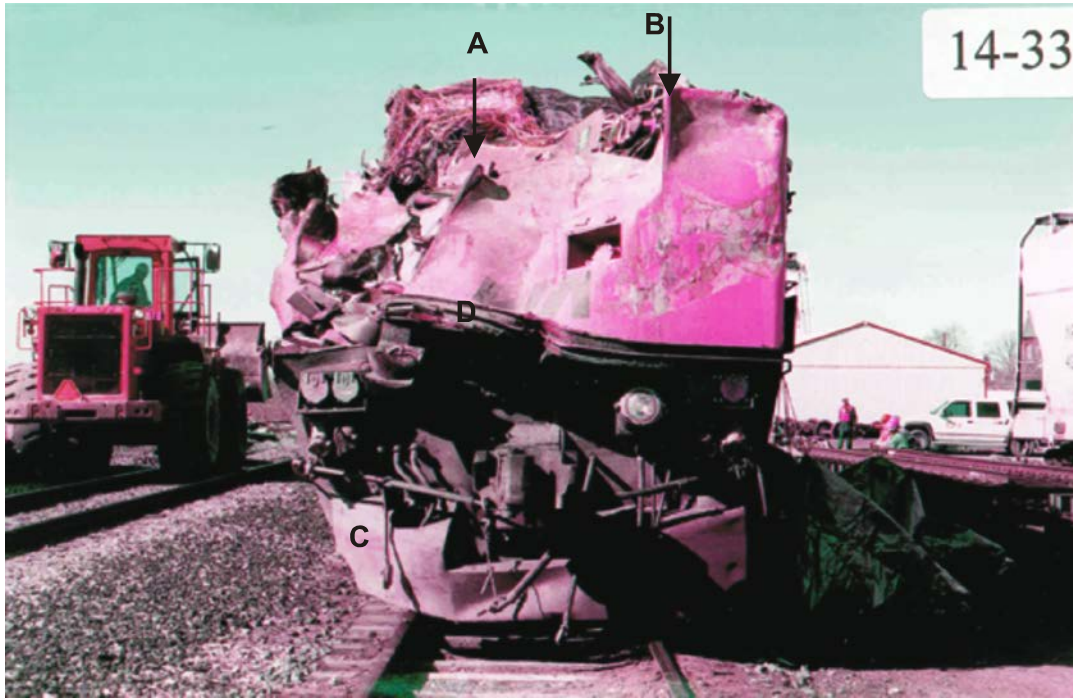
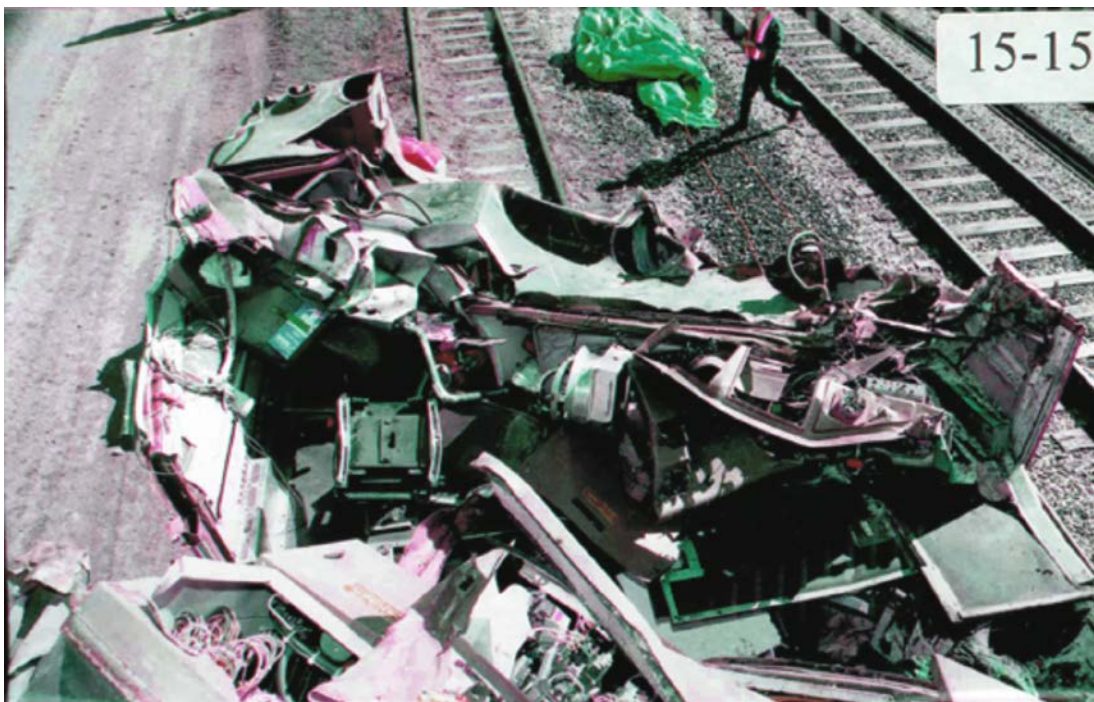
*1.12.3 Structural Damage to Locomotive 6423*

After the accident, the locomotive was taken to Ottawa where a crashworthiness analysis was conducted.<sup>21</sup> The following is a description of damage to locomotive 6423, specifically relating to its crashworthiness features.

- Collision Posts - The right collision post was forced aft and to the left whereas the left collision post was not significantly displaced. Even though the left collision post was not visibly deformed, the short hood near the top of the post was dented and sheared away. The right collision post was not bent along its length; however, the top of it was pushed aft. The structure which supports it at the bottom of the underframe was fractured. Close examination of the left collision post found similar damage to its underframe support structure, but which had not progressed to the same extent.

- Pilot and Vicinity - The right end of the pilot was pushed aft, while its left side was comparatively undamaged. The left ditch light was not broken. A large number of fine scratches on the surface of the right end of the pilot were consistent with having been caused by contact with the roadbed. The pilot or its surrounding area beneath the underframe did not contain deep gouges or severe structural damage as seen on the upper surfaces of the short hood that were consistent with contact with the hopper cars.

- Anti-Climber - The right end of the anti-climber was bent upwards. One gouge was observed on the underside of the anti-climber consistent with impact with the hopper cars. It is considered that much of this upwards bending likely resulted from damage to the underframe when the right collision post was forced aft.

- Short Hood - The short hood on the right was pushed back along with the right collision post. The short hood on the left was dented and sheared near the top of the left collision post. The left side of the short hood at the base of the collision post did not show any significant impact damage. The right side of the short hood contained numerous deep gouges in the metal where it contacted the loaded covered hopper cars.

- Control Cabin - The roof of the cabin was found separately, and was considered to have been torn away by the collision. The electrical cabinet, located behind the operators, was pushed towards the rear, more on the right than on the left. On the right side, the control console and short hood were pushed back beyond the operator's seat and downwards almost level with the cabin floor. On the left side, the operator's seat pedestal was still securely fastened to the floor, was visibly deformed towards the rear, and was not covered by the short hood or console. No buckling was observed in the cabin floor.

- Fuel Tank - The right side of the fuel tank was dented and punctured but the left side did not show any visible damage. The large number of fine scrapes suggested that the fuel tank was most likely damaged by contact with the roadbed and not with the hopper cars. There was one small puncture observed, less than 1/4 inch (6 mm) in diameter.

The short hood and roof of the locomotive had inadequate energy-absorbing capability to protect the occupants of the cab from an impact of this severity. The rocking motion that occurred as the locomotive negotiated the crossover ultimately led to its colliding in a rightward leaning orientation with the stationary loaded covered hopper cars. Because of this orientation, the locomotive sustained a frontal impact in an area least resistant to damage—the short hood and roof.
