MARINE TRANSPORTATION SAFETY INVESTIGATION REPORT M21P0297

LOSS OF CONTAINERS OVERBOARD AND SUBSEQUENT FIRE

Container vessel *ZIM Kingston*
La Perouse Bank, British Columbia
21 October 2021

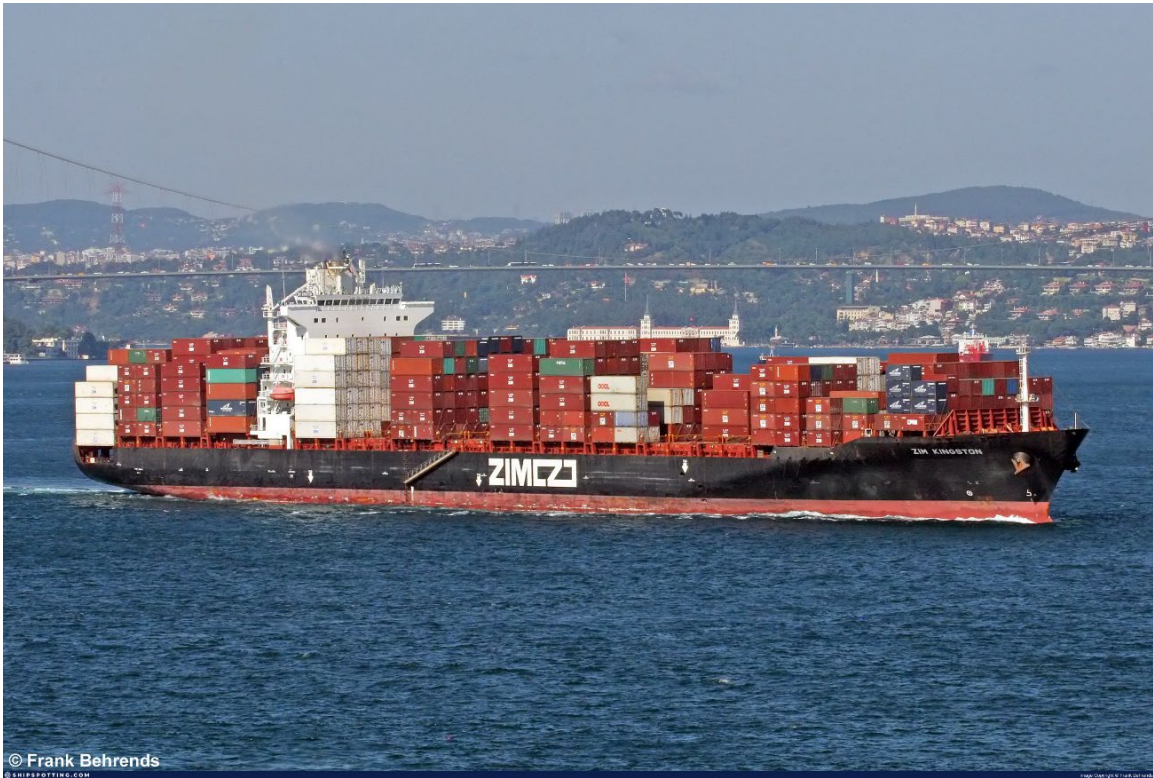
The *ZIM Kingston* (Figure 1) is a fully cellular container vessel with the accommodation located aft. The accommodation includes the navigational bridge deck and decks A to D. The wheelhouse, located on the navigational bridge deck, is equipped with all navigational equipment required under the *International Convention for the Safety of Life at Sea* (SOLAS).² The vessel was fitted with an analog inclinometer³ and a voyage data recorder.

Figure 1. The *ZIM Kingston* (Source: Frank Behrends)

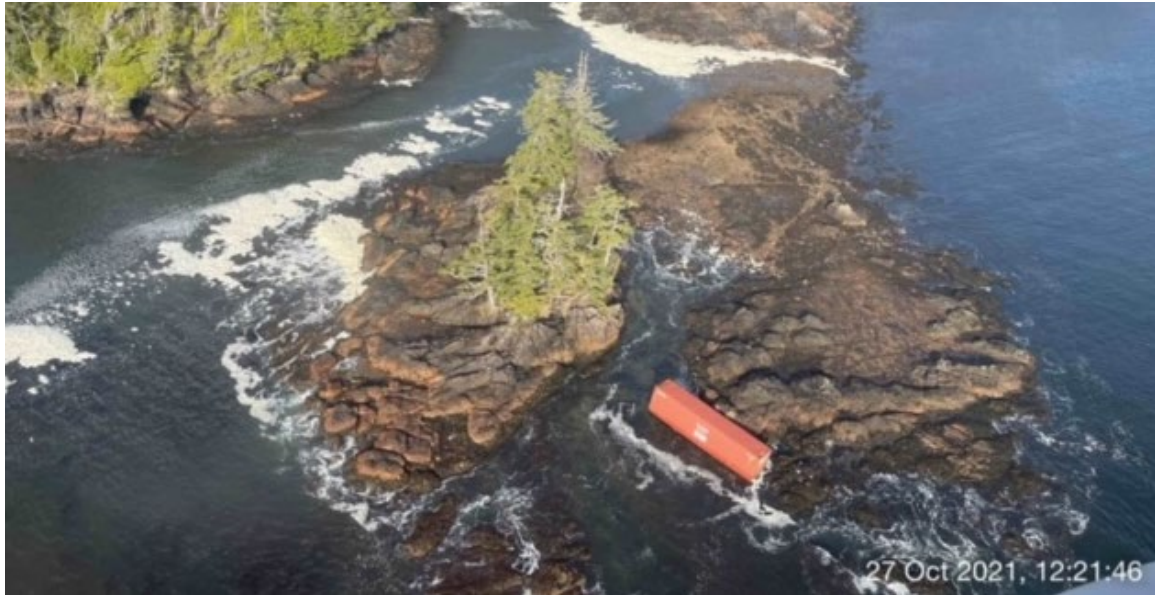
Figure 5. Aerial photo of a container from the *ZIM Kingston* washed up on land (Source: Transport Canada)

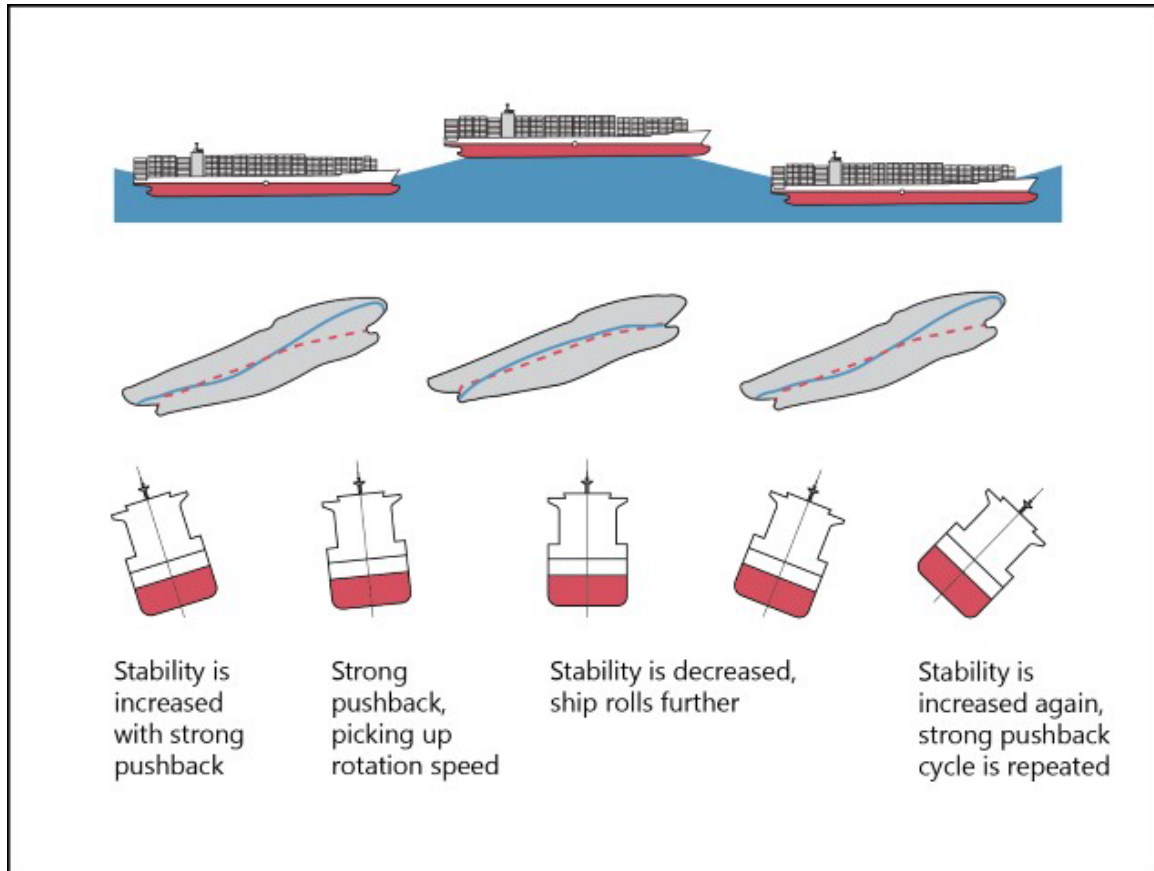
When the vessel is on a wave crest, stability is reduced and the vessel will roll over to one side, but when the wave trough reaches midship, the increased stability quickly pushes the vessel to an upright position. Once another wave crest reaches the midship position, stability is again reduced, which results in the vessel rolling in the opposite direction, but when the wave trough reaches midship, it will quickly push the vessel back upright again. This sequence is illustrated in Figure 14.

Figure 14. Diagram depicting the development of parametric rolling. Note that the diagram depicts one wave encounter and half of a vessel's roll. The top row shows the vessel moving from a wave trough to a wave crest and to a trough again. In the 2nd row, the red dotted line shows the vessel's underwater hull form in calm water and the blue line shows the changes in the vessel's underwater hull form when the vessel is in a wave trough versus on a wave crest. The last row shows the sequence of events in the development of parametric rolling. (Source: TSB, based on a diagram developed by Bureau Veritas; Parametric Roll Assessment, Rule Note NR 667 DT R00 E, July 2019)

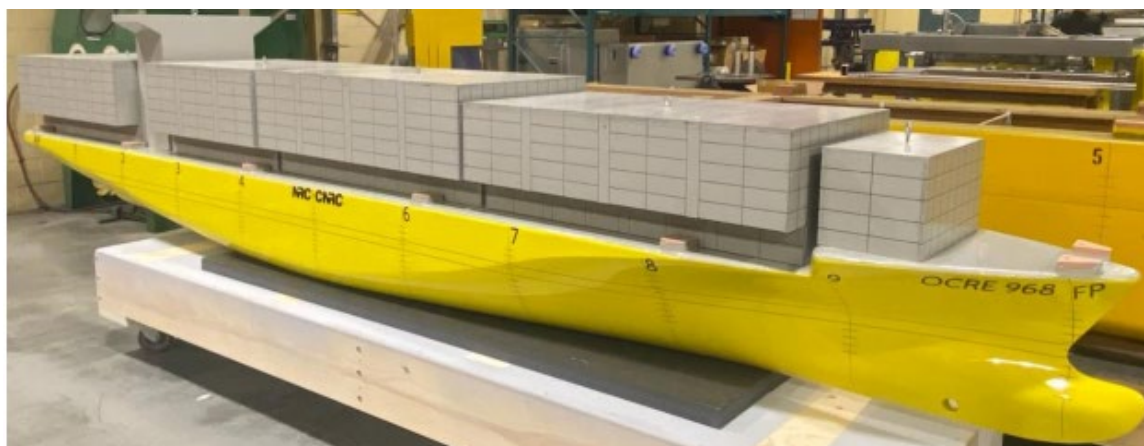
Figure 15. Scale model of the *ZIM Kingston* (Source: National Research Council Canada)

The model was built with steering capability and was self-propelled so that testing could be done in drifting, transiting, and manoeuvring operational modes. The model was also fitted with accelerometers. The testing took place in the Ocean Engineering Basin, which is 75 m long, 32 m wide, and 3.2 m deep, and had segmented wave generators along 2 of its sides to create waves (Figure 16). Wind was modelled using a fan bank stationed on one side of the basin.

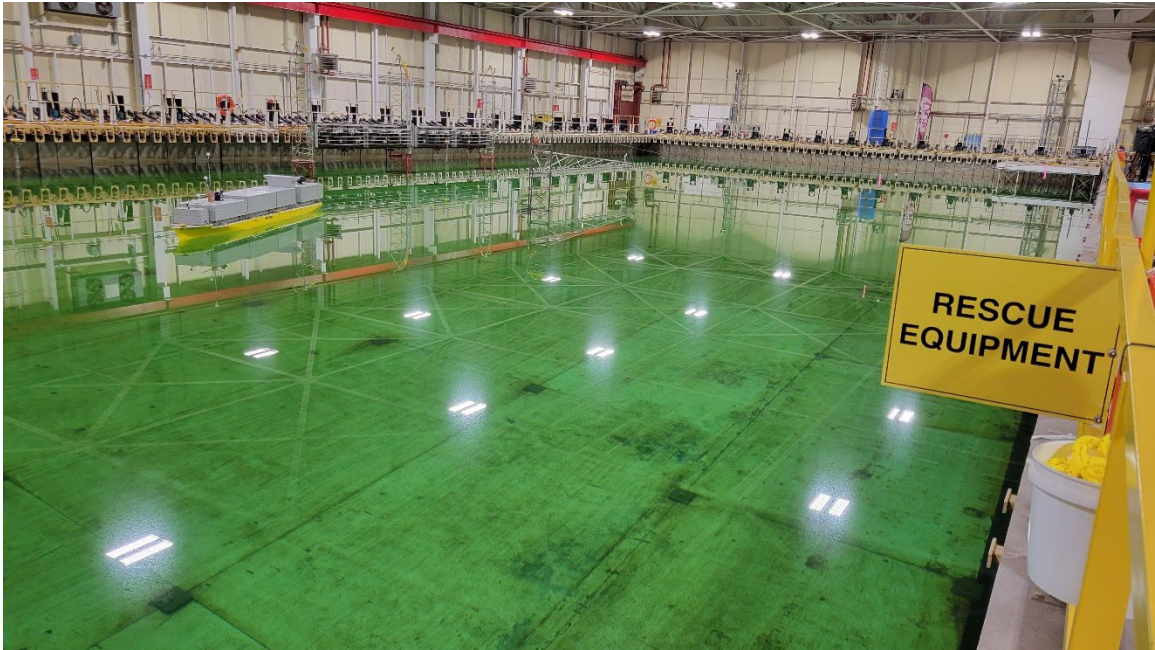
Figure 16. Ocean Engineering Basin (Source: NRC)

The basin and model used an optical motion tracking system to record the model's motions. The data recorded in the model testing were then scaled up to understand the motions experienced by the *ZIM Kingston* and the wave phenomena that can create these motions.

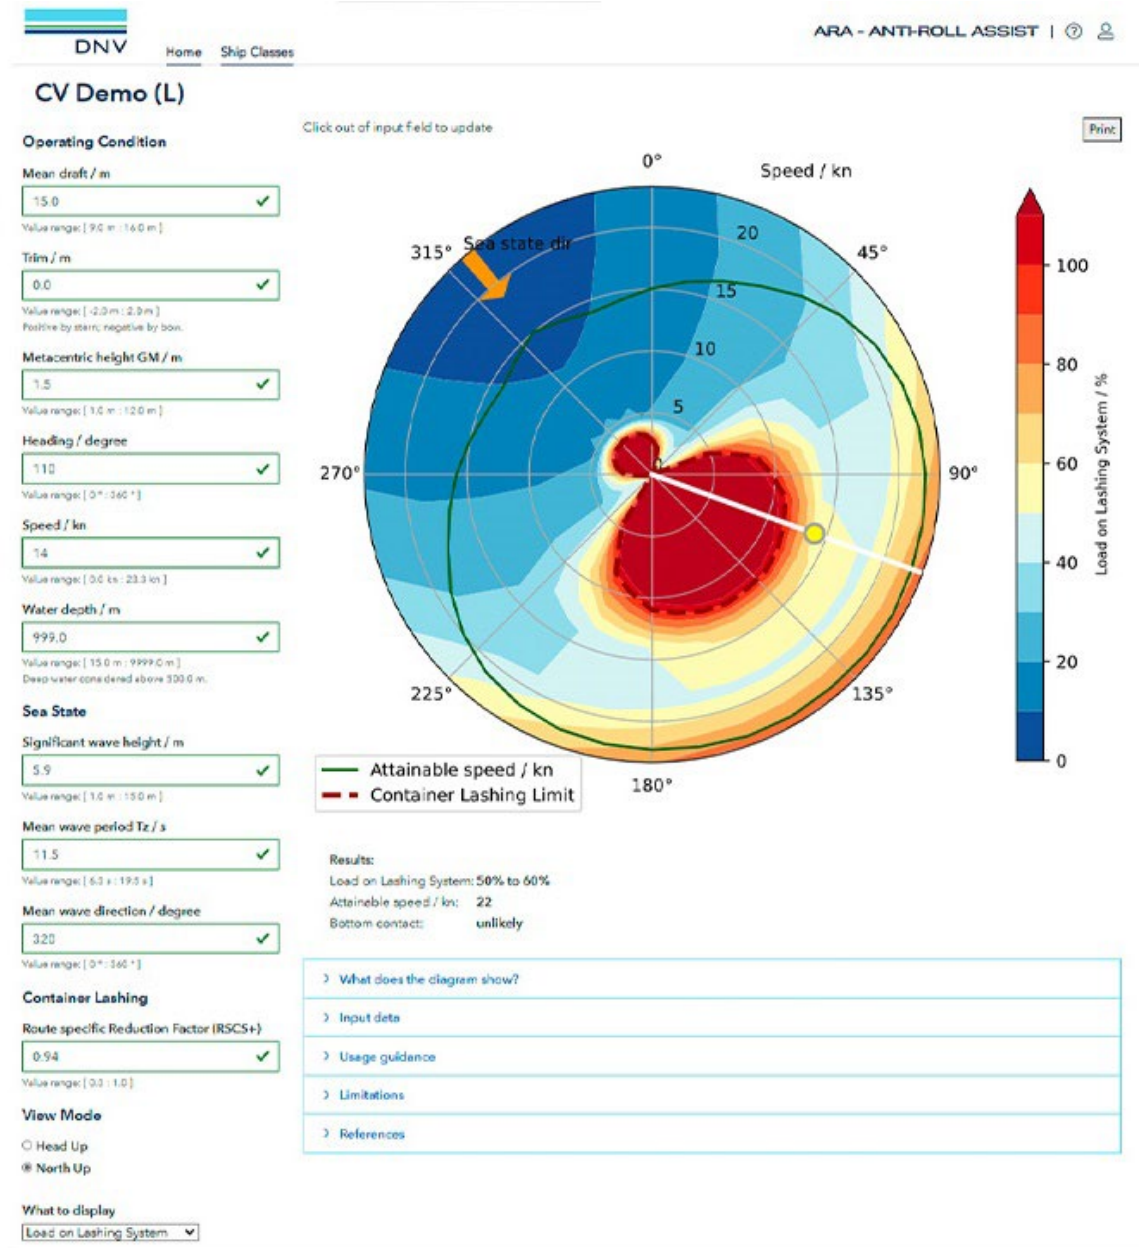
Figure 21. Example of a polar diagram provided by the Anti-Roll Assist app. The red area indicates where the vessel's container lashing limits would be exceeded (Source: Det Norske Veritas, "New DNV anti-roll app helps avoid container loss," (31 May 2022), at <https://www.dnv.com/expert-story/maritime-impact/New-DNV-anti-roll-app-helps-avoid-container-loss.html> [last accessed 16 July 2024])
