**RISK OF COLLISION**

**BETWEEN  
AIR TRANSAT  
LOCKHEED L-1011 C-FTNC  
AND  
INTER-CANADIEN  
AÉROSPATIALE ATR 42 C-GXCP  
QUEBEC VOR 19 nm SW  
06 JUNE 1995**

**REPORT NUMBER A95Q0098**

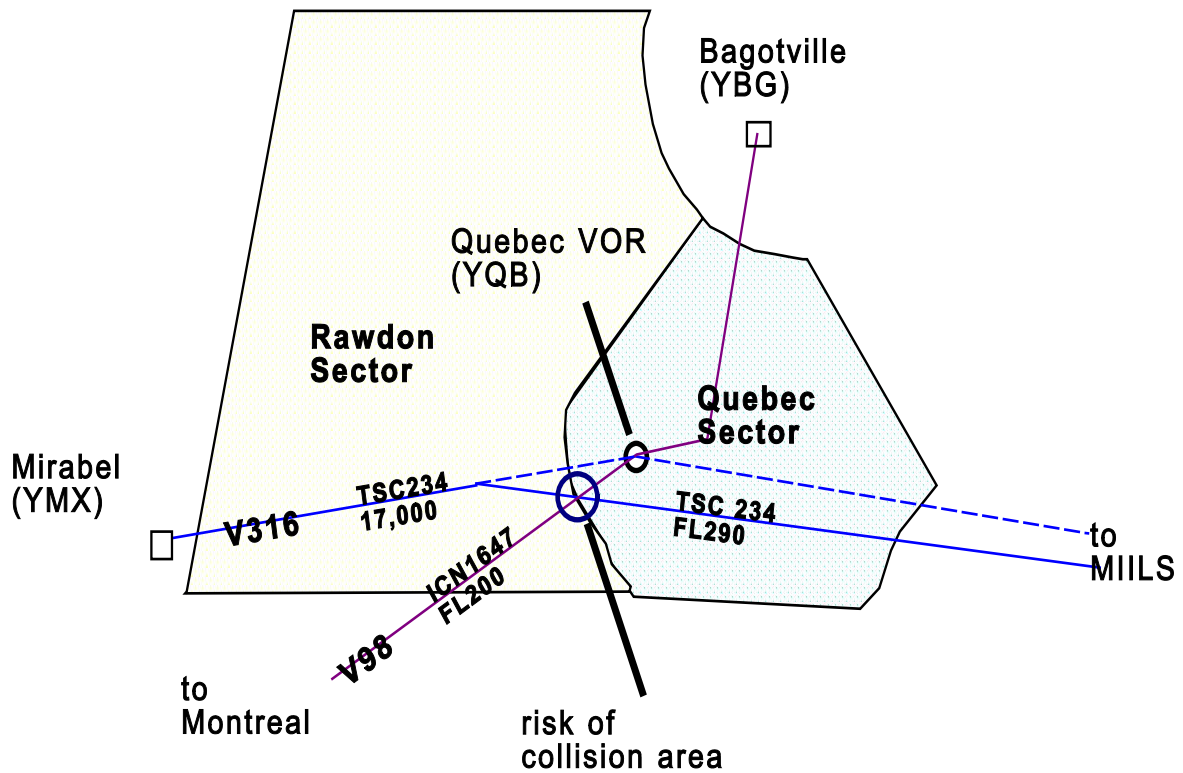
RISK OF COLLISION  
BETWEEN L-1011 (TSC 234)  
AND ATR 42 (ICN 1647)

L-1011 (TSC234) and ATR 42 (ICN1647)
