MARINE INVESTIGATION REPORT
M14P0110

MAN OVERBOARD AND SUBSEQUENT LOSS OF LIFE

SMALL FISHING VESSEL *DIANE LOUISE*
QUEEN CHARLOTTE SOUND, BRITISH COLUMBIA
06 JUNE 2014

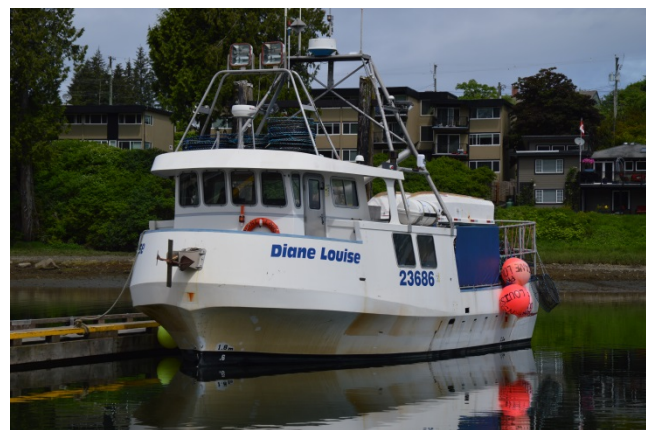
The *Diane Louise* is a small fishing vessel of closed construction, made of fiberglass and used for prawn fishing (Photo 1). The deckhouse is located forward and includes a galley, dinette, raised wheelhouse and accommodation spaces for 3 persons. The hull is subdivided by 3 transverse bulkheads into 4 compartments: a forward, the engine room, an insulated fish hold and a lazarette, which includes the freshwater and fuel tanks. The engine compartment can be accessed through a hatch in the galley floor.

Photo 1. *Diane Louise* moored at Port Hardy, British Columbia

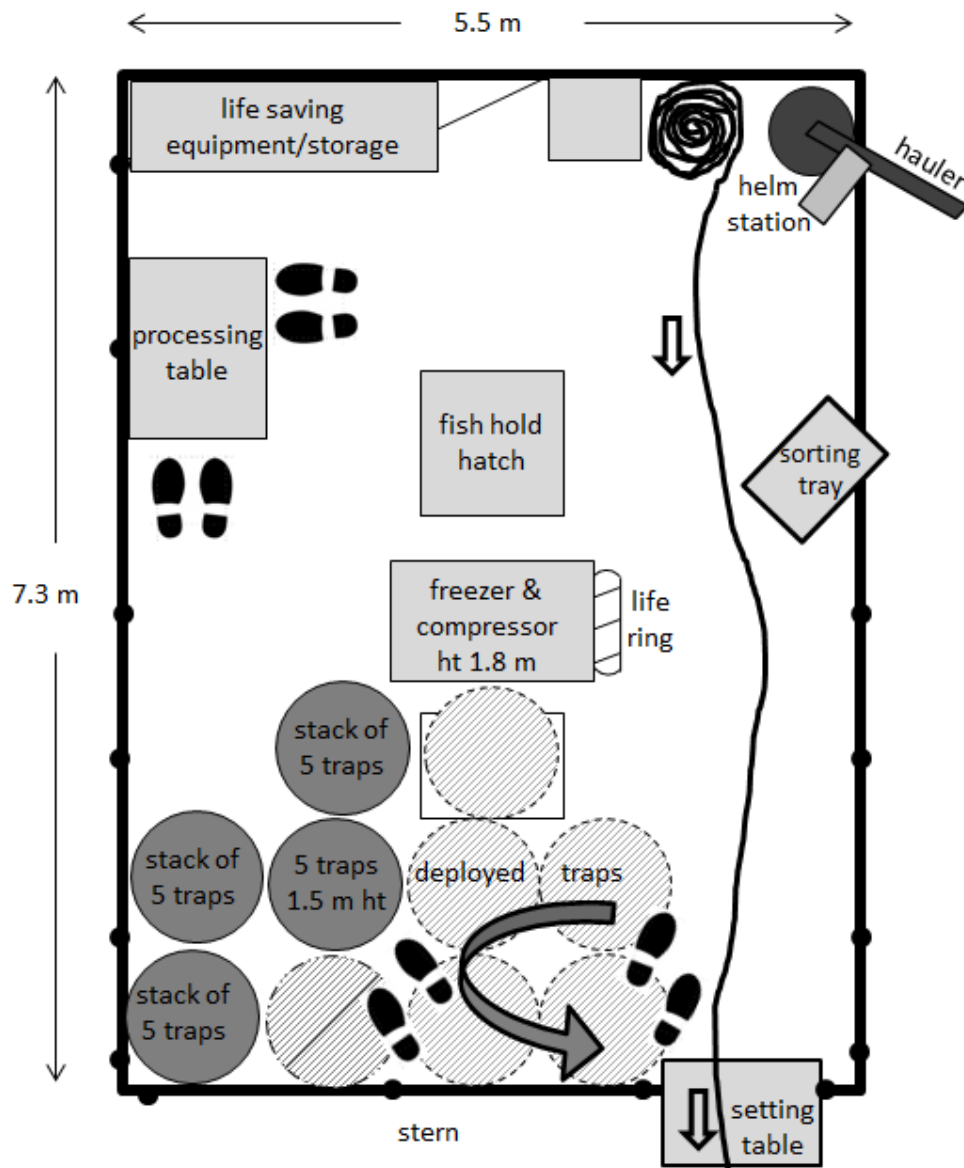
Figure 1. *Diane Louise* deck layout

The working deck is surrounded by solid bulwarks of 0.9 m in height; an aluminum railing of 1.1 m in height is attached to the top of the bulwarks, except for the hauling and setting stations, where the middle bar is removed. The working deck contains a helm station, the trap hauler, a lifesaving equipment storage cupboard, a prawn processing table, a blast freezer and a compressor, access hatches, and a setting table (Figure 1). The forward half of the working deck is covered with a tarp that protects the prawn sorting area from the weather but obstructs the visibility of the setting table from the wheelhouse.

member releases the traps off the groundline and sorts the catch. As the traps are retrieved, one crew member coils the groundline on the working deck¹³ while the new crew member re-baits the empty traps in preparation for setting. After all the traps are retrieved, the master returns to the wheelhouse and prepares to set the traps in the next location while the crew begins to process the catch¹⁴ and arrange the traps on deck. During favourable weather conditions, the new crew member was assigned to set traps. The *Diane Louise* is similar to most prawn vessels in that it is not equipped with a drum, there was therefore no emergency means to stop the free-running groundline other than to attempt to stop the forward momentum of the vessel¹⁵. The groundline can occasionally develop kinks and snarls depending on the age and material of the line, how and where the line is coiled, the motion of the vessel, and how the line gets from the coil to the setting table. On the *Diane Louise*, the line ran vertically to a ring of 10 cm in diameter above the coil and then horizontally to the setting table usually guided by the crew members hand.

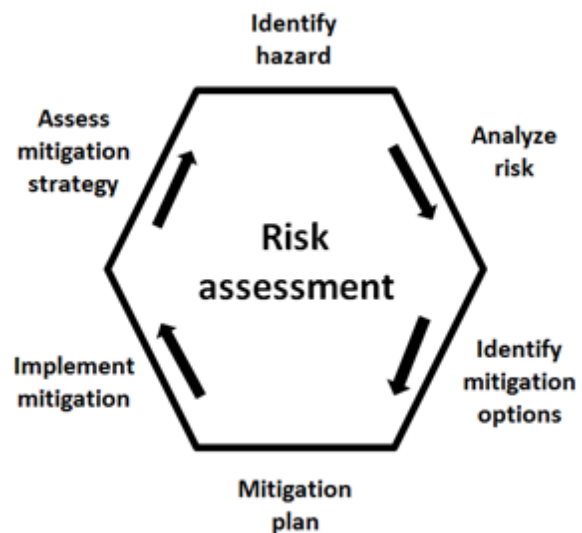
Fishermen are often aware of the risks present in their fishing operations. However, few conduct full and formal risk assessments, which are crucial to the safety of fishing operations. This form of assessment involves the identification of safety-critical tasks, equipment, and situations that may pose a risk to the operation and also the implementation of process or means for addressing those risks on an ongoing basis. During an assessment, master and crew can go through steps to more effectively identify and mitigate the risks and hazards in their operations (Figure 2).

Figure 2. Cycle of risk assessment
