## Marine Occurrence Report

### Sinking

of the Fishing Vessel "SCOTIA SUE"  
at her berth in Halifax, Nova Scotia  
18 May 1993

Report Number M93M0003

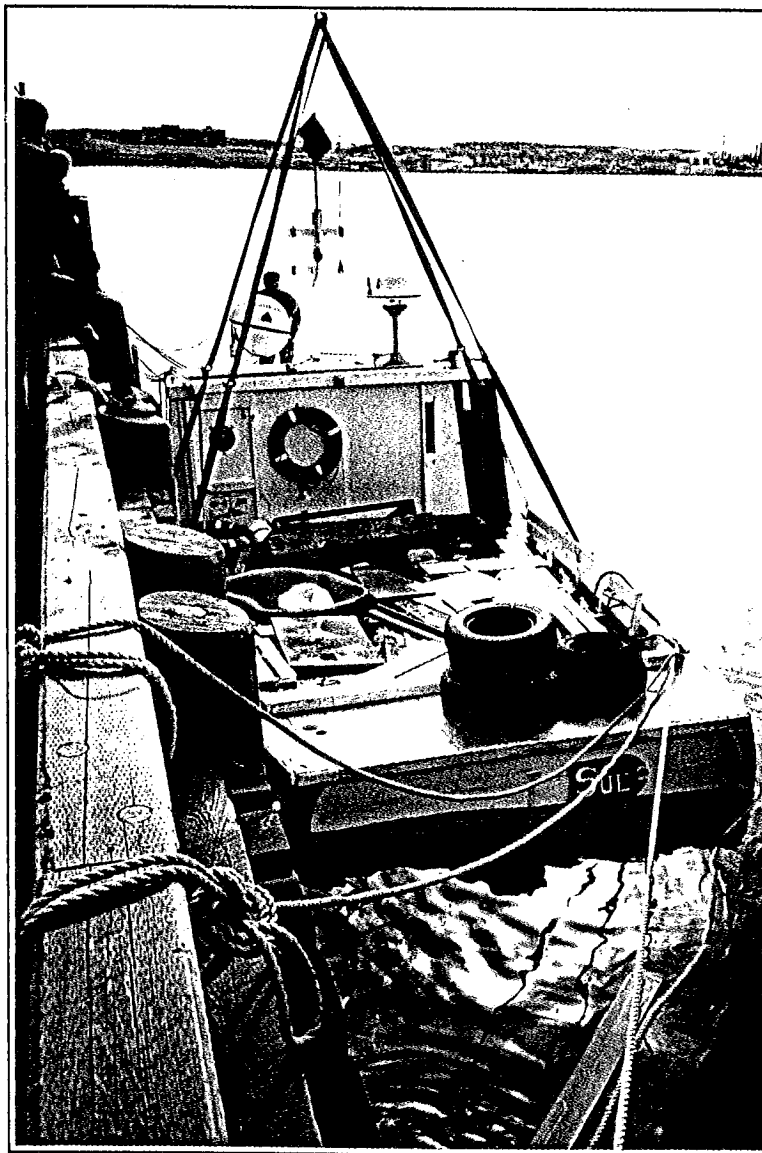
"SCOTIA SUE" in Halifax Harbour,  
18 May 1993.

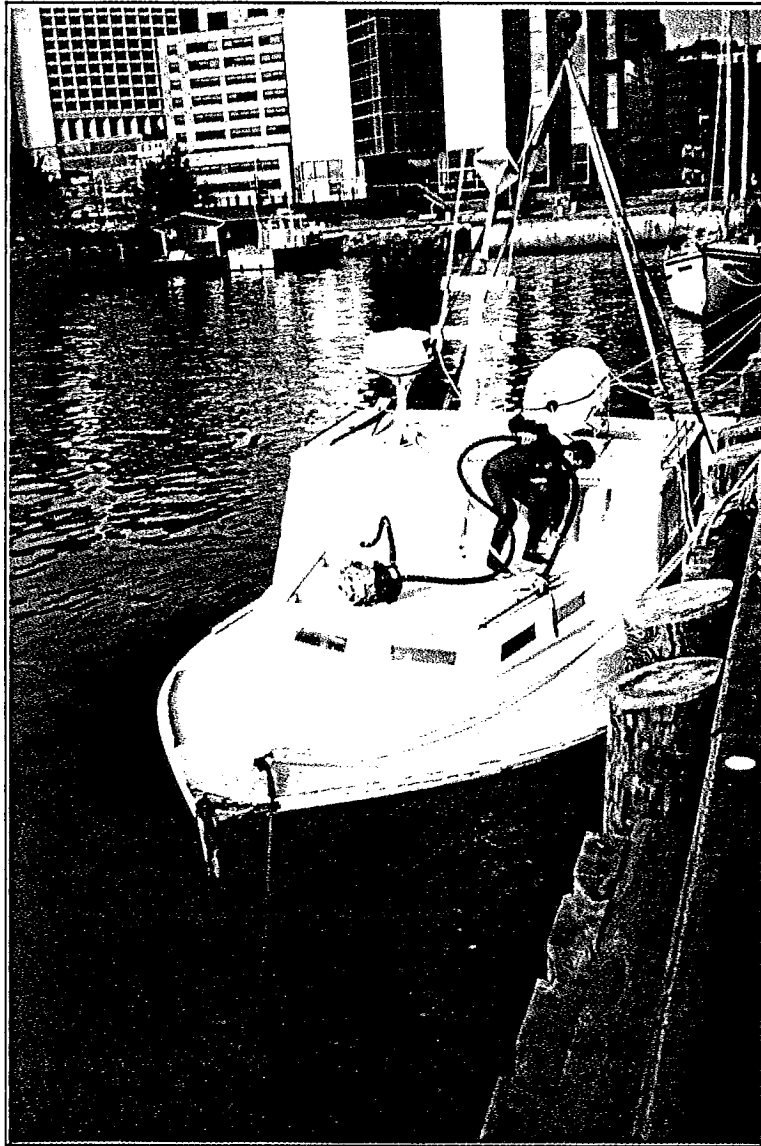
Salvage operation in Halifax Harbour,  
18 May 1993.

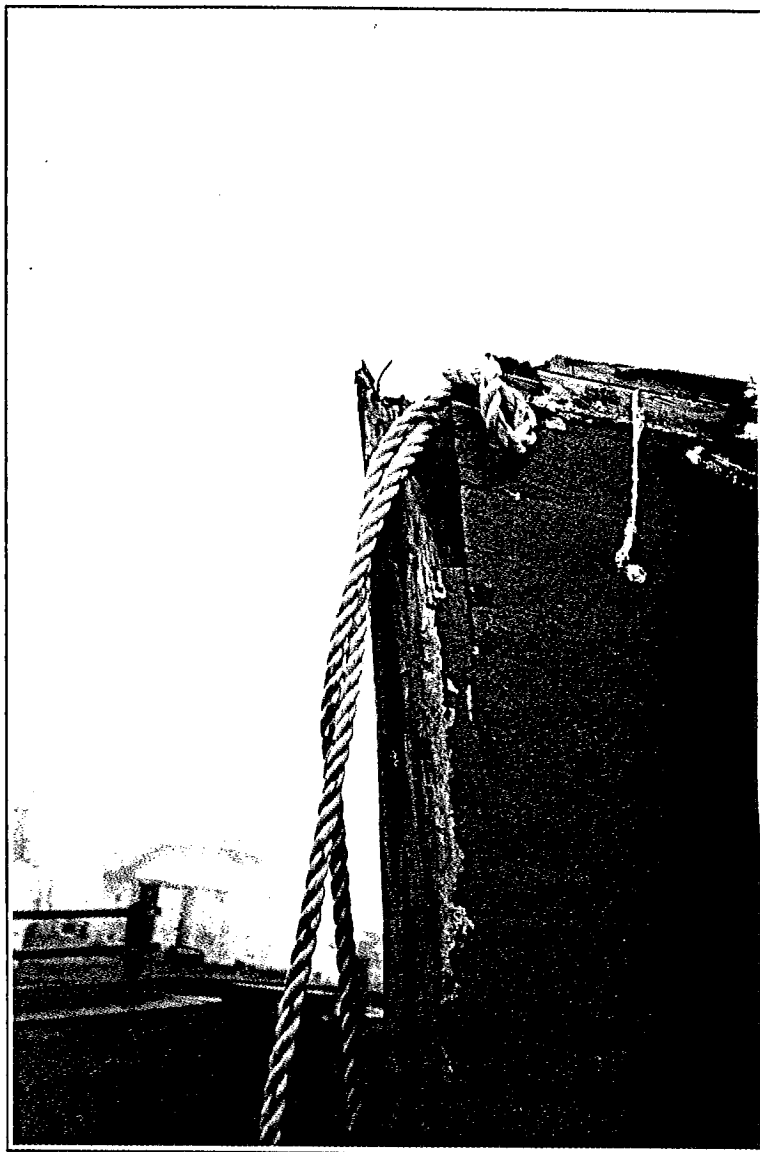
It was found that the stem was heavily rotted and damaged as were parts of the deck and the sheer strake.

Rotted/damaged stem.

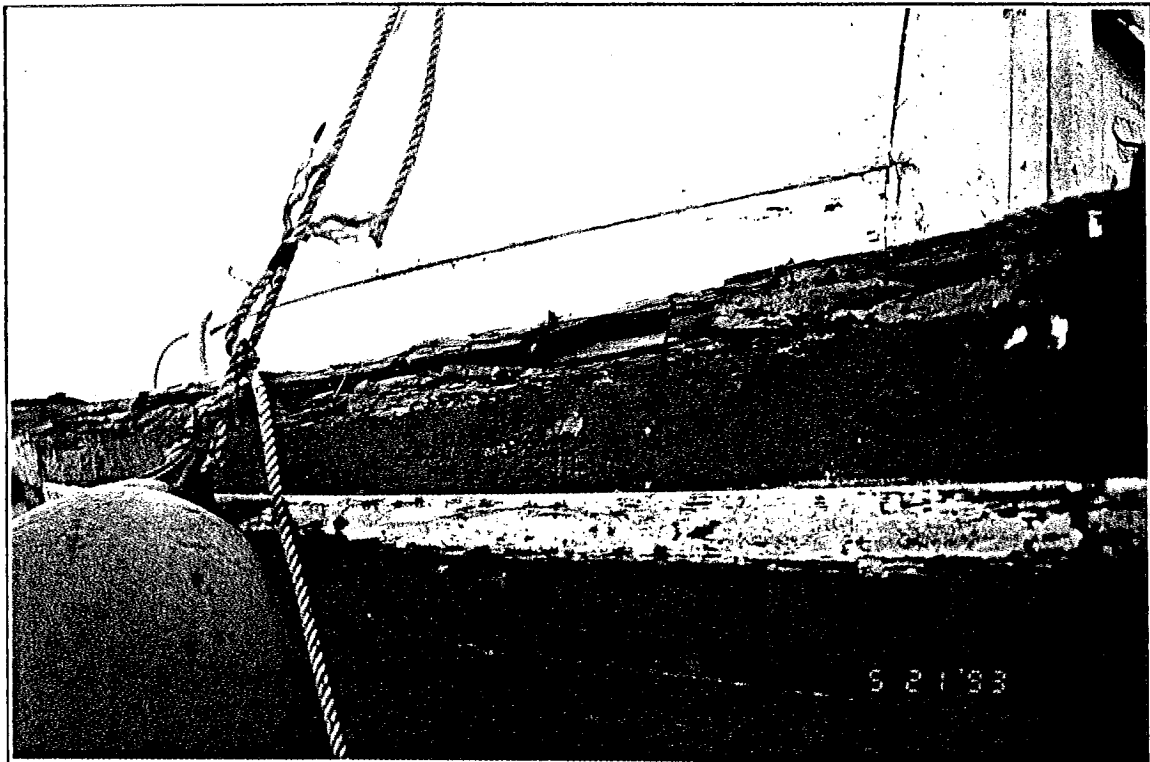
The extent of the rot in the vessel was such that it must have been an existing condition when the vessel was last inspected by the CCG Ship Safety Branch. However, at the time the vessel was salvaged, the paint finish on the vessel superficially covered this damage and made it less apparent.

Rotted deck and shear strake.

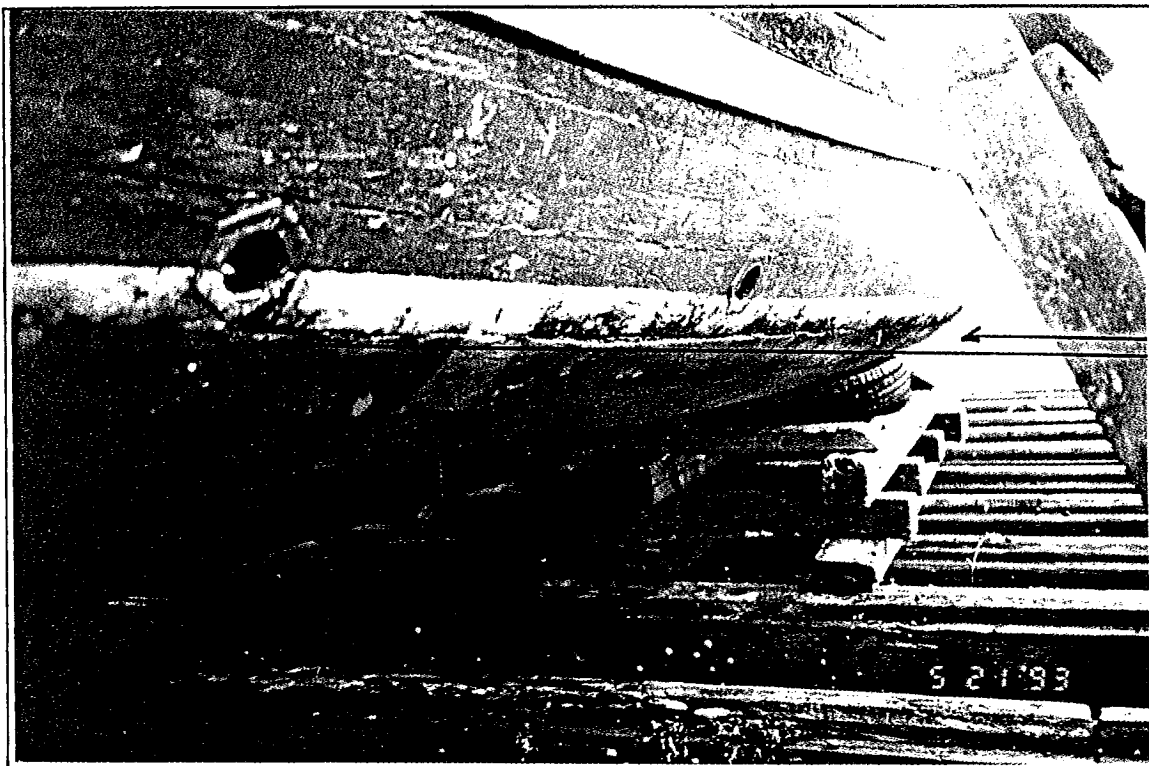
The "SCOTIA SUE" was hauled out of the water. The source of the ingress was found to be in the strake immediately below the scuppers, on the starboard side, in the wind and water area. A plank was

found to have sprung over a length of approximately 4.3 m.

While there may have been other minor sources of leakage, the main source of ingress was the sprung plank. (See Section 1.5.)

Seam partly open due to sprung plank.

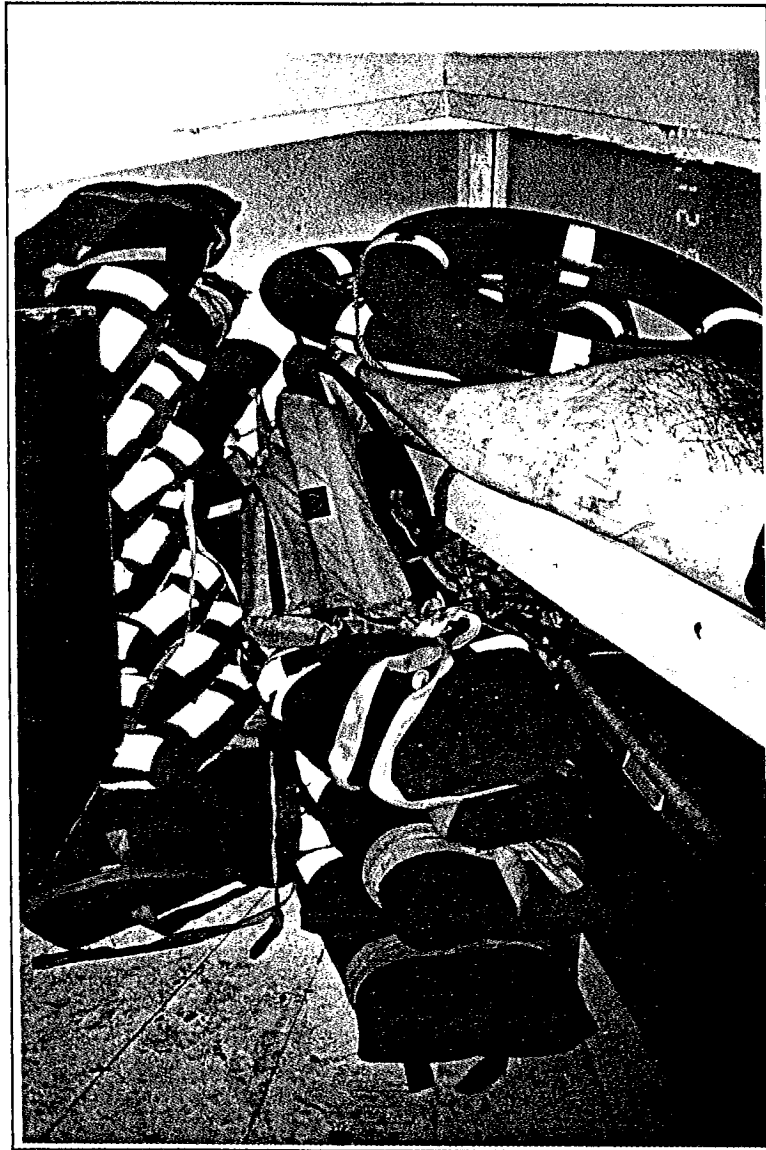
The vessel's fuel tanks were nearly empty and the lifejackets, lifebuoys and storage chests were stored in the cuddy. The reserve buoyancy of these items plus the "lift" of the mooring lines prevented the vessel from sinking completely.

Lifejackets, lifebuoys and empty storage chests increased the reserve buoyancy.
