AVIATION INVESTIGATION REPORT

ENGINE POWER LOSS AND FORCED LANDING

CESSNA 172N C-GZLJ

TORONTO/BUTTONVILLE MUNICIPAL AIRPORT 2 nm SSE

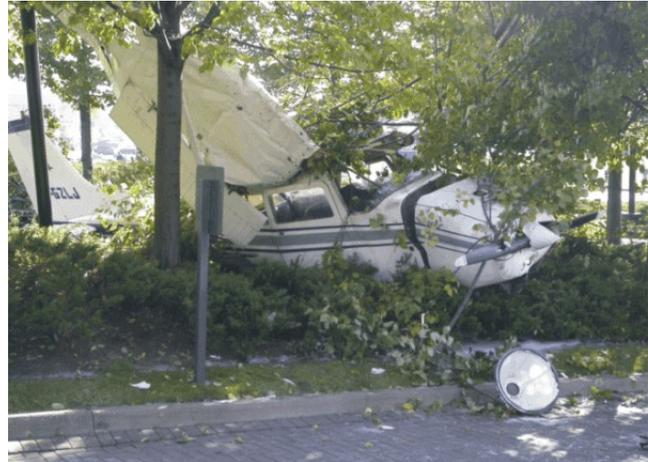
While on approach to the clearing, it appeared to the pilot that the ground was on a downslope. During the pilot's flight training, it was shown that landing on soft ground with a downslope may result in the landing gear digging in and the aircraft flipping over. Aware of this possibility, the pilot chose to stall the aircraft into the trees to reduce impact forces and injuries.

1. The pilot was unable to find a suitable landing area and intentionally stalled the aircraft into the trees, resulting in substantial damage to the aircraft.
