**AVIATION INVESTIGATION REPORT  
A05W0222**

**ENGINE TORCHING**

**ALASKA AIRLINES INC.  
BOEING 737-900 N317AS  
CALGARY INTERNATIONAL AIRPORT, ALBERTA  
30 OCTOBER 2005**

Report Number A05W0222

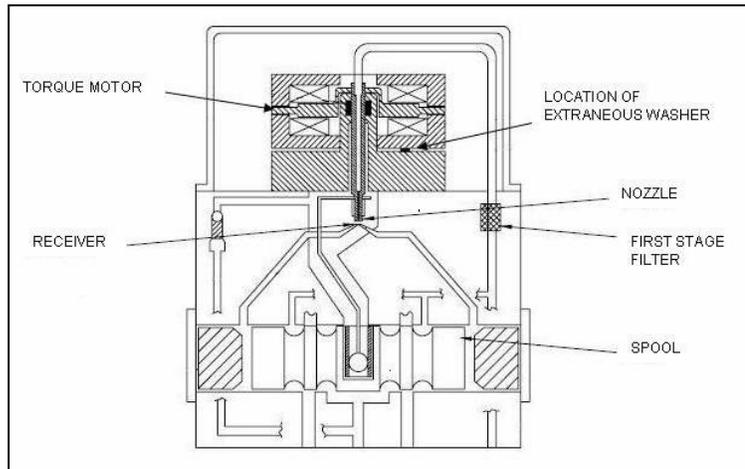
**Figure 2.** Electro-hydraulic servo valve schematic

The fuel control system for the CFM 56-7B26 engine is a full authority digital engine control (FADEC) system that meters engine fuel flow for any engine operating condition. The hydro-mechanical unit (HMU) responds to electrical signals from an electronic engine control (EEC). The HMU fuel metering function is carried out by one of six integral, four-way electro-hydraulic servo valves (EHSV), which, in turn, command the fuel metering valve (FMV). The two stages of the FMV EHSV consist

of a fluidic amplifier first stage and a spool valve second stage. The fluidic amplifier directs a small fuel stream to two ports that deliver this servo fuel to either end of the spool valve. Fluidic amplifier nozzle position is a function of torque motor input from the EEC, with the flow of signal fuel split between the two ports according to commands from the torque motor (see Figure 2). The HMU (model CH-T1, part number 442317-9, serial number BECW1597) was manufactured by Honeywell International Inc. and had 3257 operating hours since overhaul. The EEC was manufactured by BAE Systems.
