AVIATION INVESTIGATION REPORT
A07P0209

TAIL ROTOR DRIVESHAFT FRACTURE

**BLACK TUSK HELICOPTERS
BELL 214B1 (HELICOPTER) C-FWQU
RAMSAY ARM, BRITISH COLUMBIA**

02 JULY 2007

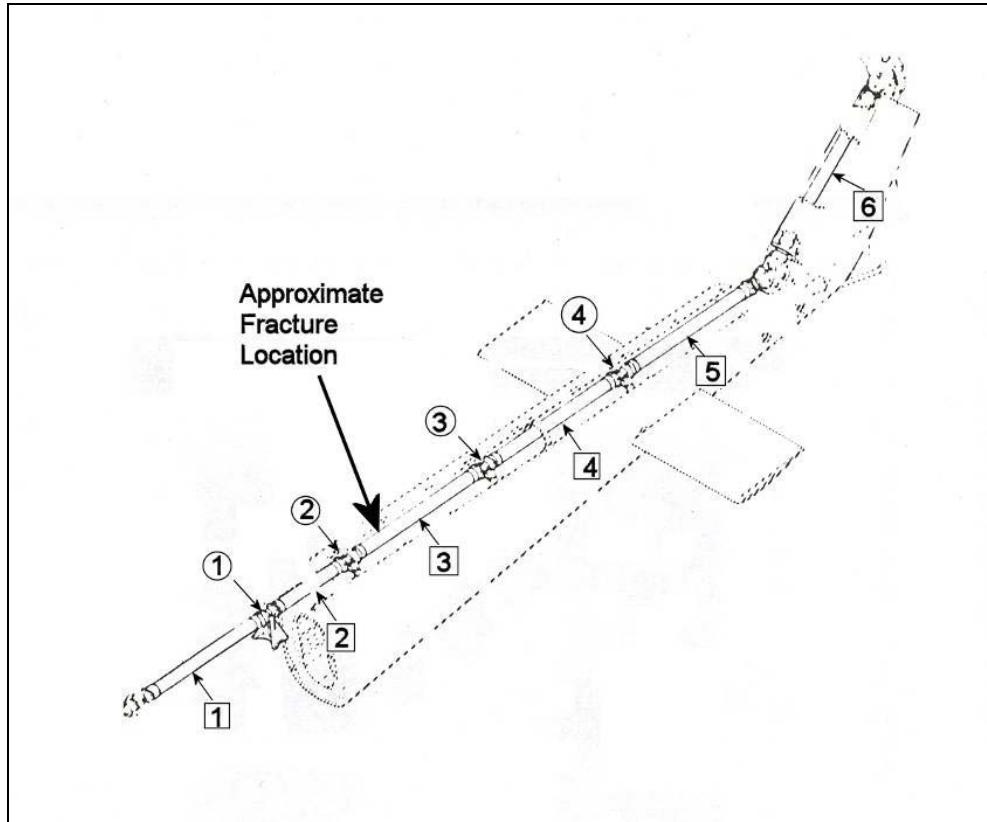
Figure 2. Tail boom showing shaft segments

On this Bell 214B1 helicopter, the TRDS comprises six separate driveshaft segments, of which five are identical. The No. 2 shaft segment is shorter than the rest. The remaining five shafts are interchangeable³ and are normally identified by part number 214-040-622-005 and a unique serial number etched or stamped on each component. The shafts are normally referred to as No. 1 at the main transmission through to No. 6 in the tail boom pylon (see Figure 2). The shafts are manufactured by BHTI from aluminium tube stock, with attachment flanges riveted onto each end.

TSB laboratory analysis determined that the alloy was most probably 2024-T3 or -T4. The shaft segments are interconnected at the flanges using Thomas couplings supported by hanger bearing assemblies mounted on top of the tail boom. The required dynamic balancing of each shaft is done only by BHTI, either at the time of manufacture or repair. If the shaft is re-balanced or repaired, the serial number remains unchanged.
