MARINE INVESTIGATION REPORT
M02C0011

STRIKING

OF CRIB LIGHT 82

BY THE TUG-BARGE UNIT *PROGRESS/PITTS CARILLON*

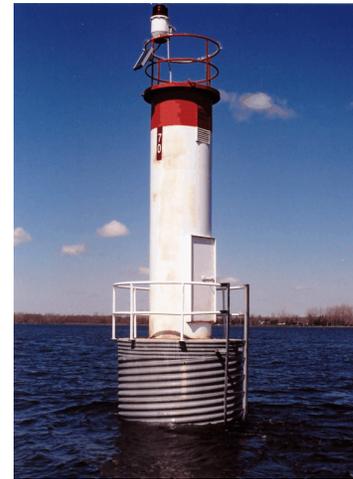
Photo 3. Typical crib light

Crib light 82 is located approximately 100 m southeast of Broder Island. The fixed navigation aid is a white circular tower with a red top 10.1 m high above water level, resting on a 3.5 m diameter concrete base. The light characteristic is flashing red with a four-second interval and it has a nominal range of 4 nautical miles (see Photo 3).
