MARINE INVESTIGATION REPORT
M04L0105

STRIKING OF WHARF

HIGH-SPEED PASSENGER CATAMARAN
FAMILLE DUFOUR II
PUBLIC WHARF, ÎLE AUX COUDRES, QUEBEC
24 AUGUST 2004

Report Number M04L0105

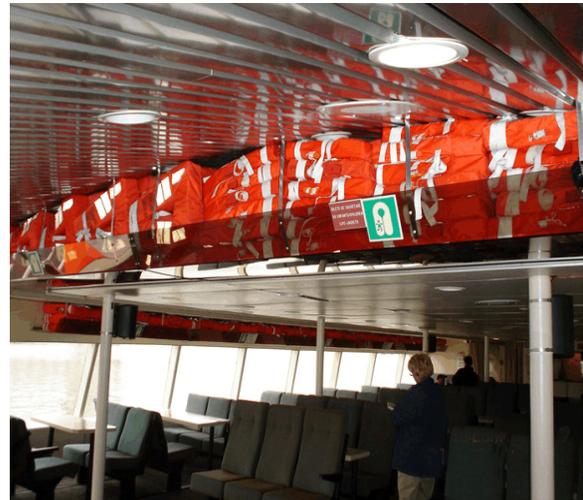
Initially, the passenger lifejackets were stowed in lockers, suitably positioned, on deck. After the modifications, they were stowed in overhead racks located above the windows along the port and starboard sides of the main and upper decks. All of the children's lifejackets and the remaining adult lifejackets were stowed in an overhead athwartships rack located above the third row of seats from the forward end of the accommodation space on the main deck (see Photo 7).

The lifejackets were tightly stacked within the rack and were difficult to retrieve because of the height of the front panel and the vertical metal strapping used to secure the rack in place. The height from the top of the front panel of the overhead rack to the deck was 2.18 m (86 inches). Although the row of seats under the overhead rack was in place at the time of the occurrence, its removal for seating reconfiguration happens from time to time on this vessel (see Photo 8).

Photo 7. Overhead rack containing adult (left-hand side) and children's (right-hand side) lifejackets
