**RAILWAY INVESTIGATION REPORT
R04T0013**

MAIN-TRACK DERAILMENT

**CANADIAN PACIFIC RAILWAY
FREIGHT TRAIN NO. 104-18
MILE 24.83, MACTIER SUBDIVISION
BOLTON, ONTARIO
22 JANUARY 2004**

Report Number R04T0013

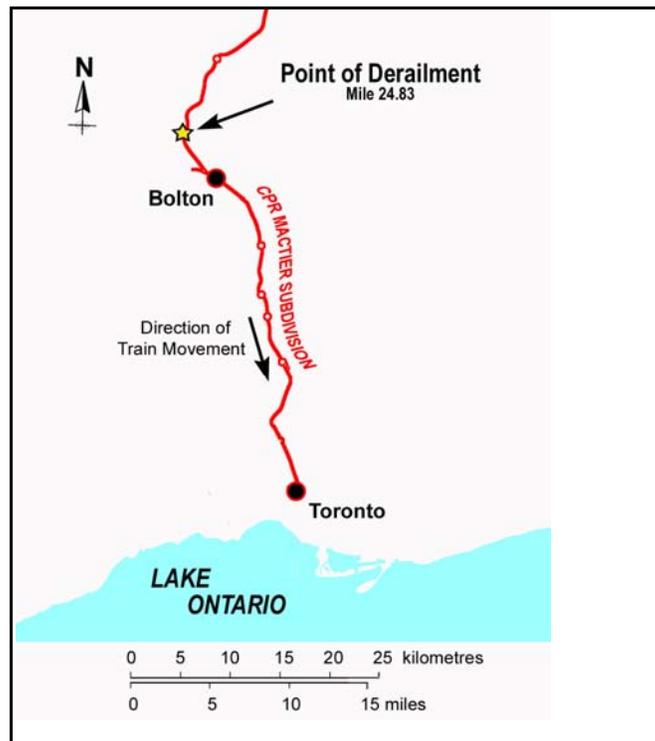
Canadian Pacific Railway (CP Rail) freight train 104-18 (the train), comprised of 3 locomotives and 43 loaded freight cars, was en route from Edmonton, Alberta, to Toronto, Ontario,¹ and was proceeding southward on the MacTier Subdivision (see Figure 1). It was 4284 feet long and weighed 5077 tons. The crew, a locomotive engineer and a conductor, had taken control of the train at MacTier. They were familiar with the territory, qualified for their positions, and met fitness and rest requirements.
