**RAILWAY INVESTIGATION REPORT  
R07V0213**

**NON-MAIN-TRACK COLLISION**

**CANADIAN NATIONAL RAILWAY  
BELTPACK ASSIGNMENT YPSS01-04  
MILE 464.33, CHETWYND SUBDIVISION  
PRINCE GEORGE, BRITISH COLUMBIA  
04 AUGUST 2007**

Report Number R07V0213

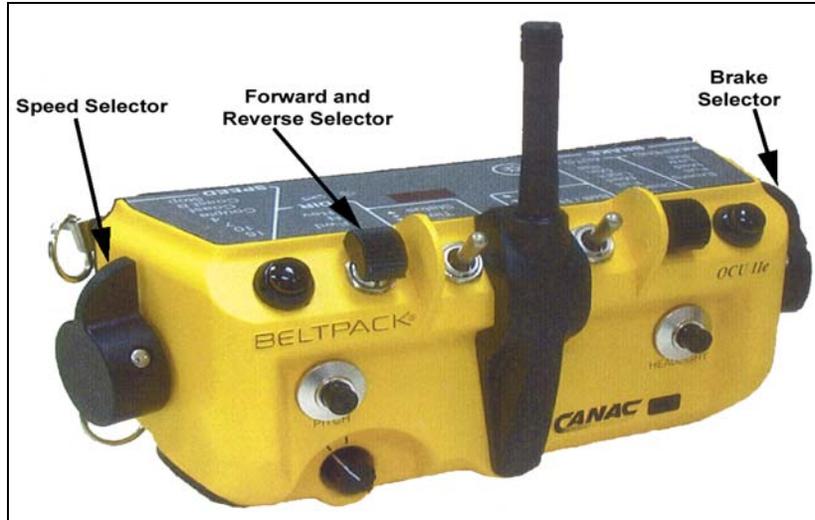
**Photo 2.** Beltpack operator control unit

With Beltpack operations, the operator uses an OCU, a three to five pound box attached to the operator’s safety vest, to remotely control the locomotives (See Photo 2). Radio commands transmitted by the OCU are received and processed by a computer onboard the locomotive. The Beltpack OCU is equipped with (but not limited to) a speed selector, a forward and reverse selector, and a brake selector that includes an emergency brake feature.
