**RAILWAY INVESTIGATION REPORT  
R14W0041**

**MAIN-TRACK TRAIN DERAILMENT**

**CANADIAN PACIFIC RAILWAY  
FREIGHT TRAIN 490-15  
MILE 43.10, MINNEDOSA SUBDIVISION  
KEYES, MANITOBA  
15 FEBRUARY 2014**

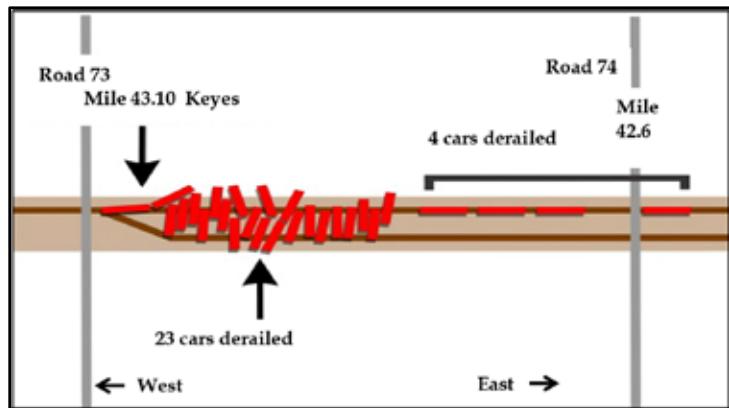
Figure 2. Site diagram

Site examination determined that 27 cars—the 16th to the 42nd cars inclusive from the head end of the train—had derailed. The derailed cars came to rest in various positions, blocking the main track and siding between Miles 42.6 and 43.10 (Figure 2).

About 1443 feet of main track and 292 feet of adjacent siding track were damaged. No marks were observed on the track
