# Air Transportation Safety Investigation Report A19Q0096

## COLLISION WITH TERRAIN

Rans S-6ES Coyote II (advanced ultralight), C-IIIJ  
Rougemont, Quebec  
01 July 2019

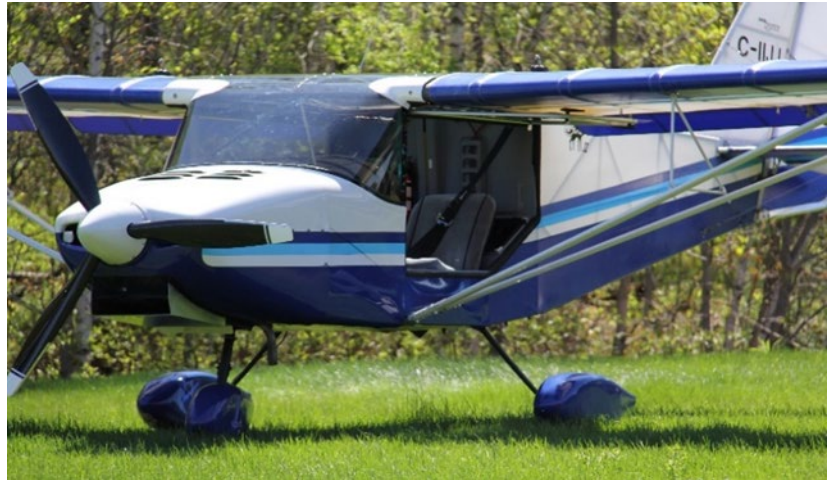
The Rans S-6ES Coyote II is a 2-seat, high-wing advanced ultralight aircraft made from metallic tubes covered in fabric (Figure 2). The aircraft was built in the United States in 2008. It was imported into Canada in early 2009 and inspected by a Rans representative, because it had never flown. The manufacturer then issued a certificate of compliance on 04 May 2009. When the aircraft was purchased on 09 January 2019, its technical logbook indicated that the aircraft had accumulated 336 flight hours since its construction.

Figure 2. Occurrence aircraft (Source: former owner of the aircraft)
