# AIR TRANSPORTATION SAFETY INVESTIGATION REPORT A21P0018

## **LOSS OF CONTROL AND COLLISION WITH TERRAIN**

Airspan Helicopters Ltd.  
Bell 212, C-GNYI  
Bowen Island, British Columbia  
05 March 2021

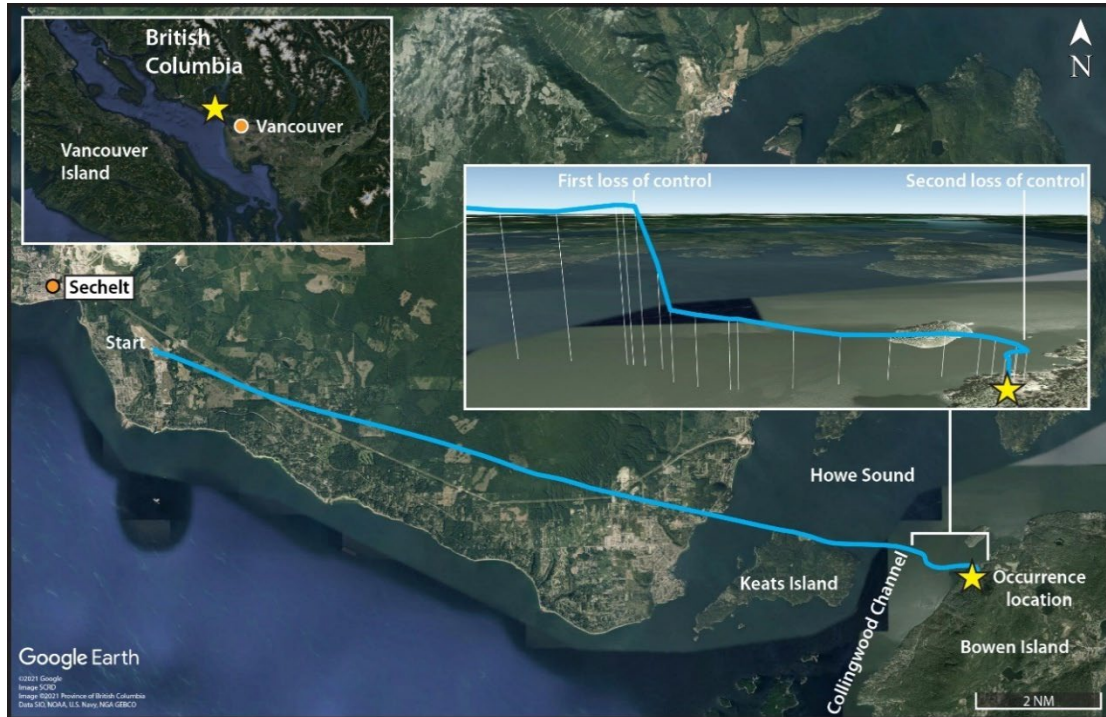
Figure 1. The occurrence helicopter's flight path, derived from its global positioning system (Source: Google Earth, with TSB annotations)

The helicopter's speed increased as it began crossing Collingwood Channel, reaching a speed of 78 knots ground speed at an altitude of approximately 2560 feet ASL. As it flew above the channel, the helicopter passed through an area of moderate turbulence. Soon after, at 0945:24, the helicopter was roughly 2 NM west of Bowen Island, on the lee side at an altitude of approximately 2430 feet ASL, when it entered another area of turbulence with a severe downward force.

While travelling at a ground speed of 73 knots on a track of approximately 110°, the helicopter violently pitched nose down and began a rapid right roll. The cyclic was momentarily pulled from the second pilot's hand due to the aircraft's violent, rapid movement. The helicopter rolled inverted, or close to inverted, during this loss of control, and the PIC joined the second pilot on the controls to attempt a recovery. The second pilot applied maximum aft cyclic in the recovery attempt. During this period, the helicopter fell approximately 1400 feet to an altitude of approximately 1040 feet ASL; a descent rate of 8220 fpm.

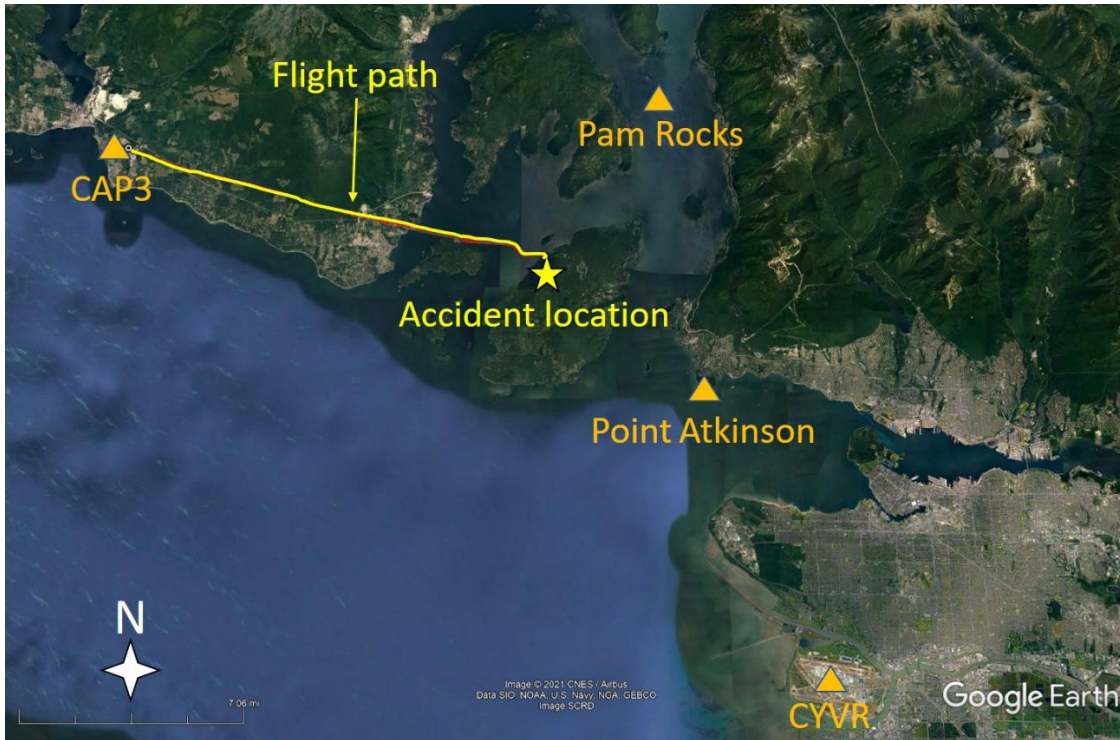
In addition to the information available from the weather observations at CYVR, there are a number of other stations in the vicinity of the accident that also report weather (Figure 2).

Figure 2. Map showing weather reporting stations relative to the aircraft’s flight path and the accident location (Source: Google Earth, with TSB annotations)

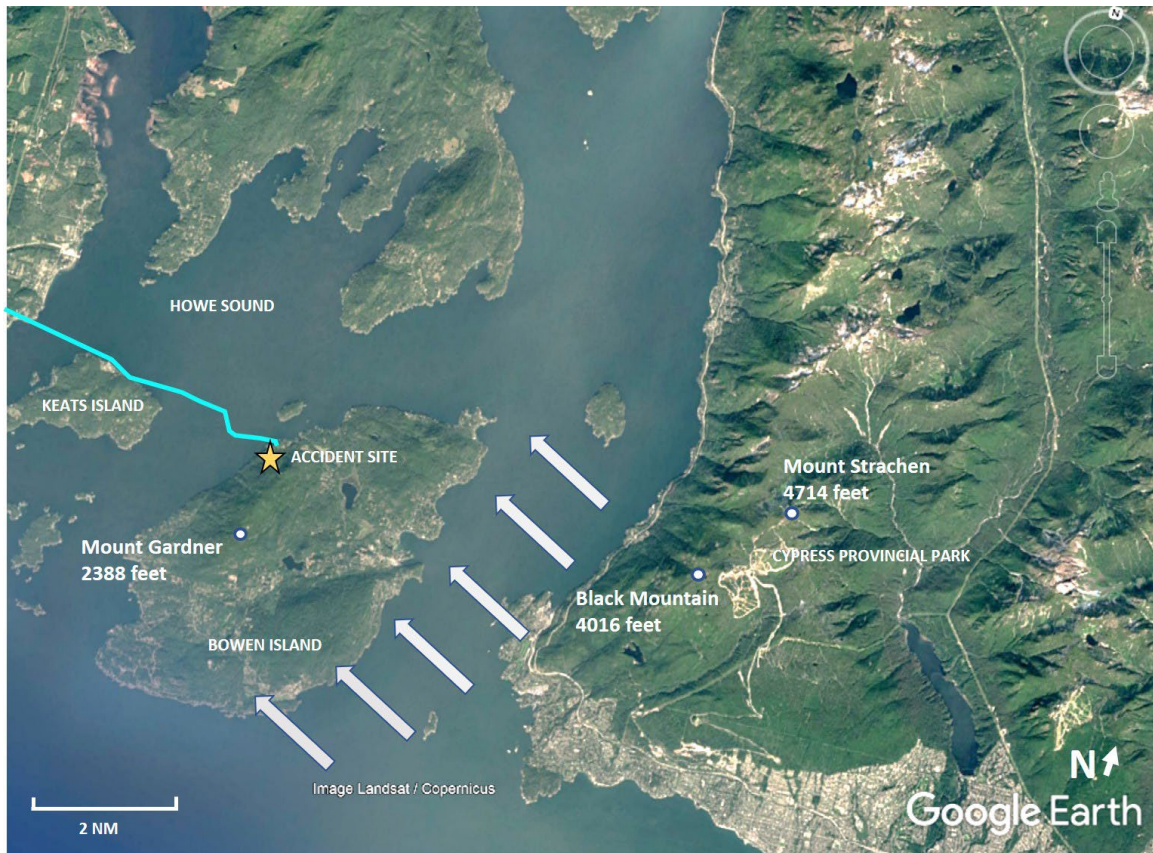
On the morning of the occurrence, strong southeasterly winds were blowing in the vicinity of the accident site. The west side of Bowen Island is dominated by a long ridge which is anchored at the south end by Mount Gardner with an elevation of 2388 feet ASL. The flight's intended destination, Cypress Provincial Park, is approximately 6 NM east of Bowen Island. Within the park are Mount Strachan with an elevation of 4714 feet ASL and Black Mountain with an elevation of 4016 feet ASL (Figure 3).

Figure 3. Map showing the helicopter's flight path (blue line) and the prevailing wind direction (white arrows) (Source: Google Earth, with TSB annotations)

The final minutes of the occurrence flight would have been flown on the downwind, or lee side, of this terrain. NAV CANADA's *The Weather of British Columbia Graphic Area Forecast 31* explains that, "[w]hen air flows across a mountain or hill, it is disturbed the same way as water flowing over a rock."<sup>8</sup> Wind on the lee side of a hill or mountain is affected by its passage over the terrain and lee effects of wind in mountainous areas are known to create severe turbulence. A large eddy called a "rotor" may form below each wave crest once a lee wave pattern has been established (Figure 4). Lee effects are described in *The Weather of British Columbia* as follows:

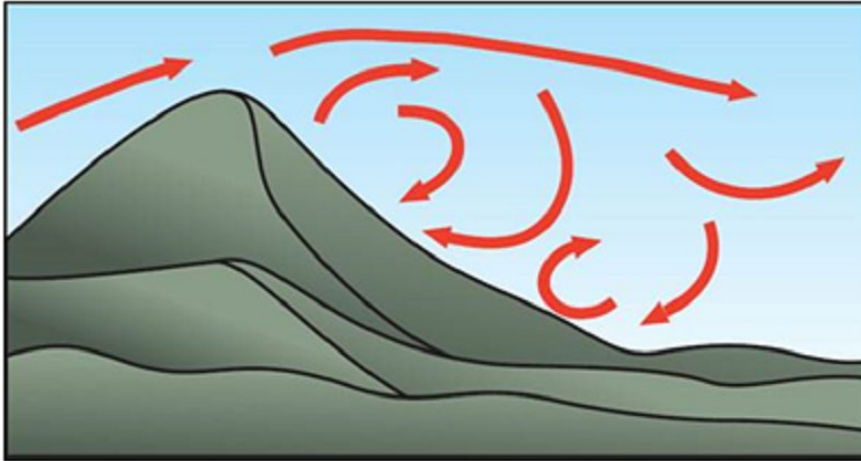
When the winds blow against a steep cliff or over rugged terrain, gusty turbulent winds result. Eddies often form downwind of the hills, which create stationary zones of stronger and lighter winds. These zones of strong winds are fairly predictable and usually persist as long as the wind direction and stability of the air stream do not change. The lighter winds, which occur in areas called wind shadows can vary in speed and direction, particularly downwind of higher hills. In the lee of the hills, the wind is usually gusty and the wind direction is often completely opposite to the wind blowing over the top of the hills. Smaller reverse eddies may also be encountered close to the hills.<sup>9</sup>

Figure 4. Lee effects (Source: NAV CANADA, *The Weather of British Columbia: Graphic Area Forecast 31* [2001], Figure 2-10.)
