AIR TRANSPORTATION SAFETY INVESTIGATION REPORT A21Q0097

CONTROLLED FLIGHT INTO TERRAIN

Synergy Aviation Ltd.
Guimbal Cabri G2 (helicopter), C-GSYN
Wachigabau Lake, Quebec
08 October 2021

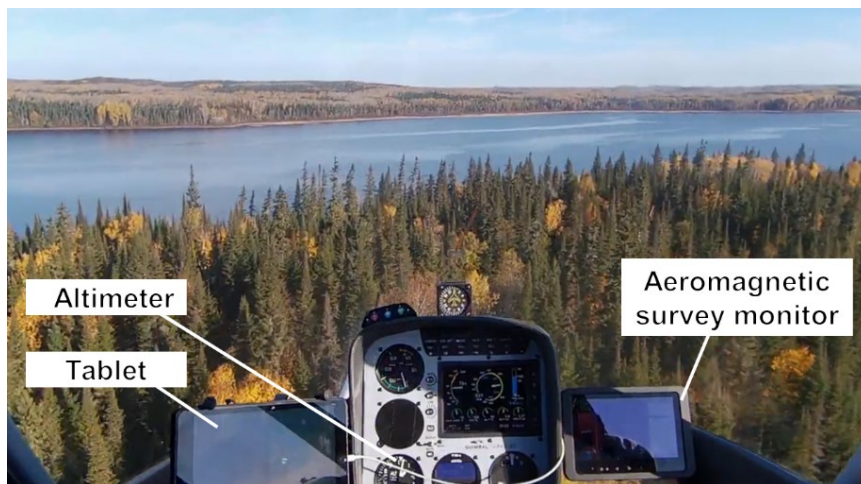
Figure 3. View from the cockpit (Source: Still image taken from a video recorded by the occurrence pilot, with TSB annotations)

A conventional barometric altimeter⁹ was the only instrument on board that provided a useable indication of the helicopter's altitude.¹⁰ The Novatem aeromagnetic survey monitor, mounted to the right of the console directly in front of the pilot, displayed the survey blocks and flight tracks (Figure 3).

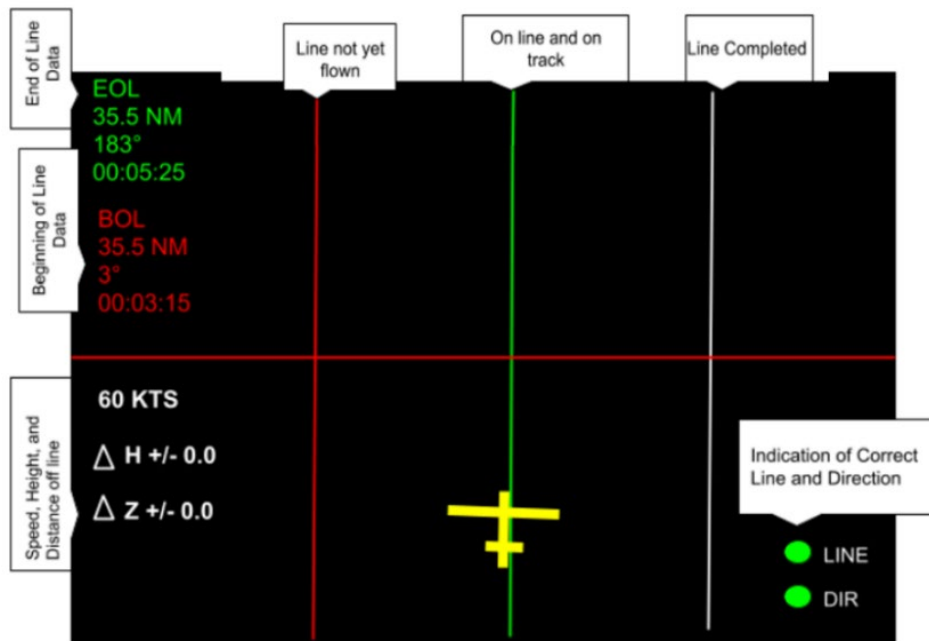
Figure 8. Aeromagnetic survey monitor (Source: Synergy Aviation Ltd., Guimbal Aeromagnetic Survey Procedure, p. 9)

The aeromagnetic survey monitor provides some navigational data to assist the pilot when flying the survey block, such as survey line spacing (25 m [82 feet] apart), the lateral distance off the line, and the remaining distance to the end of the current survey line being flown (Figure 8).

The information displayed on Novatem’s aeromagnetic survey monitor is meant to be a navigational aid to increase the precision of the flight profile, but it does not help pilots manage the risk of being too low if an inadvertent descent occurs. Thus, Synergy pilots did not have precise information to determine their height above the ground. In addition, there are no TC regulations or requirements for CARs Subpart 702 day visual flight rules (VFR) helicopter operations to require equipment that provides a means of alerting the pilot to the precise height of the aircraft above land or water, or to alert the pilot if the aircraft descends below a specific height.
