AIR TRANSPORTATION SAFETY INVESTIGATION REPORT A22P0057

COLLISION WITH TERRAIN

Tyax Air Service Limited
de Havilland DHC-2 MK. I (Beaver), C-GIYV
Pemberton Aerodrome, British Columbia, 52 NM NNW
17 July 2022

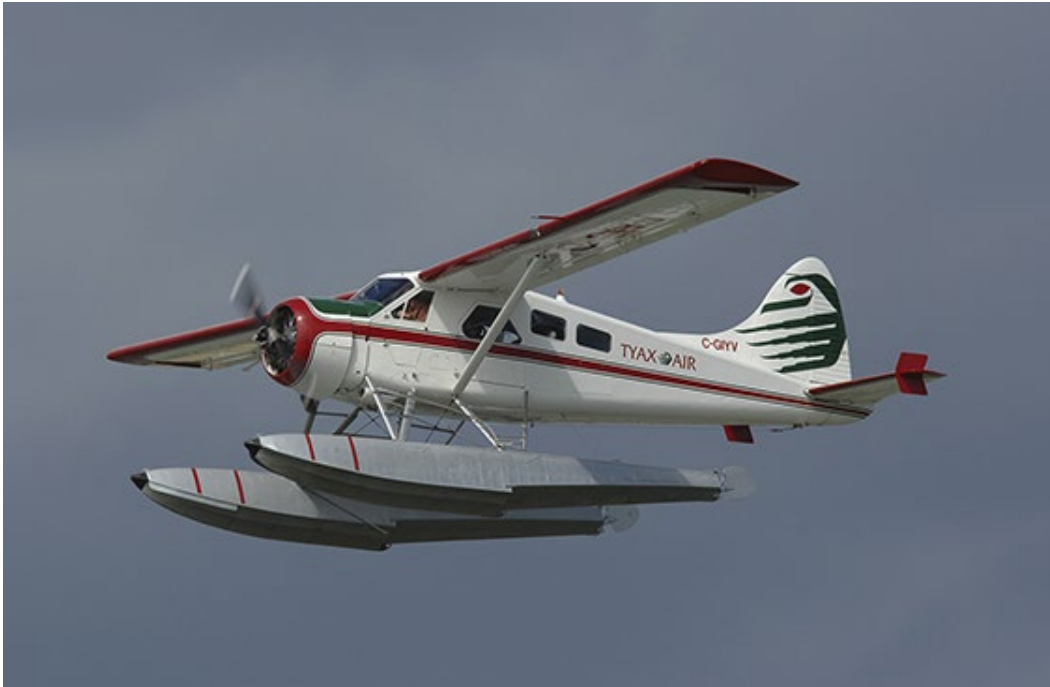
Figure 3. Occurrence aircraft (Photo: Peter J. Cooper, Beaver Tails at <https://dhc-2.com/id498.htm> [last accessed on 28 March 2024].)

The DHC-2 MK. I (Beaver) is a single-engine, high-wing, propeller-driven aircraft. The occurrence aircraft (Figure 3) was equipped with EDO 679-4930 floats.
