# MARINE INVESTIGATION REPORT

## M17P0400

### Striking of No. 2 berth

Roll-on/roll-off ferry *Seaspan Swift*  
Tilbury Island, Delta, British Columbia  
15 November 2017

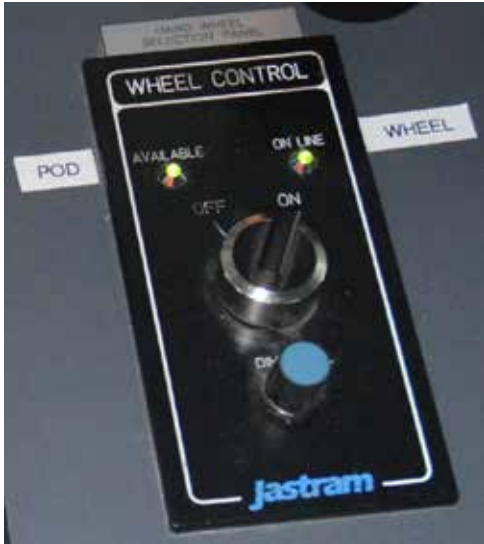
Figure 6. Wheel control switch

<sup>9</sup> After the occurrence, the company electrician checked the switch and determined that it had a loose connection.

<sup>10</sup> The chief officer and the regular master had experienced a similar situation with this switch in the past, which helped them to identify the cause. The relief master had not experienced this situation before.

The wheel was integrated such that the operator can switch between steering systems, with only 1 system in operation at any given time. To change the steering control from the pod handles to the wheel or vice versa, a control switch with visual indicators (green LED lights) was installed (Figure 6). The green LED on the left-hand side indicates the availability of electrical power supply to the wheel, and the green LED on the right-hand side indicates when wheel steering is selected. Placing the vessel on wheel steering isolates steering control from the handles of both pods. The operator can still rotate the pod handles, but this action will not have any effect on the pods. When the operator switches the steering from the pod handles to the wheel or vice versa, there is an audible confirmation in the form of a single

beep. When the wheel is deselected, the steering automatically transfers to the pod handles and the green light on the right side of the wheel control selection panel extinguishes.
