## **MARINE TRANSPORTATION SAFETY INVESTIGATION REPORT M18P0230**

### **GIRDING AND CAPSIZING**

Tug *George H Ledcor*

13 August 2018

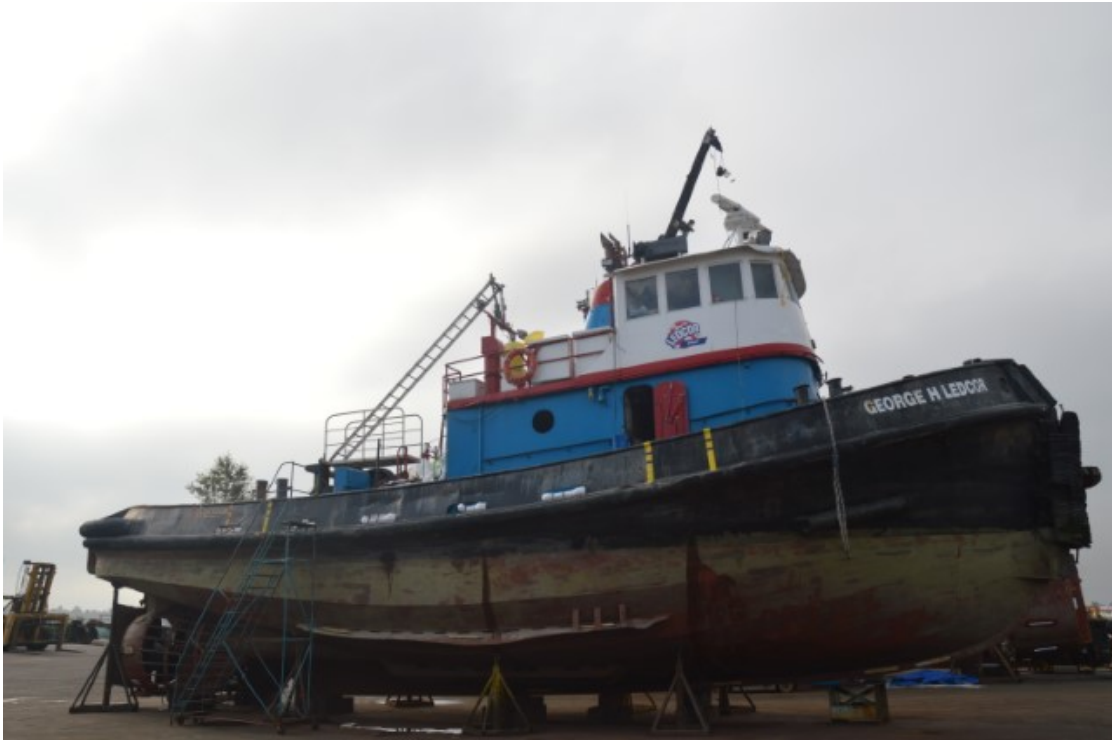
Figure 1. The George H Ledcor (Source: TSB)

After the *George H Ledcor* was recovered, it was determined that the tug was still structurally intact, but that electronic navigation equipment, wiring, and machinery had been damaged. The tug was declared a total constructive loss.

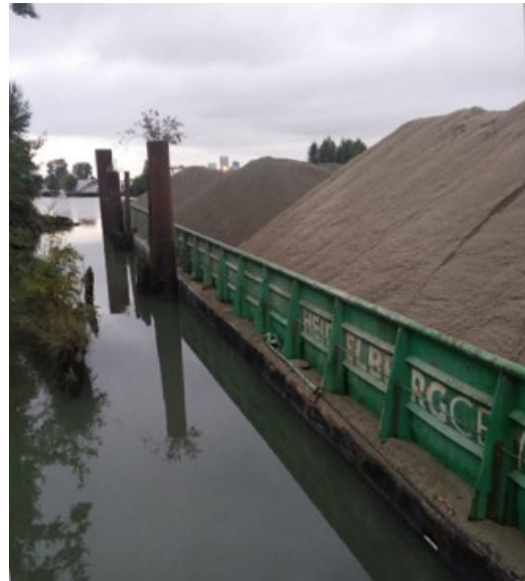
Figure 2. The *Evco 55*, shown from the port side, at the unloading facility (Source: TSB)

The *Evco 55* (Figure 2) is a flat-decked, non-propelled barge of steel construction with a cargo capacity of 5800 tonnes. The barge was loaded with 4621 tonnes of gravel and trimmed evenly with a draft of approximately 4.7 m at the time of the occurrence.

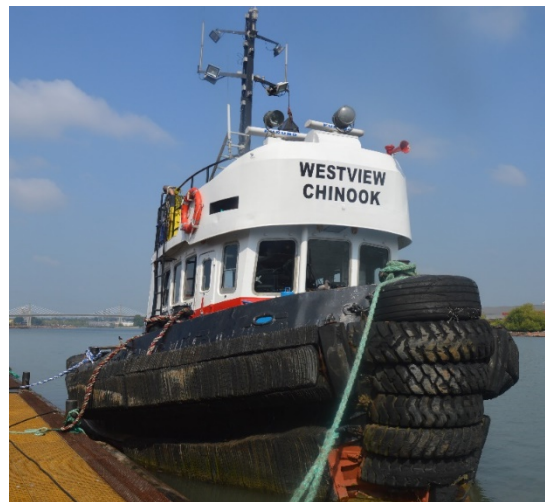
Figure 3. Assist tug *Westview Chinook* (Source: TSB)

The *Westview Chinook* (Figure 3) is a tug of steel construction used mostly for yarding operations. The wheelhouse is located on the fore part of the main deck. There are 3 conning stations with steering and engine controls: 1 inside the wheelhouse, 1 atop the wheelhouse, and 1 on the starboard side of the winch on the aft part of the main deck. At the time of the occurrence, the tug was being used to push the *Evco 55*.

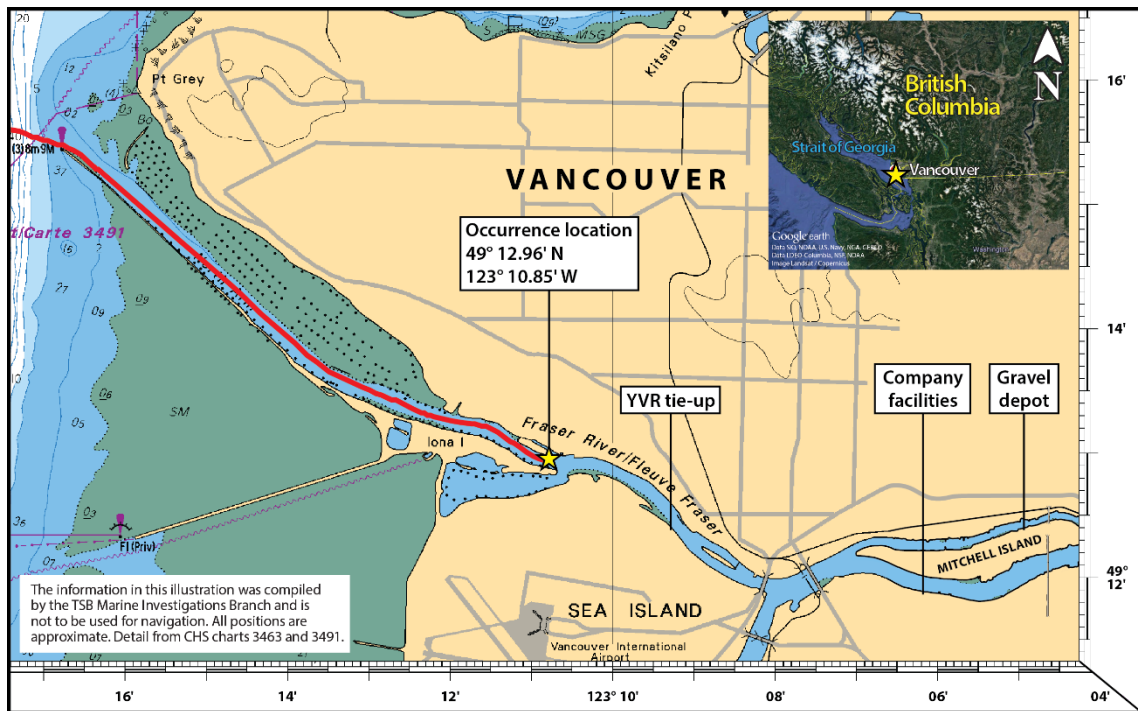
Figure 4. Area of the occurrence, with the vessel's track shown in red (Main image source: Canadian Hydrographic Service charts 3463 and 3491, with TSB annotations. Inset image source: Google Earth, with TSB annotations)

There are a series of natural bends between the entrance to the river and the gravel depot on Mitchell Island. At 2148, the tug and barge navigated the first of these bends, then navigated the second bend a few minutes later. The tug and barge approached the third bend, which was slightly larger, at a speed of 6 knots. At 2208, the master initiated a course alteration of 31° to port. Within a minute, the master on the *George H Ledcor* noticed that the barge was not responding to the course alteration. He then called the master on the *Westview Chinook* by very high frequency radiotelephone and told him to stop pushing the barge, which he then did. The master on the *George H Ledcor* then applied more port rudder, but the barge continued on a straight course.

The towline connecting the *George H Ledcor* and the *Evco 55* pulled over to the tug's starboard side as the barge began to overtake the tug, which caused the tug to develop a starboard heel and placed it in a girded position.<sup>5</sup> The master attempted to reposition the tug in front of the barge by increasing the throttle to full and applying full starboard rudder. This action increased the starboard heel of the tug.
