Transportation
Safety Board
of Canada

MARINE TRANSPORTATION SAFETY INVESTIGATION REPORT M22A0332

PERSON OVERBOARD

Pilot boat *A.P.A. No. 18*

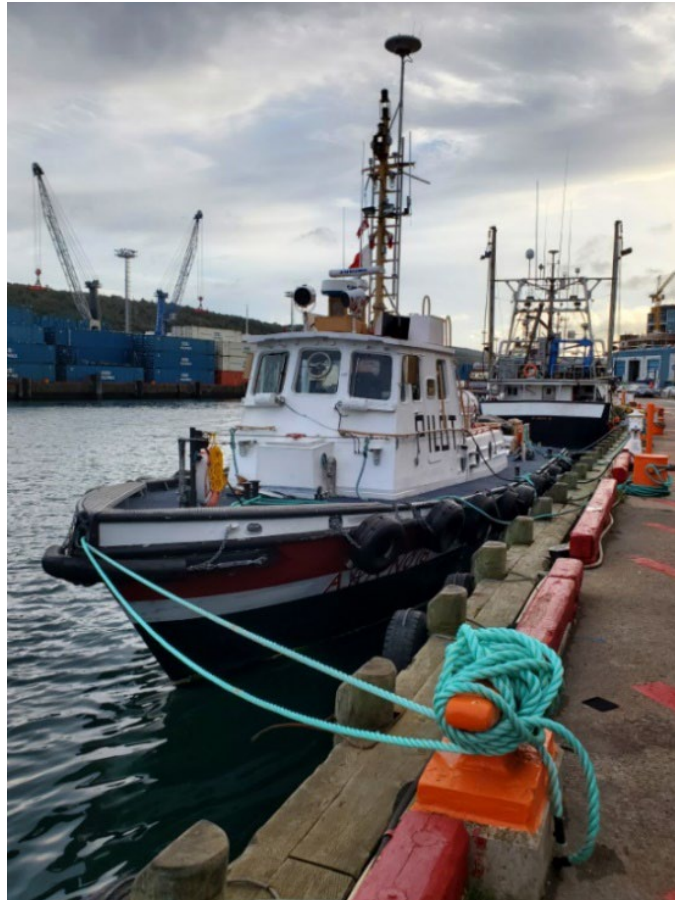
Figure 1. The *A.P.A. No. 18* alongside Pier 7 in St. John's Harbour, Newfoundland and Labrador (Source: TSB)

The *A.P.A. No. 18* is a twin-screw, aluminum hull, 18.78 m long pilot boat, built in 1974 (Figure 1) that is used to transport pilots between land and an inbound vessel, or to transport pilots from outbound vessels to land. The vessel is owned by the Atlantic Pilotage Authority (APA), managed by Canship Ugland Ltd. (Canship) and is crewed with 1 master¹ and 1 deckhand while conducting pilot transfer operations.

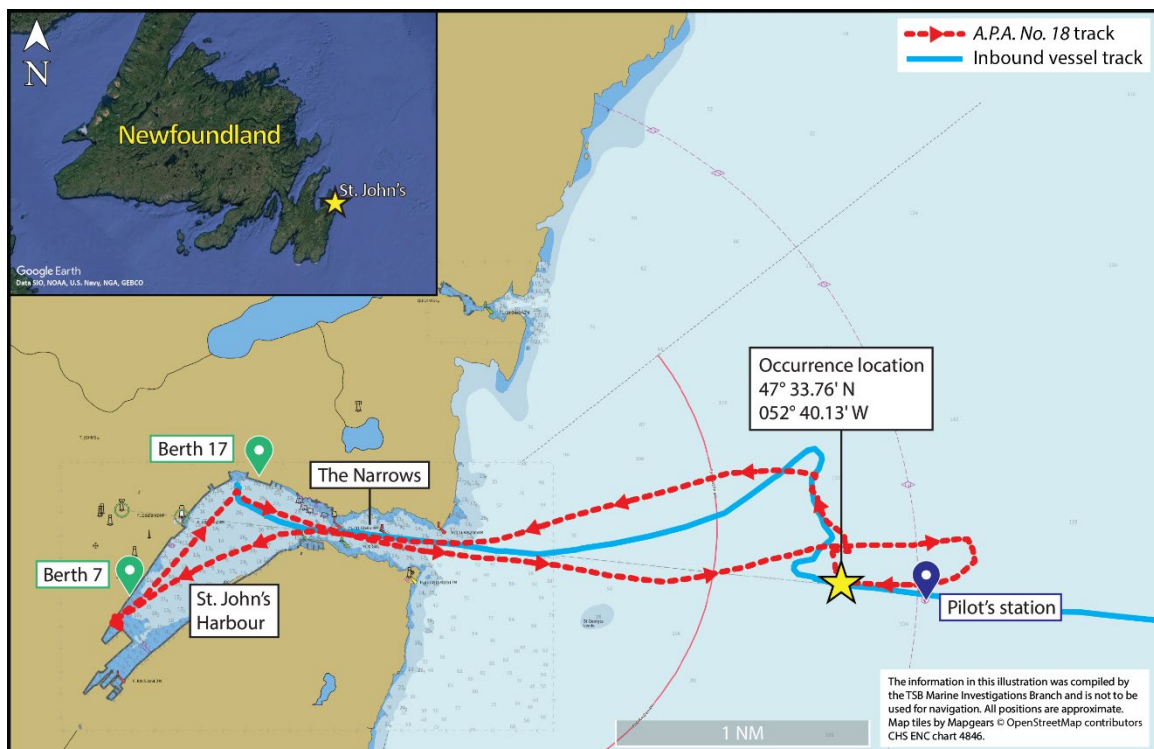
Figure 3. Occurrence map showing vessel tracks and occurrence location (Source: Canadian Hydrographic Chart No. 4846, with TSB annotations)

At around 2320, the *A.P.A. No. 18* departed the berth and proceeded on a course toward the pilot station, which is a position approximately 2 nautical miles (NM) east-southeast of The Narrows (Figure 3). While transiting out of St. John's Harbour, the master of the *A.P.A. No. 18*, the pilot, and the master of the inbound vessel discussed via very high frequency (VHF) radiotelephone the specifics of the upcoming transfer operation. A plan was established for the pilot boat to approach the inbound vessel on the vessel's starboard side at a speed of approximately 7 knots.
