RAILWAY INVESTIGATION REPORT R16H0024

Collision between train and track unit

Canadian Pacific Railway

Mile 118.36, Nemegos Subdivision

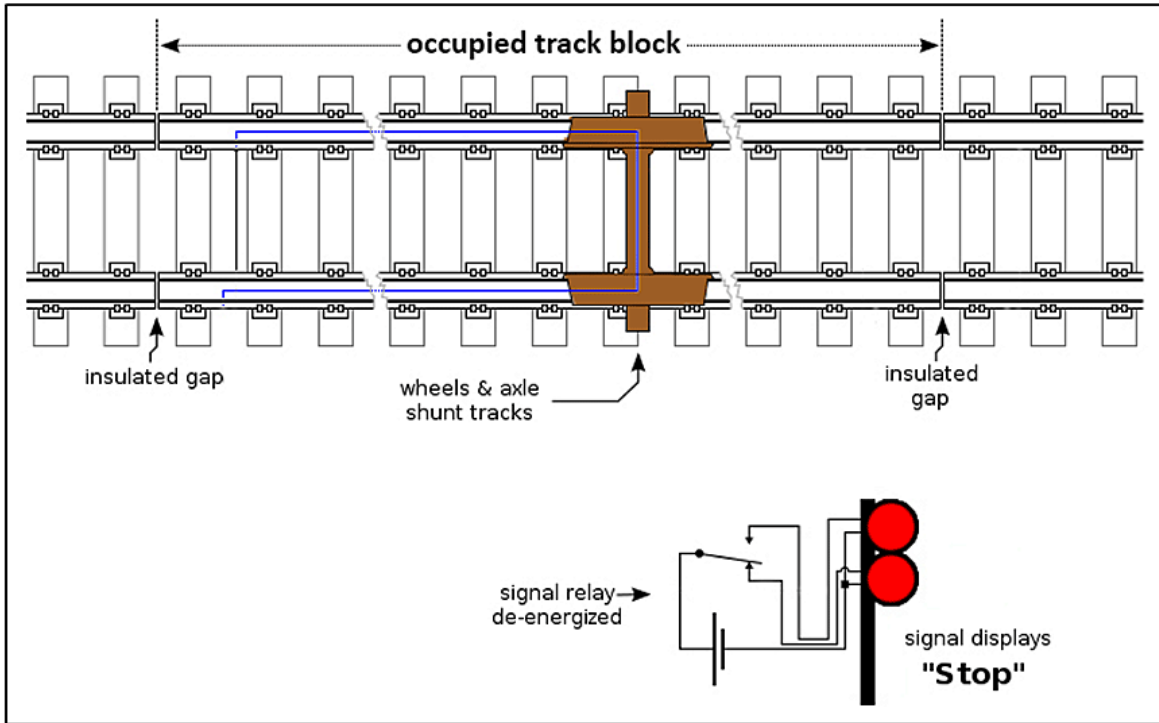
Figure 4. Occupied track block

Tracks are divided into blocks of varying length and each block is divided from adjacent blocks by insulated joints. In CTC territory, at the entrance of each block, railway signals are in place to govern train movements and to ensure proper train separation. When a train approaches a block that is free of traffic, the signal will display a permissive signal indication. However, if another train or another vehicle that shunts the rail (shorts the circuit) is occupying a block ahead or if the electrical continuity of the rails is interrupted due to a broken rail or an open switch, the system generates a sequence of signals informing the crew to stop the train or to reduce its speed enough for it to be able to stop within half the range of vision (figures 4 and 5).

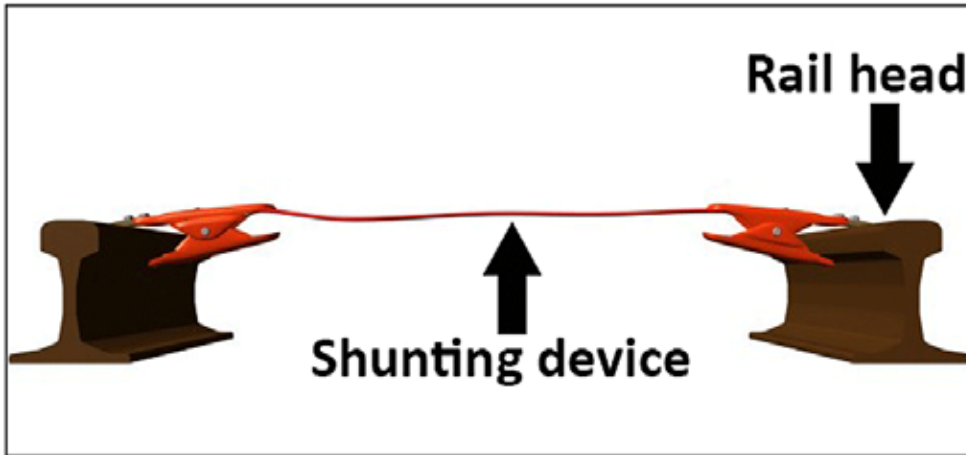
Figure 6. Shunting device

In the United States, the Union Pacific Railroad has required all equipment operating on its track, including track units, to be shunted. Other U.S. railways have implemented the requirement to use shunting devices while work crews are working on the track (Figure 6). These shunting devices are typically installed by hand and are used to protect work crews. This track protection system ensures that stop signals will be displayed to trains when approaching the blocks that are occupied by the workers. These shunting devices are not designed to protect MOW employees while travelling as they must be installed on the track and then removed upon travelling through the block. Therefore, shunting devices would not have prevented this occurrence since the track unit was moving.

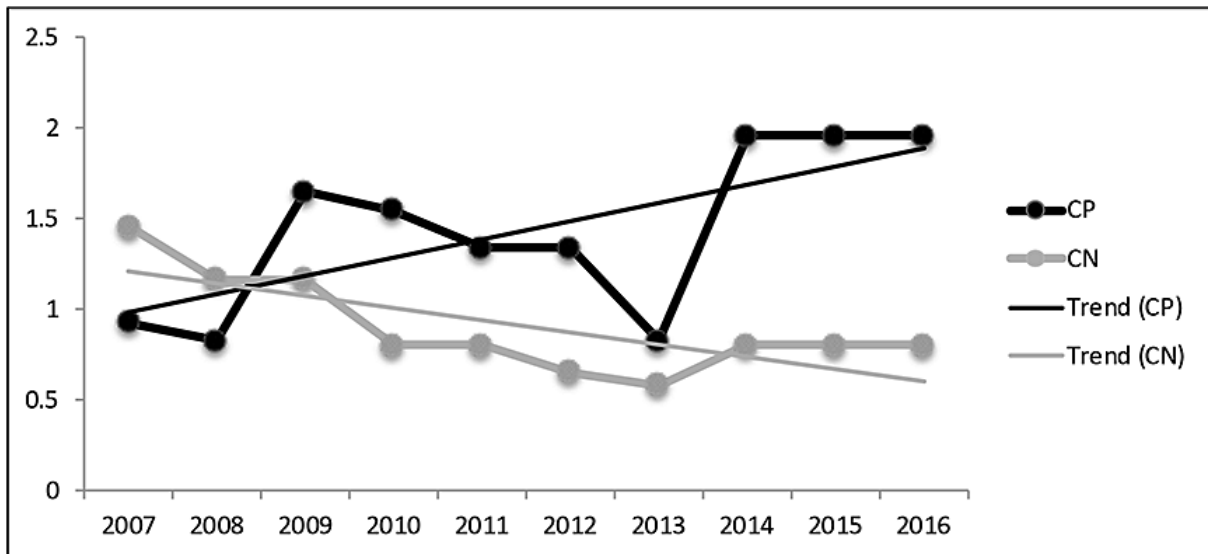
Figure 7. Number of occurrences per 1000 main-track miles per year in which CP⁵³ and CN⁵⁴ track units operated outside their limits of authority, 2007–2016

During this 10-year period, there were 263 such occurrences (Figure 7) – 139 at CP and 124 at CN. Of these 263 occurrences, 16 resulted in a collision between a train and the track unit on the main track.

At CN, in the 5 years since the introduction of the ETOP system in 2012, there has been no additional improvement in the rate of these occurrences. During the same time period, at CP,
