# RAILWAY INVESTIGATION REPORT

## R16W0242

### **Uncontrolled movement, collision and derailment**

Mile 138.70, Weyburn Subdivision

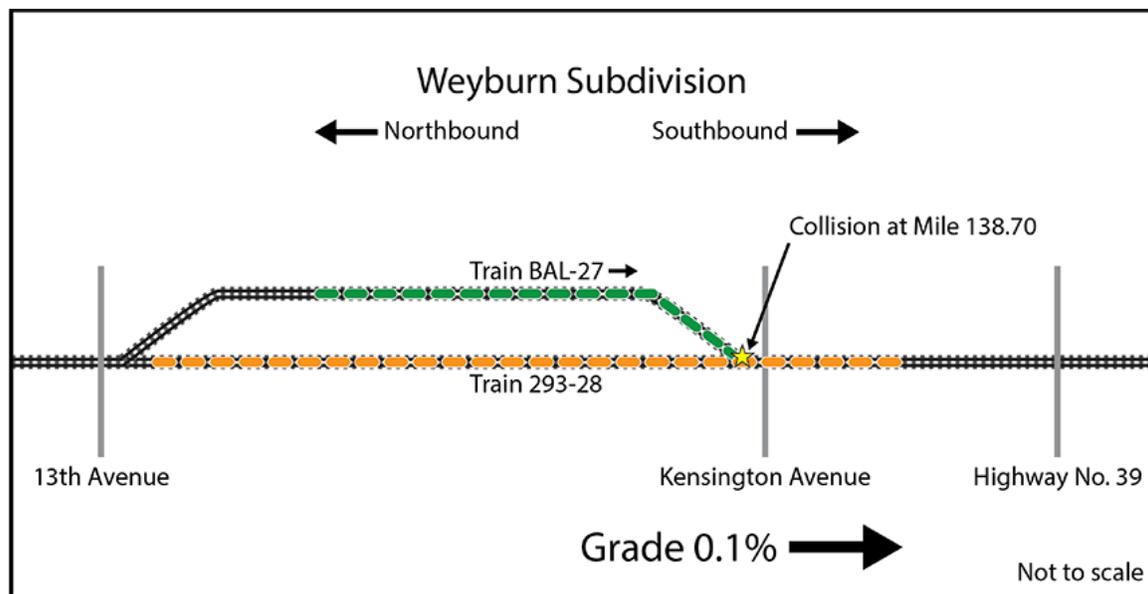
At about 0440, train BAL-27 entered the Estevan siding from the north siding switch and proceeded southward through the siding. As the train approached the south end of the siding, the LE manipulated the throttle and used the automatic brakes to slow the train. As train BAL-27 was stopping, the LE also used light independent brake applications and kept the train stretched as it stopped. At about 0445, train BAL-27 was brought to a stop, just clear of the fouling point with the main track at the south end of the siding. Train BAL-27 was left parked in the siding with the independent and automatic brakes fully applied as the crew waited for the arrival of northbound train 293 (Figure 2). The crew prepared to perform a passing train inspection of train 293 in accordance with the *Canadian Rail Operating Rules* (CROR)<sup>2</sup> and with CP's *General Operating Instructions*.<sup>3</sup>

Figure 2. Site diagram with train BAL-27 in siding and northbound train 293 on the main track

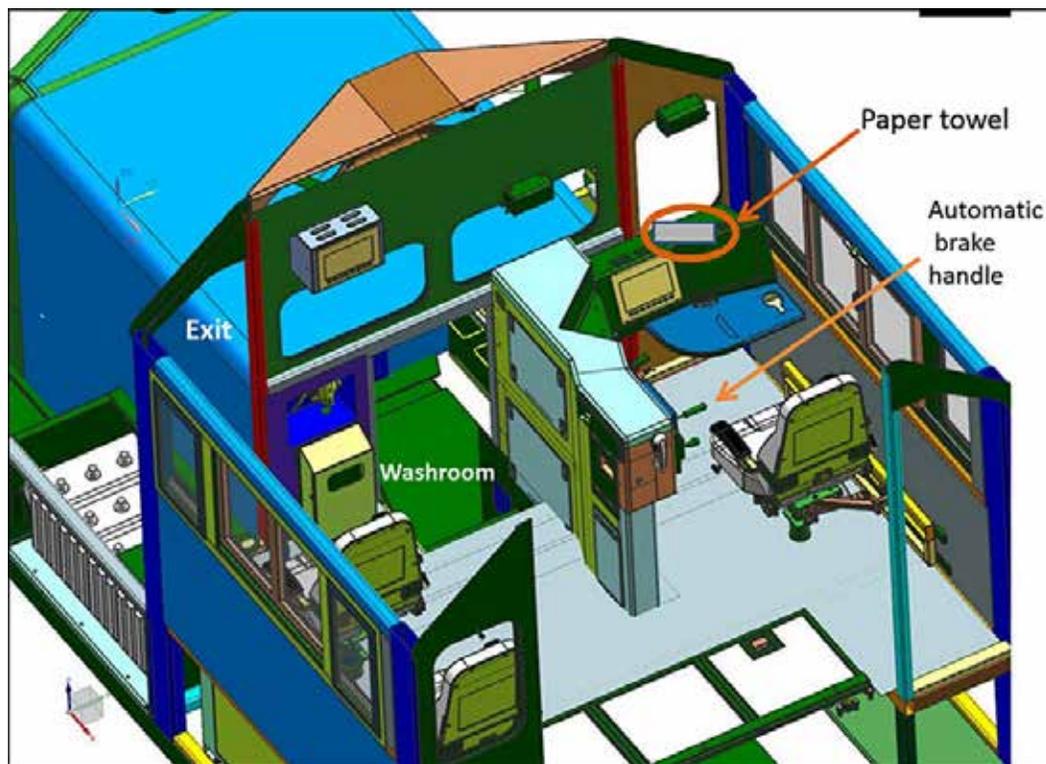
As train 293 was passing, the LE from train BAL-27 returned to the cab of locomotive CP 2275 for personal reasons. While in the locomotive cab, the LE went between the locomotive control stand and the seat to retrieve a paper towel from the locomotive console (Figure 3) and inadvertently moved the automatic brake handle to the release position. Unaware that the automatic brake handle was in the release position, the LE exited the locomotive cab and returned to the ground to complete the passing train inspection.

Figure 3. Locomotive cab layout
