# RAIL TRANSPORTATION SAFETY INVESTIGATION REPORT R23Q0022

## **MOVEMENT EXCEEDS LIMITS OF AUTHORITY**

Quebec North Shore and Labrador Railway  
Ore train W039  
Mile 128.3, Wacouna Subdivision  
Mai, Quebec  
22 February 2023

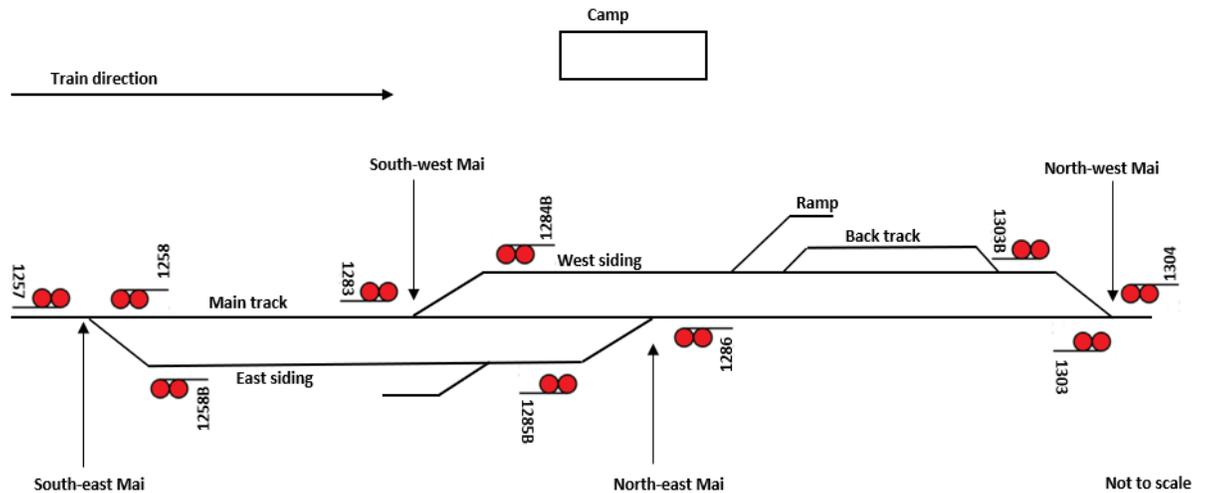
Figure 2. Track arrangement at Mai (Source: TSB)

When signal 1283 was displaying a permissive indication and the block it was controlling was clear, the LE had developed the habit of stopping the lead locomotive of his train just after this signal, in front of the camp installations (Figure 2) at Mai Station, as this made it easier to perform the crew change.

Mai Station is approximately 4.5 miles long. It comprises a single main track and 2 sidings, one on each side of the main track, with a spur each (Figure 2).
