AIR TRANSPORTATION SAFETY INVESTIGATION REPORT A23W0040

COLLISION WITH TERRAIN

Government of Canada, Royal Canadian Mounted Police
Pilatus Aircraft Ltd. PC-12/47E, C-GMPX
Whitehorse/Erik Nielsen International Airport, Yukon
17 April 2023

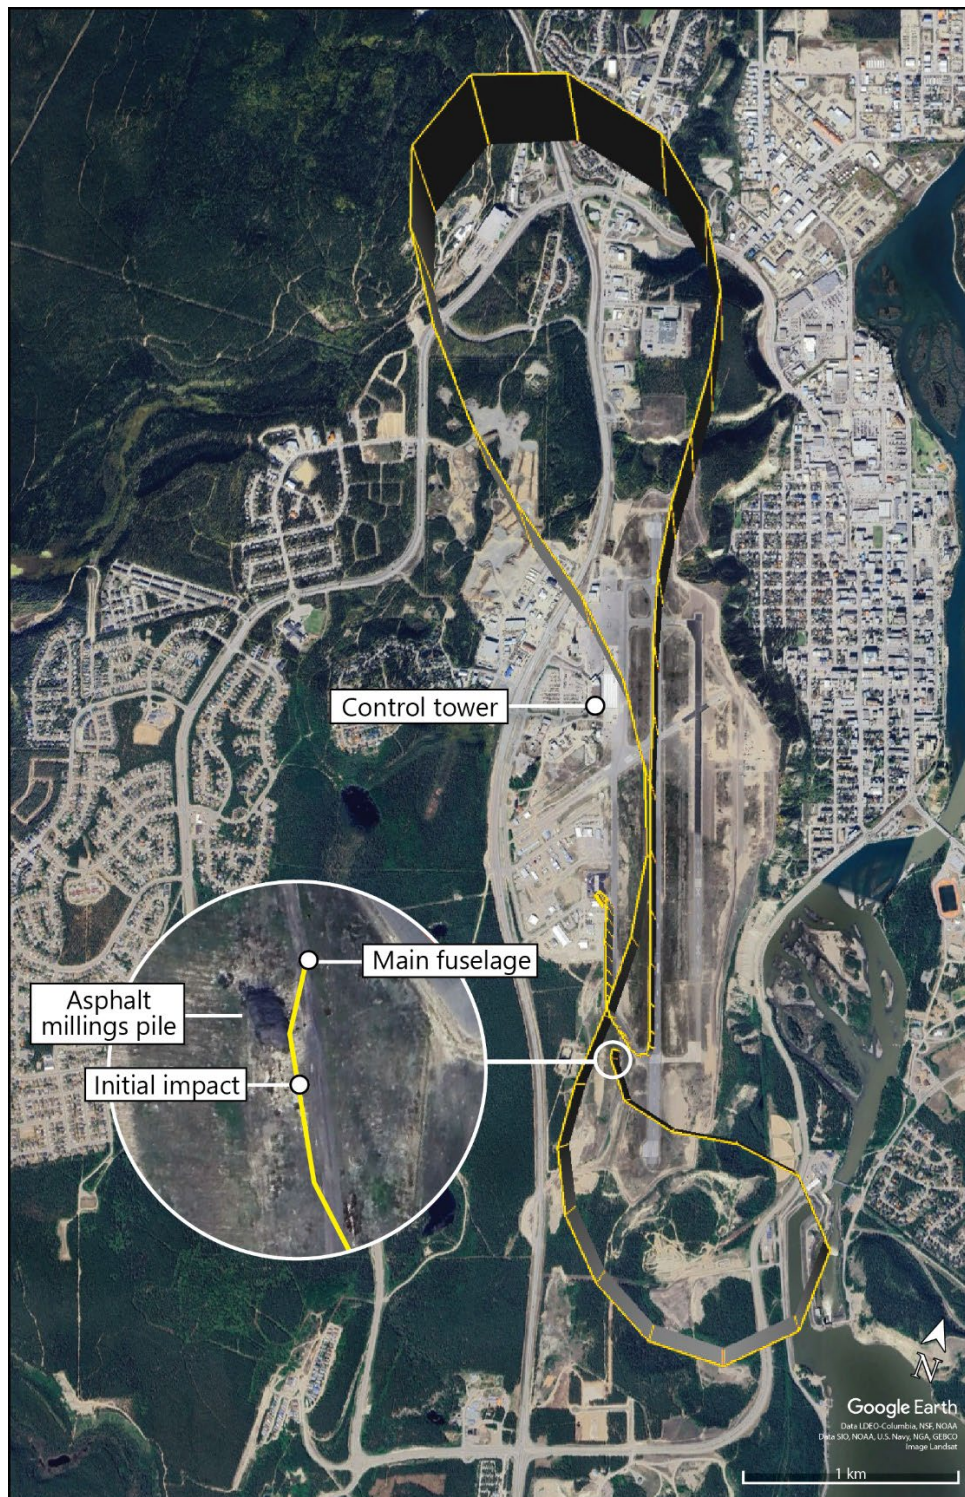
While attempting to line up for Runway 14R, the aircraft passed roughly halfway between the runway and the control tower, at a height of approximately 450 feet AGL (Figure 1).

Figure 1. Map showing the occurrence aircraft's flight track, with a close-up of the impact location and the final location of the main fuselage in inset (Source of main image and inset image: Google Earth, with TSB annotations)

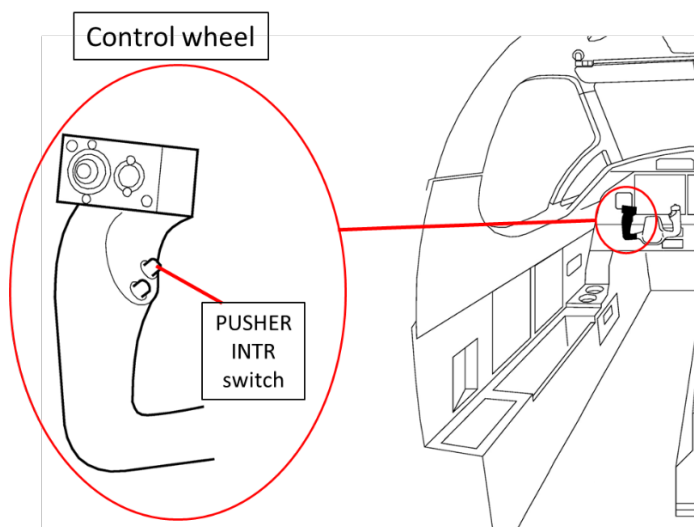
Each outboard control wheel horn is equipped with a PUSHER INTR switch (Figure 2), which, as long as it is pressed, enables the pilot to quickly disable the pusher and allows for free movement of the elevators from the cockpit using the control column.

Figure 2. Left control wheel in the cockpit, with a close-up in inset showing the PUSHER INTR switch (Source: Pilatus Aircraft Ltd., Report No. 02277, *Pilot's Operating Handbook and EASA Approved Airplane Flight Manual*, Revision 23 [14 October 2022], section 7-21: Stall Warning / Stick Pusher System, Figure 7-21-1: Stall Warning/Stick Pusher System [Sheet 3 of 3], p 7-21-7, with TSB annotations)

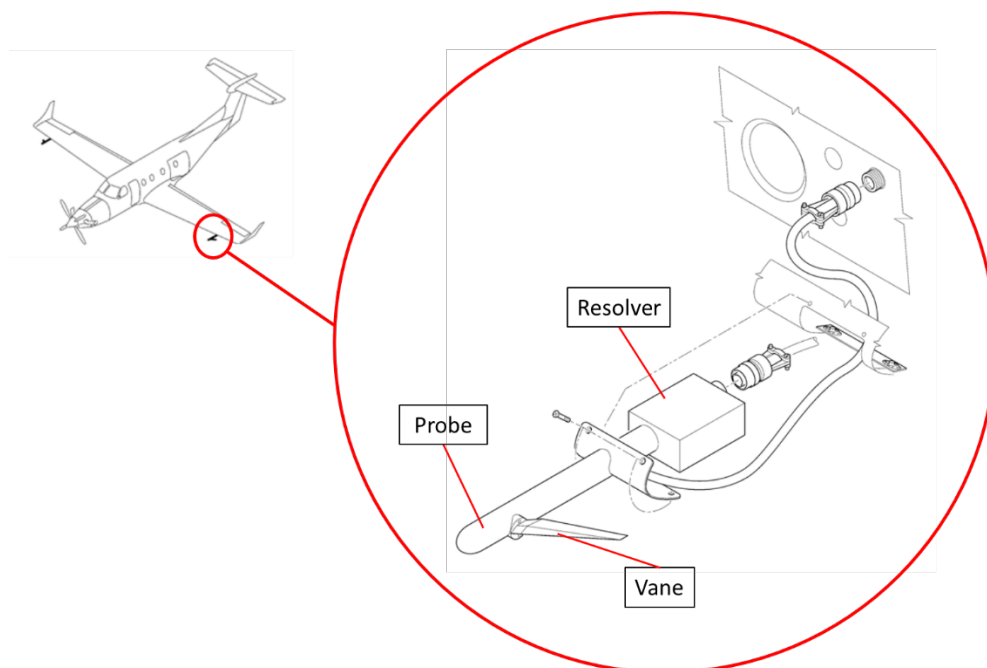
The AOA system uses moveable, electrically heated vanes on probes, located on each wing, that extend forward from the leading edge (Figure 3). According to the POH, during the pre-flight inspection, pilots must check both AOA probes to ensure "free movement."¹⁶

Figure 3. Angle of attack system, with close-up of vane and probe in inset (Source: Pilatus Aircraft Ltd., Doc. No. 02300, *PC-12/47E Aircraft Maintenance Manual*, Issue 01, Revision 30, Figure 1: AOA Transmitter – Removal/Installation, p. 5, with TSB annotations)

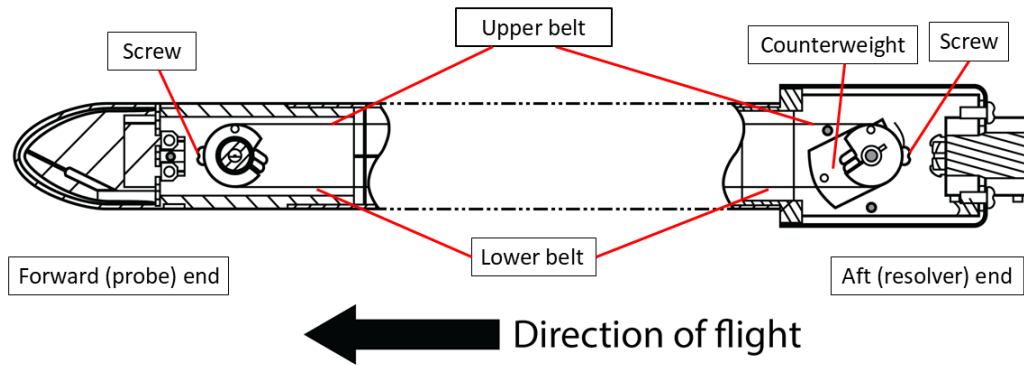
As the AOA vane moves based on relative airflow, its movement is transmitted ultimately to the stick pusher computer via a small stainless steel belt (approximately 4 mm wide by 432 mm long by 0.05 mm thick) on a pulley-type system (Figure 4). The belt forms a loop and wraps around a pulley at the probe (forward) end of the pulley system, where the belt is secured by a screw. The 2 ends of the belt wrap around a 2nd pulley at the resolver (aft) end of the pulley system, overlap each other, and are also secured with a screw.

Figure 4. Schematic diagram of the general assembly of the angle of attack system (Source: TSB)

If the lower belt were to be severed or detached from either pulley, the rotation of the vane would not be transmitted to the resolver, and the tensile aligning forces on the belt would be lost. The free rotation angle of the counterweight (as a result of gravitational forces) is greater than its nominal rotational angle range when the belt is intact. Therefore, if there were a broken or detached lower belt in any flight attitude, gravitational forces would cause the counterweight to rotate and drop to a position at the bottom of the resolver.

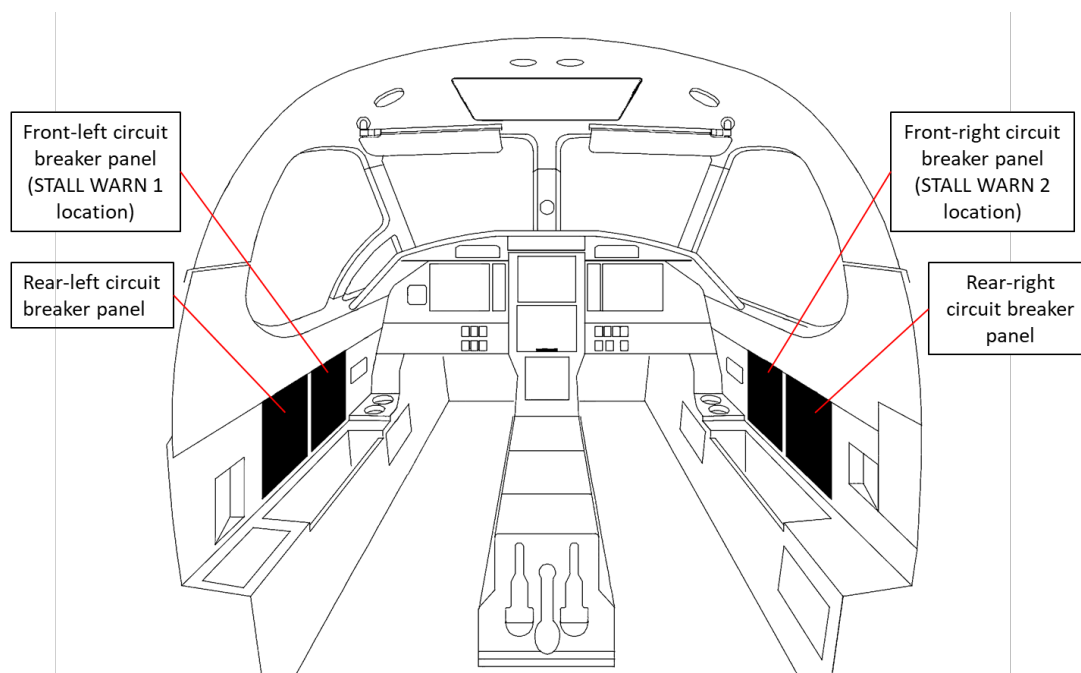
The STALL WARN 1 circuit breaker is located on the front-left circuit breaker panel, approximately adjacent to the left pilot’s seat (figures 6 and 7). The STALL WARN 2 circuit breaker is located on the opposite side of the cockpit, on the front-right circuit breaker panel, outboard of the right pilot’s seat (figures 6 and 8). The STALL WARN circuit breakers are not collared.²⁴ According to Pilatus, circuit breakers are grouped by their associated electrical bus and, to ensure physical bus separation, placed on individual circuit breaker panels.²⁵

Figure 6. Cockpit layout showing location of circuit breaker panels and STALL WARN circuit breakers (Source: Pilatus Aircraft Ltd., Report No. 02277, Pilot's Operating Handbook and EASA Approved Airplane Flight Manual, Revision 23 [14 October 2022], section 7-13: Electrical, p. 7-13-10, with TSB annotations)
