# AIR TRANSPORTATION SAFETY INVESTIGATION REPORT A24P0054

## COLLISION WITH TERRAIN

Privately registered  
Murphy Rebel (amateur-built aircraft), C-FTWO  
Squamish Municipal Aerodrome (Don Patrick Field) (CYSE),  
British Columbia, 12.5 NM SSW  
24 May 2024

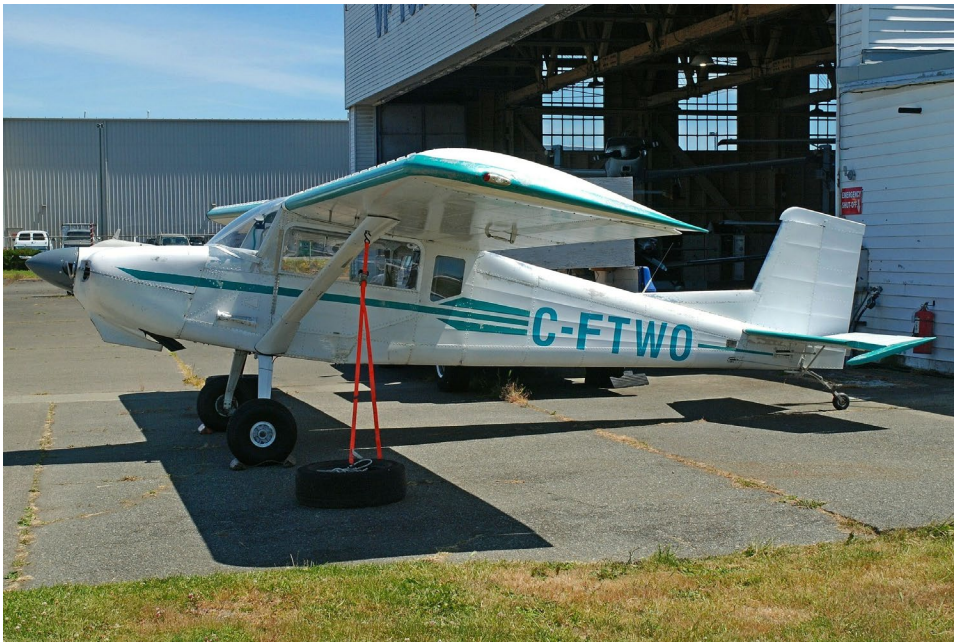
The occurrence aircraft was an amateur-built Murphy Rebel manufactured in 2000. It was equipped with a Franklin Aircraft Engines 4A-235-B31 reciprocating piston engine and a metal, fixed-pitch propeller (Figure 2). The aircraft was not equipped for flight under instrument flight rules.

Figure 2. Occurrence aircraft (Source: Third party, with permission)
