# MARINE TRANSPORTATION SAFETY INVESTIGATION REPORT M22A0258

## ENGINE ROOM FIRE

Roll-on/roll-off ferry *Holiday Island*  
Wood Islands, Prince Edward Island  
22 July 2022

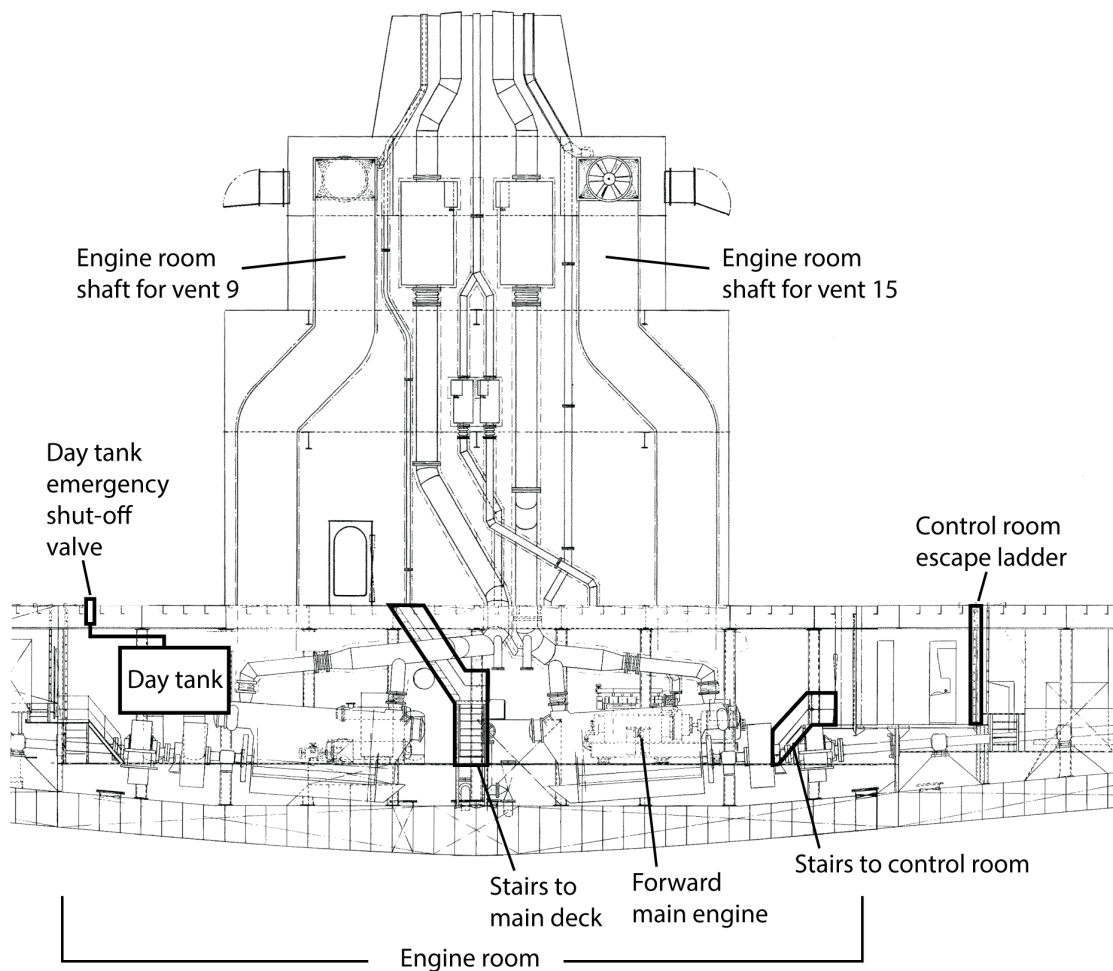
Figure 3. Profile view of the centre of the *Holiday Island* from the starboard side, showing the main engine room, engine control room, and engine room ventilation (Source: Port Weller Dry Docks Ltd., with TSB modifications)

The master used an intercom system to speak with the second engineer, who was in the ECR and who confirmed that there was a fire, informed the master that the engines had to be shut down, and then began to shut them down. The master then used the PA system to instruct all crew to prepare for an engine room fire. Deckhand 4 began to close vents and dampers. At the same time, the assistant engineer and the fourth engineer attempted to enter the main engine room from the main deck stairwell (Figure 3) but determined that the main engine room was too hot to enter. The assistant engineer went to don his firefighting suit.

Shortly afterward, the chief engineer went down to the main engine room. He also attempted to enter the engine room using the same door on the main deck but saw flames at the bottom of the stairs and closed the door. He then entered the ECR using the emergency escape hatch.
