AVIATION INVESTIGATION REPORT

A02A0107

RUNWAY OVERRUN

DC-8-63F N441J

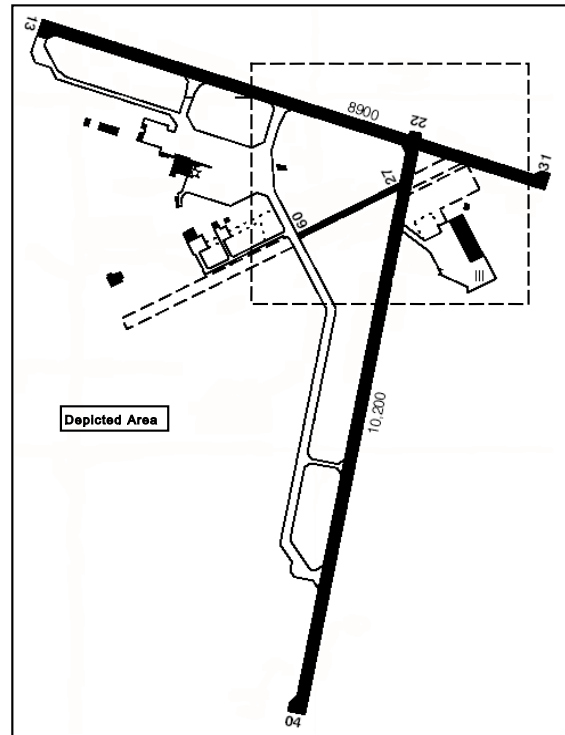
Appendix A - Runway Diagram

A runway analysis chart is used to calculate the maximum landing weight of the aircraft for a particular runway. The chart takes into account wind and runway surface conditions and is based on the aircraft touching down at the calculated landing speed. The runway analysis chart used by the crew indicated a 1020 feet runway length reduction, leaving a usable runway length of 9180 feet. It should actually have reflected information from a published NOTAM indicating that the threshold of Runway 22 had been relocated 1100 feet (from 10 200 feet to 9100 feet), leaving a landing distance available for Runway 04 of 9100 feet.
