AVIATION INVESTIGATION REPORT

A02O0123

CARGO BAY FIRE

BOEING 767-300 C-GHML

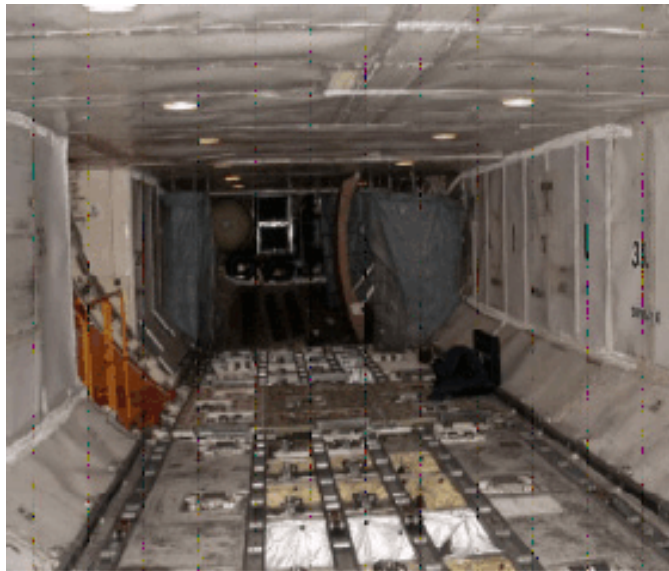
Photo 2. Aft cargo compartment

There are two cargo compartments on the passenger version of the Boeing 767: the forward compartment located ahead of the wings and the aft compartment located behind the wings. The aft compartment is subdivided into a main section and a bulk cargo section (see Photo 2). The bulk cargo section is at the aft end of the aft compartment and has an aluminum sloping floor due to the geometry of the aircraft. The bulk cargo area is separated from the main section by a cargo-restraining net and can be accessed independently through a door on the left side of the aircraft. There are six roller tracks with power drive units (PDUs) to facilitate moving cargo/baggage containers longitudinally through the cargo compartments. The tracks are located at buttock line (BL) 44, BL 22 and BL 6 left and right. The PDUs are controlled by externally accessed controls located behind a panel, adjacent to the cargo compartment door, on the right side of the aircraft.
